## DETAILS OF INTERESTING CLAIM

No: DOIC 62 (CAR)

Retention wall

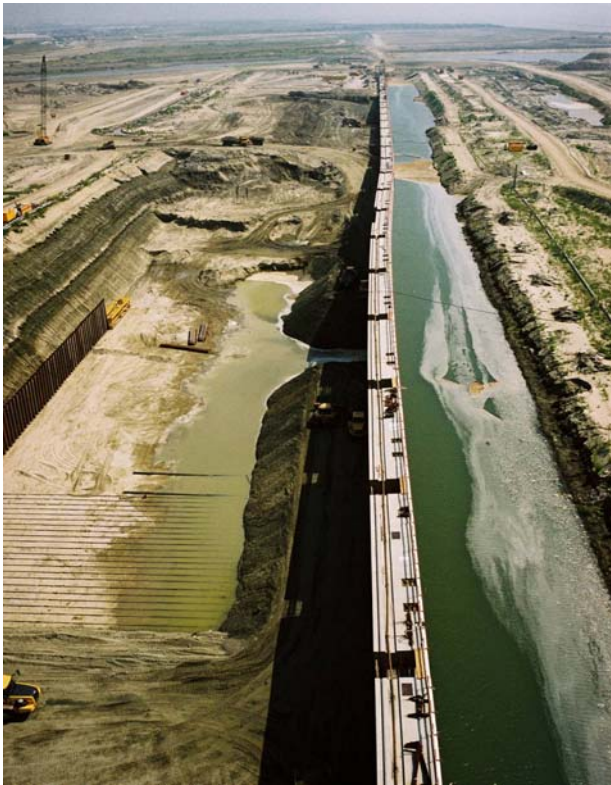
At the time of the loss, 350 m of the wall were finished with top coping and pinning and exposed to the water behind the dike because the dredging had already started. Tide movements gradually hollow out the underwater part of the first cofferdam until it broke. Soon afterwards, the second cofferdam, not being able to resist the water pressure, yielded letting the water flood the ditch.

Retention wall and flooded ditch

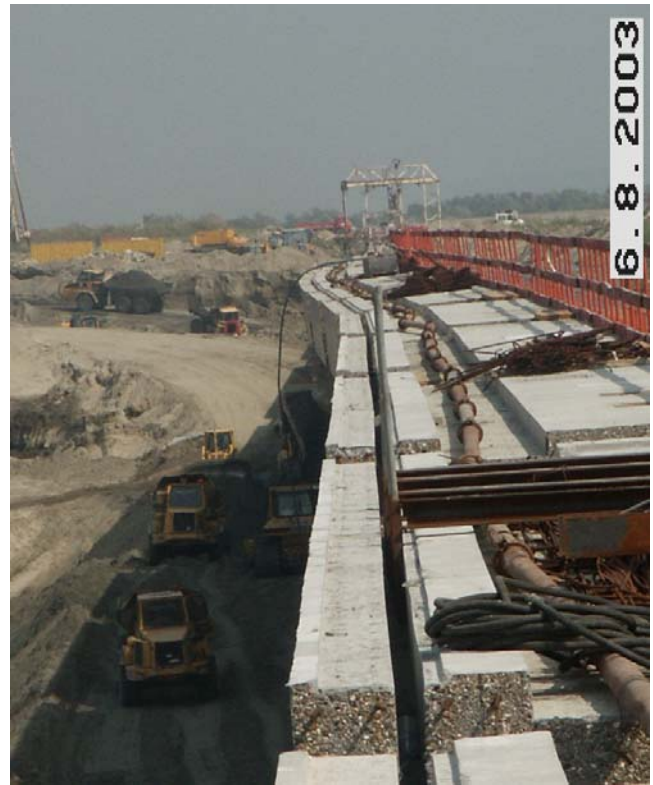
The water stream broke into the ditch and quickly reached the other ditch end, bounced and returned in the direction it had come, in a progressive wave mode. As a result of this, the part of the wall that was still not reinforced by pinning and earth was stretched and cracked (see pictures in power point presentation attached).

Deformed section of retention wall

The cause of the loss was a rupture of the cofferdam due to a design error and the action of the sea. No specific “*normal action of the sea*” exclusion was attached to the policy since it was initially understood that the quay was going to be built fully onshore.

Harbour and sea works are intricate and as such difficult to assess and price. The size of the accepted share should reflect these uncertainties. In addition, never consider works in a harbour as dry, even if the main part of the construction is going to be executed on earth. An exclusion of “*normal action of the sea*” should always be inserted.
