**Nondestructive Examination of Turbine and
Generator Components
Experience with Mechanized Examination Techniques**

Michael Siegel*, Hans Rauschenbach*, Bruno Metzner**

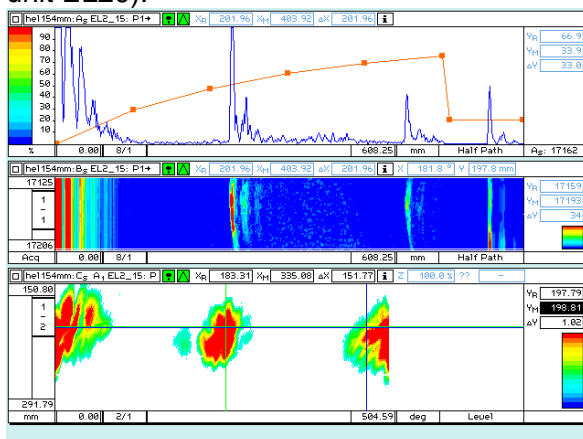
The maximum reflectivity of the indication was a little bit lower in both the manual and the mechanized examination. In the manual examination, an axial half-value extension of approximately 30 mm (2 MHz vertical search unit, \varnothing_{eff} 15 mm) was determined. Assessment of the data recorded in the mechanized ultrasonic examination resulted in a half-value extension of approximately 23 mm (search unit B4S-O, measurement results shown in Figure 4). The backwall echo attenuation was 12 dB, the same value as in the first examination (search unit EL20).

Figure 3
A-, TD- and C-scan of the indication area using search unit EL2-15 (2 MHz)

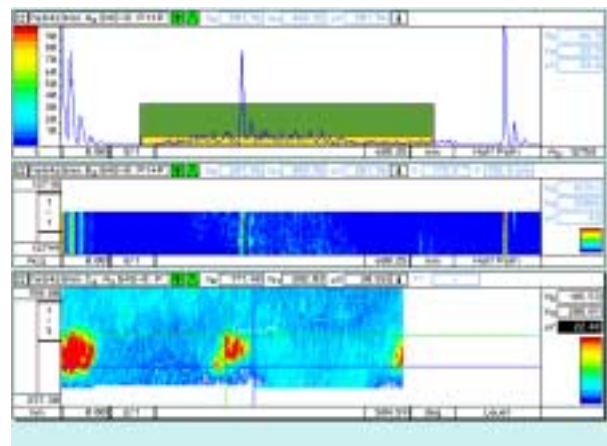
Figure 4
A-, TD- and C-scan of the indication area using search unit B4S (4 MHz)

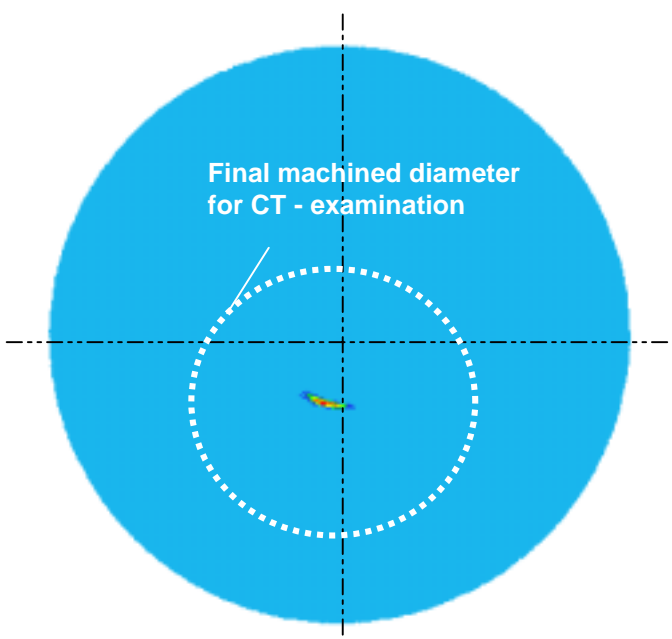
In addition, the synthetic aperture focusing technique (SAFT) was used to determine the position of the indication. This technique enables the position of the ultrasonic indication in the cross-section of the examined turbine shaft to be established on the basis of the determined ultrasonic data (see Figure 5). To verify the examination result, the indication area was removed and subjected to X-ray CT (computerized tomography) examination by the Federal Institute for Materials Testing (BAM) in Berlin. A flaw extension of approximately 17 mm in the axial direction and around 10 mm in the tangential direction was determined using this technique (see Figure 6).

Figure 5
SAFT reconstruction of ultrasonic examination result (2 MHz)

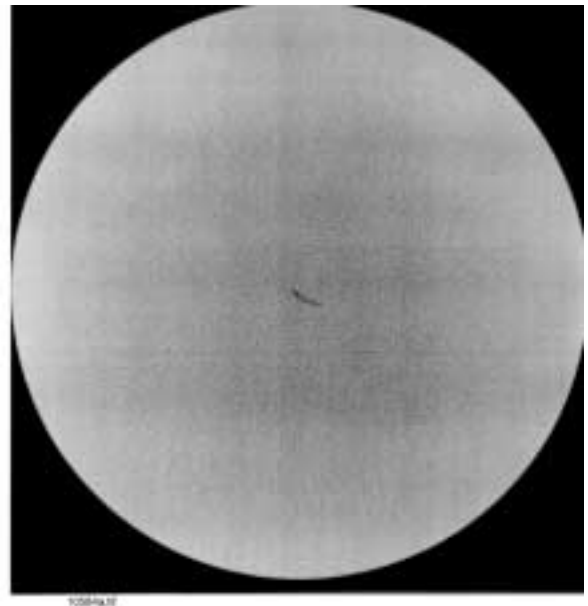
Figure 6
CT examination (by BAM Berlin) of the indication area, Feed pump turbine shaft, detectable flaw width = 10 mm

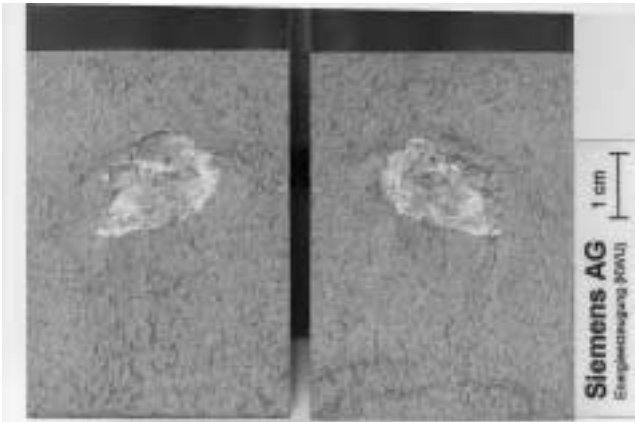
Figure 7 shows the two halves of the CT specimen after forced fracture. The appearance of the flaw differs clearly from the fracture surface. Dimensions are shown in Figure 8 (extension along long axis: 21.86 mm; extension along short axis: 14.38 mm; area approx. 215 mm²). The surface of the flaw was covered with a crystalline layer. Analysis showed this to be aluminum oxide (Al₂O₃).

Figure 7
Fracture surface of CT specimen, showing exposed flaw

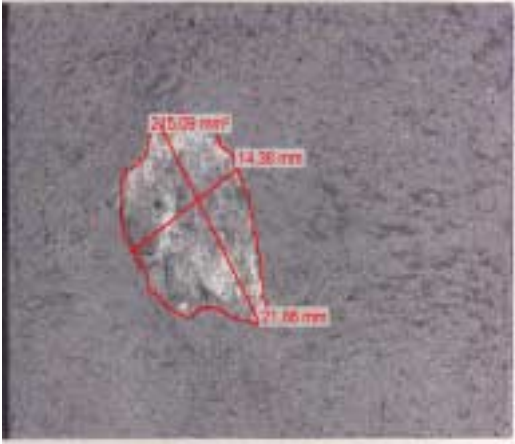
Figure 8
Determination of actual flaw size following forced fracture of the CT specimen

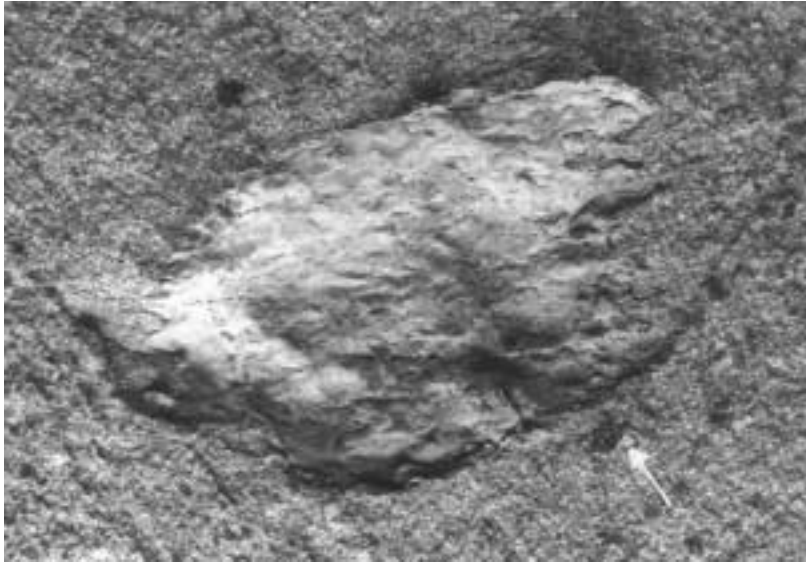
Figure 9
Flaw following forced fracture
of the CT specimen

Figure 9 shows the surface of the flaw. It differs clearly from the surrounding fracture surface of the CT specimen, and appears macroscopically to be smoother, viewed. Fractographic examination using a scanning electron microscope, in addition to provide information on the type of flaw, was aimed in particular at clarifying whether a service-induced change has occurred. A statement for this is from the following reason unambiguously possible.

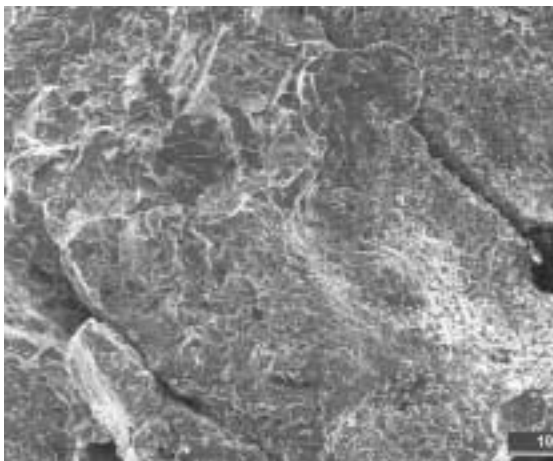
The flaw surface and the flaw/fracture surface transition were systematically examined using the scanning electron microscope. The flaw surface (Figure 10) exhibits the typical structure, with inclusions characteristic of manufacturing flaws. These are internal voids with exposed surfaces, which were not adequately compressed/closed by the forging process. The aluminum oxide inclusions are distributed across the whole flaw. The flaw boundary (designated F) and the adjacent fracture surface (designated S) are shown in Figure 11. Cleavage faces are characteristic of the fracture structure arising on forced rupture of the specimen.

Figure 10 Flaw surface

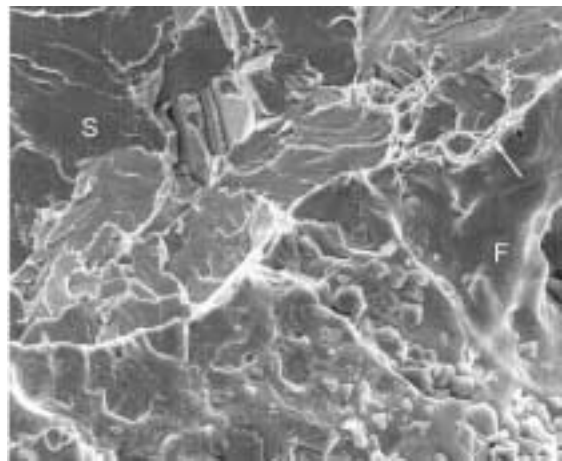
Figure 11
Flaw boundary (F) with transition (marked with arrow) to fracture surface of CT specimen (S). Aluminum oxide inclusions are distributed across the whole flaw.

The results of the fractographic analysis show that the indications arising from the ultrasonic examination were caused by a manufacturing flaw in the form of a void (shrinkage cavity) inadequately closed by forging, in conjunction with an accumulation of aluminum oxide. There were no indications of service-induced changes.

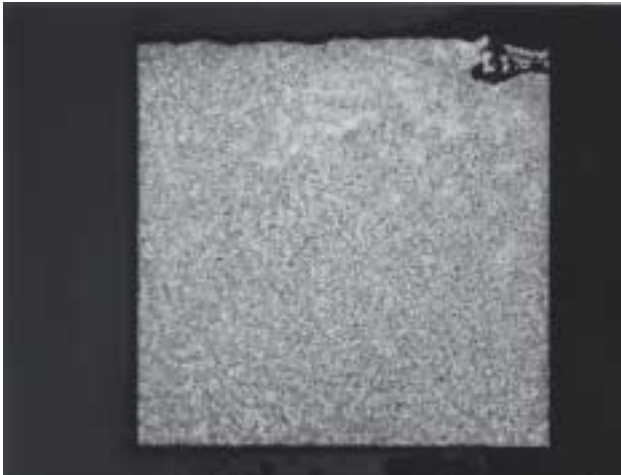
Figure 12 Section through the flaw; the top edge of the section corresponds to the surface of the flaw.

Sections through the flaw were made using the other half of the CT specimen (the part of the specimen not examined using the scanning electron microscope). The section was made through the center of the flaw (Figure 12). Analysis using polarized light shows that the voids are filled with aluminum oxide (Figure 13).

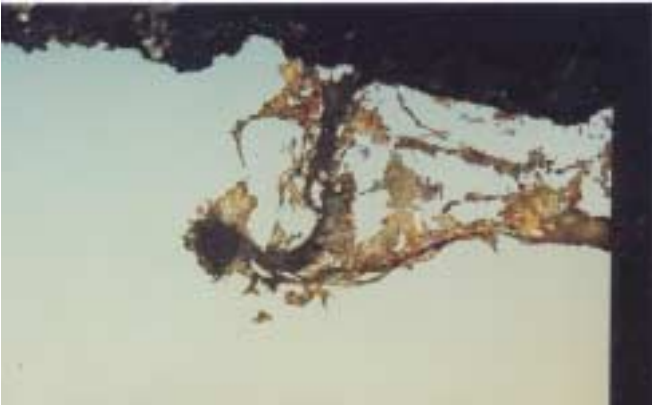
Figure 13 Flaw center; the aluminum oxide inclusions become optically active when polarized light is used.

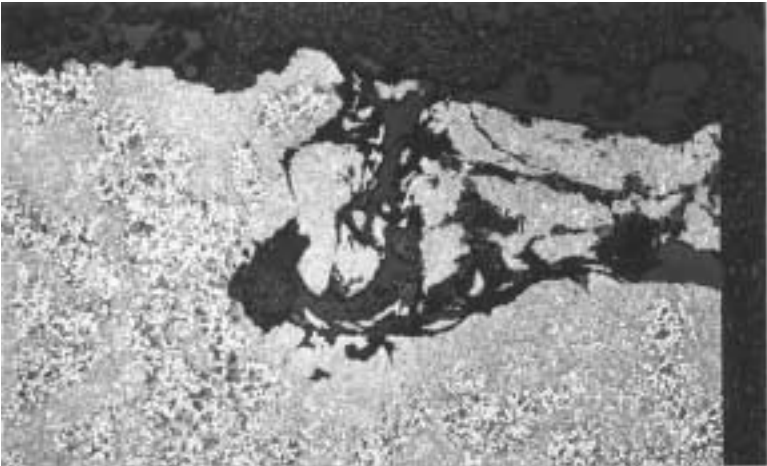
Figure 13 a Flaw center; inhomogeneous structure consisting bainite and ferrite/perlite.

The structure exhibits extensive inhomogeneities in the form of bainite structure and ferrite/perlite components (Figure 13). Micro-hardness measurements highlighted significant differences in hardness between the ferritic/perlitic structure and the bainite (approximately 200 HV and 320 HV respectively).

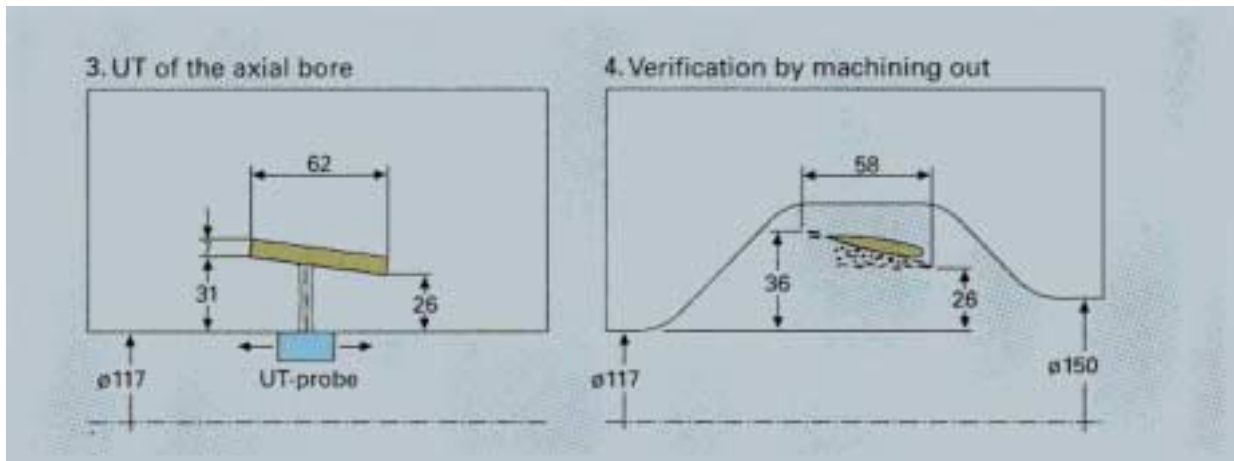
A single indication (equivalent to a circular reflector size 5.5 mm in diameter) was identified in the gland area during ultrasonic volumetric examination from the outside surface of an HP turbine shaft of Russian design (LMZ). This indication was located approximately 26 mm from the surface of the through axial bore. No indications were identified during surface crack testing of the axial bore. Ultrasonic examination from the axial bore confirmed the indication detected from the outside. An angular oriented indication (26-31 mm from the bore surface) approximately 62 mm long was identified. Analysis of the recorded echo dynamics enabled a radial extension of 7 mm to be determined. Figure 19 shows the results of the ultrasonic volumetric examination (from the outside surface) and the ultrasonic examination from the bore.

Fracture-mechanics analysis of this flaw led to the assessment that the flaw was unallowable in terms of safe and reliable continued operation of the turbine shaft.

Figure 19
Results of ultrasonic volumetric examination and ultrasonic bore inspection on HP turbine shaft

It was decided to machine away the flaw area in stages while carrying out a surface crack examination (MP examination) to determine the actual flaw size.

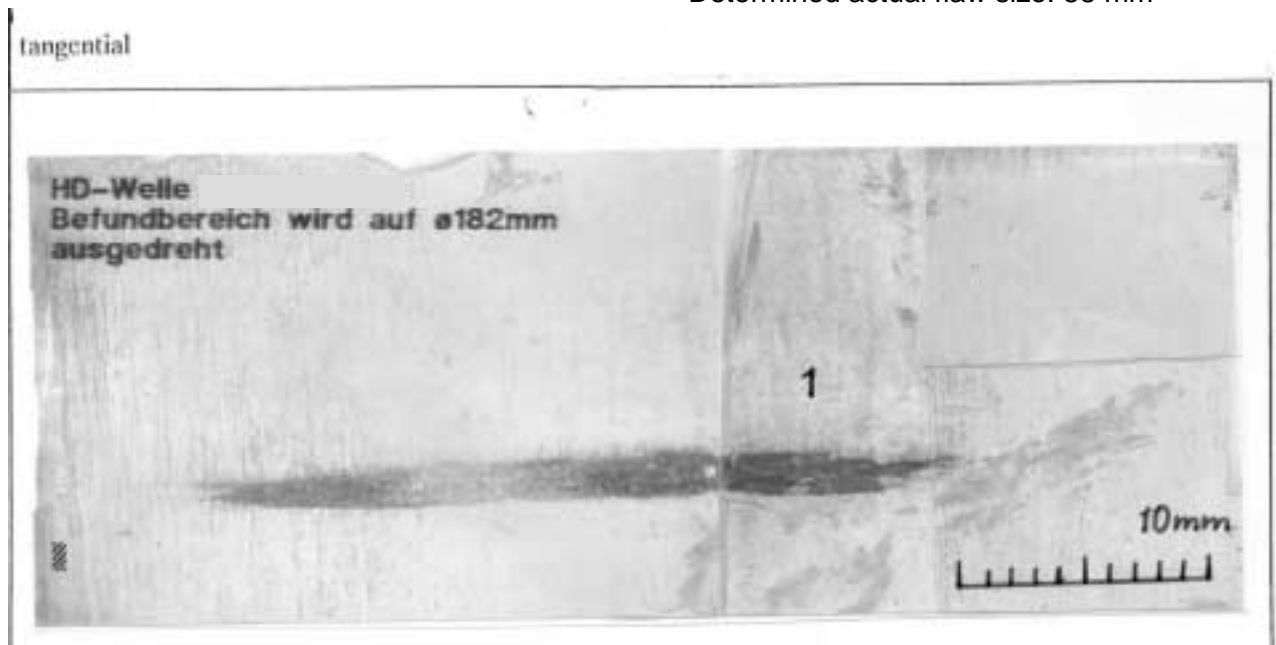
Assessment of all examinations carried out (step-by-step machining-away of the indication area was carried out in 2.5 mm stages, with an MP examination carried out after each stage) showed that the total axial extension of the tube-type forging flaw was 58 mm, and the distance from the original bore diameter was 26 - 36 mm.

Figure 21
Results of MP examination of axial bore during machining away of indication area
Depth from original bore surface: 31 mm

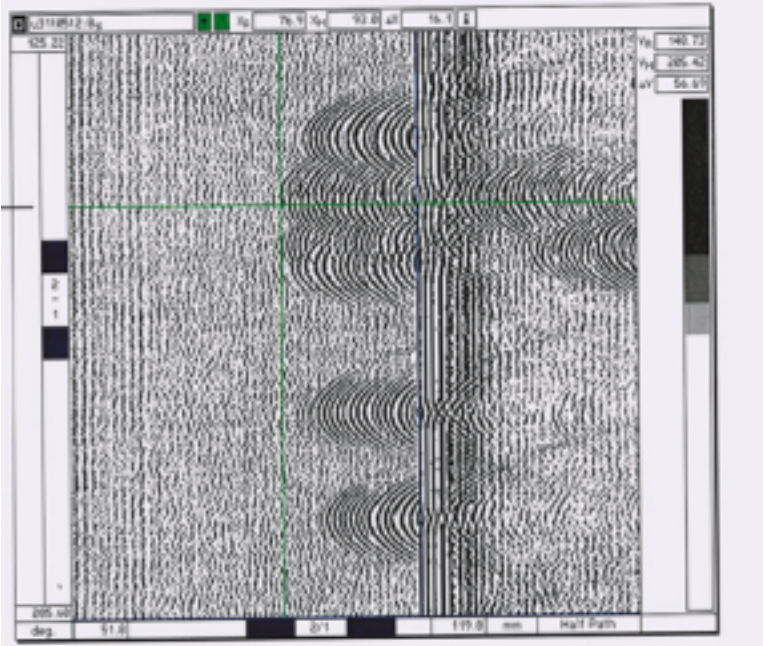
Figure 24
Indication from a
wheel disk inspection
(analytical measure-
ment using TOFD
technique).

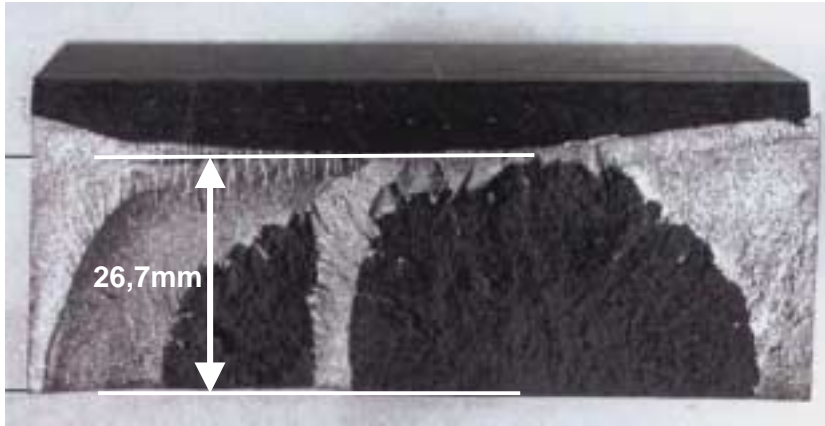
Figure 25
Crack detected during wheel disk inspection, investigated using destructive methods

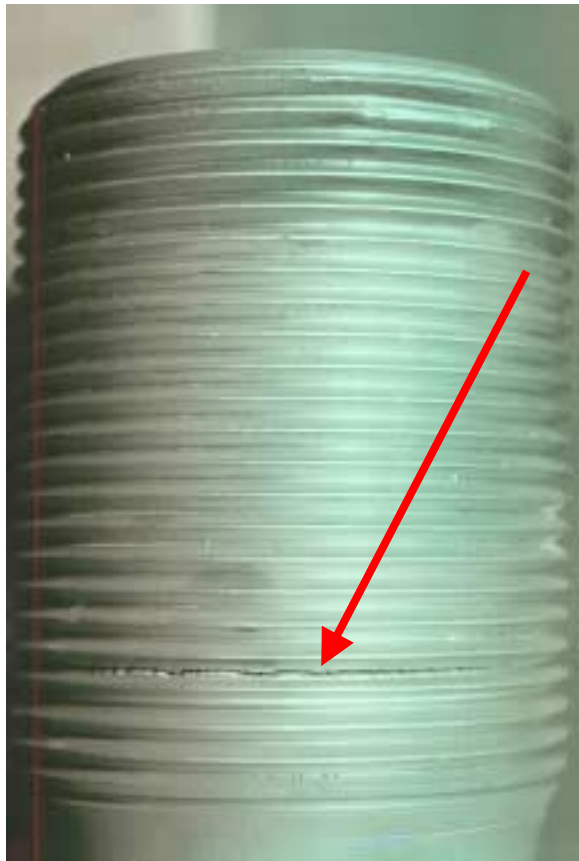
Figure 29
Incipient crack in the thread root of
a bolt
