Short Paper on an interesting case of damage
Machinery Insurance
Prepared for IMIA

Cement mill – Cracks in the mill ends

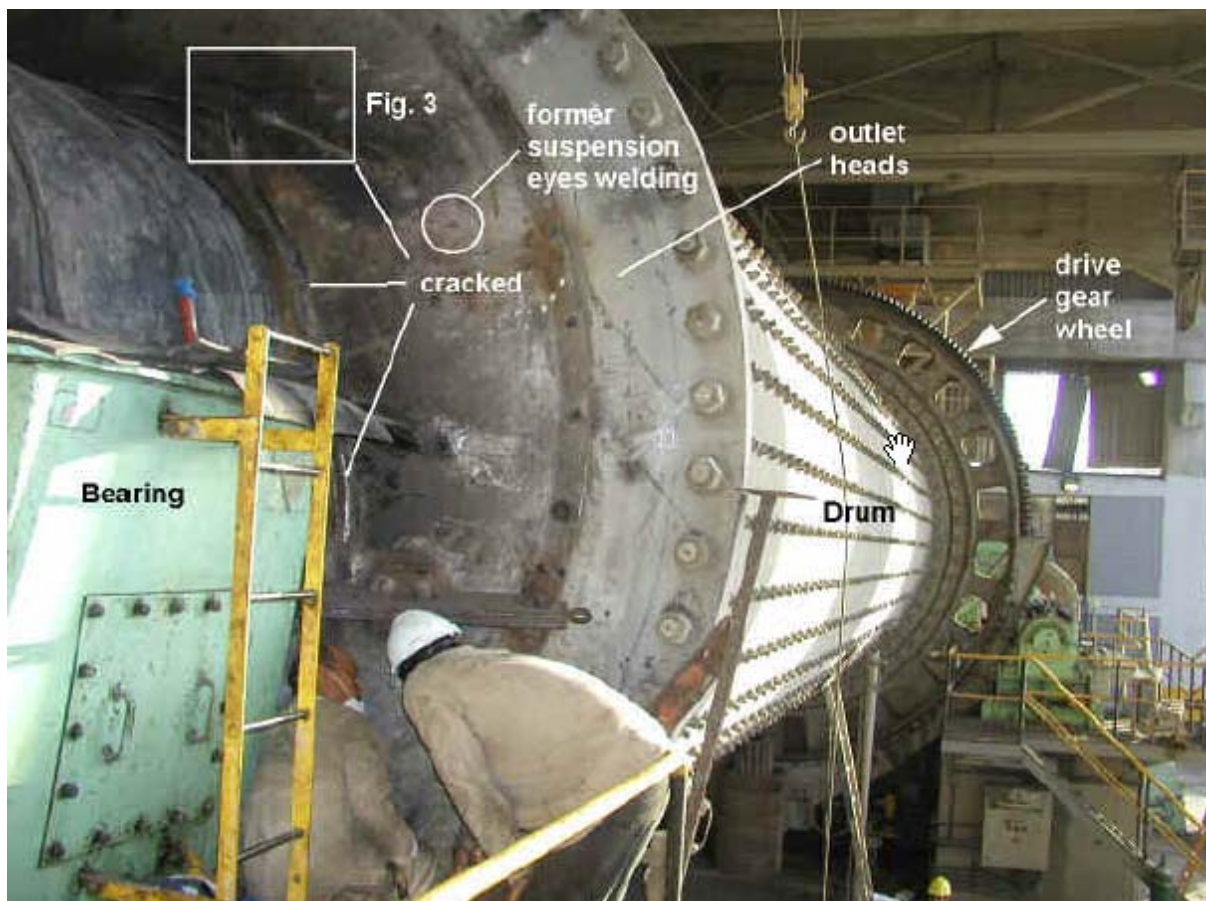
During a routine inspection of a cement mill, the owner of the cement plant noted that one of the cement mills was damaged. Severe cracks were found in the feed and discharge areas (inlet and outlet) of the cylinder ends of the mill. The crack at the outlet end already had progressed for almost 270° of the circumference, and there was a danger of the end breaking apart. This would have resulted in a substantial business interruption loss in addition to the material damage.

Figure 2: Tube mill with broken outlet head
 Source: Allianz Centre for Technology, Ismaning

Experts examining the cracks in the outlet end of the cement mill.

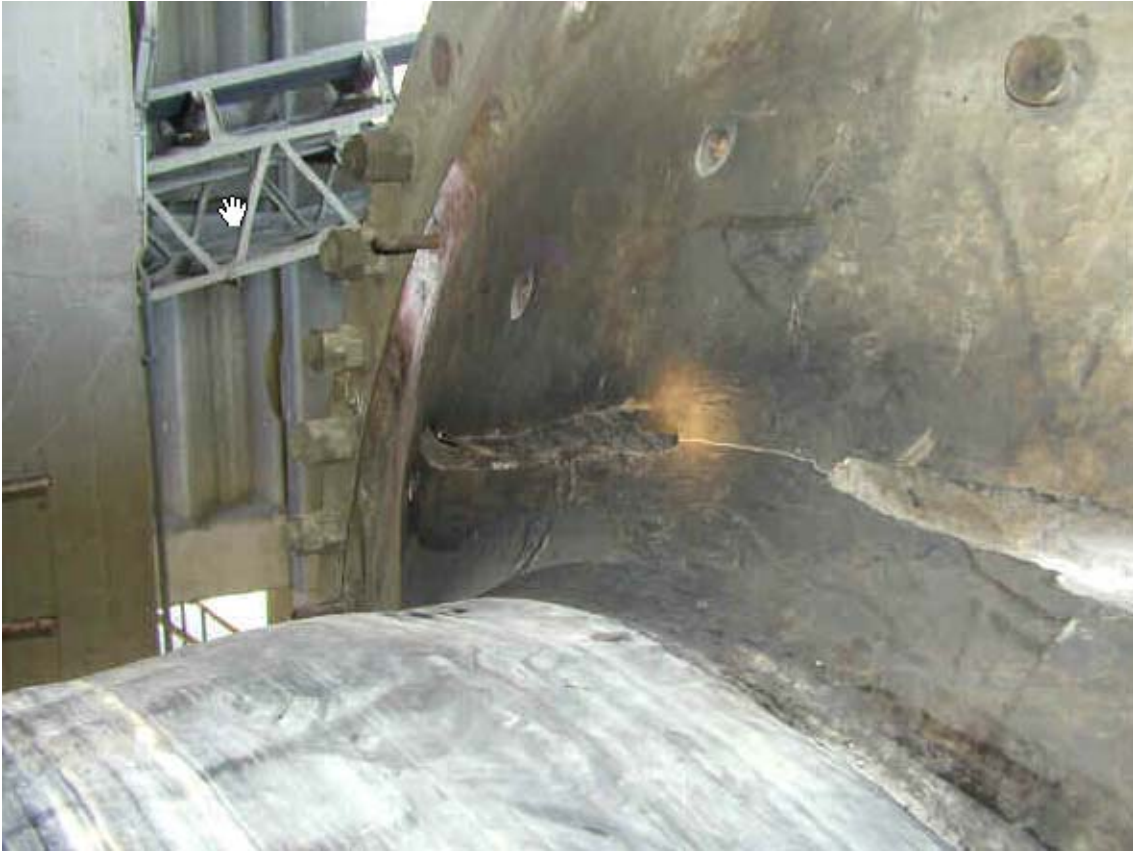
heat treatment. This cast material needs to be preheated to a temperature of 250°C before welding work can start, but when the welding was done, the material could only be preheated to a temperature of 150°C. Hard spots consequently formed in the immediate vicinity of the weld seams. This must have happened when the assembly lugs were welded on, because the cracks started exactly where the lugs had been (see Fig. 2 below). The possibility that further cracks would develop from the provisional repair could therefore not be ruled out completely.

Figure 3: Outlet head; cracks are being repaired

The research institute's recommendation was to grind out the cracks in the cylinder end and repair-weld them, but this was only to be seen as a temporary repair measure. The mill ends would have to be replaced without doubt. In the interests of maintaining operations until the new mill ends became available for replacement, the weld areas were examined every week for further signs of cracking.

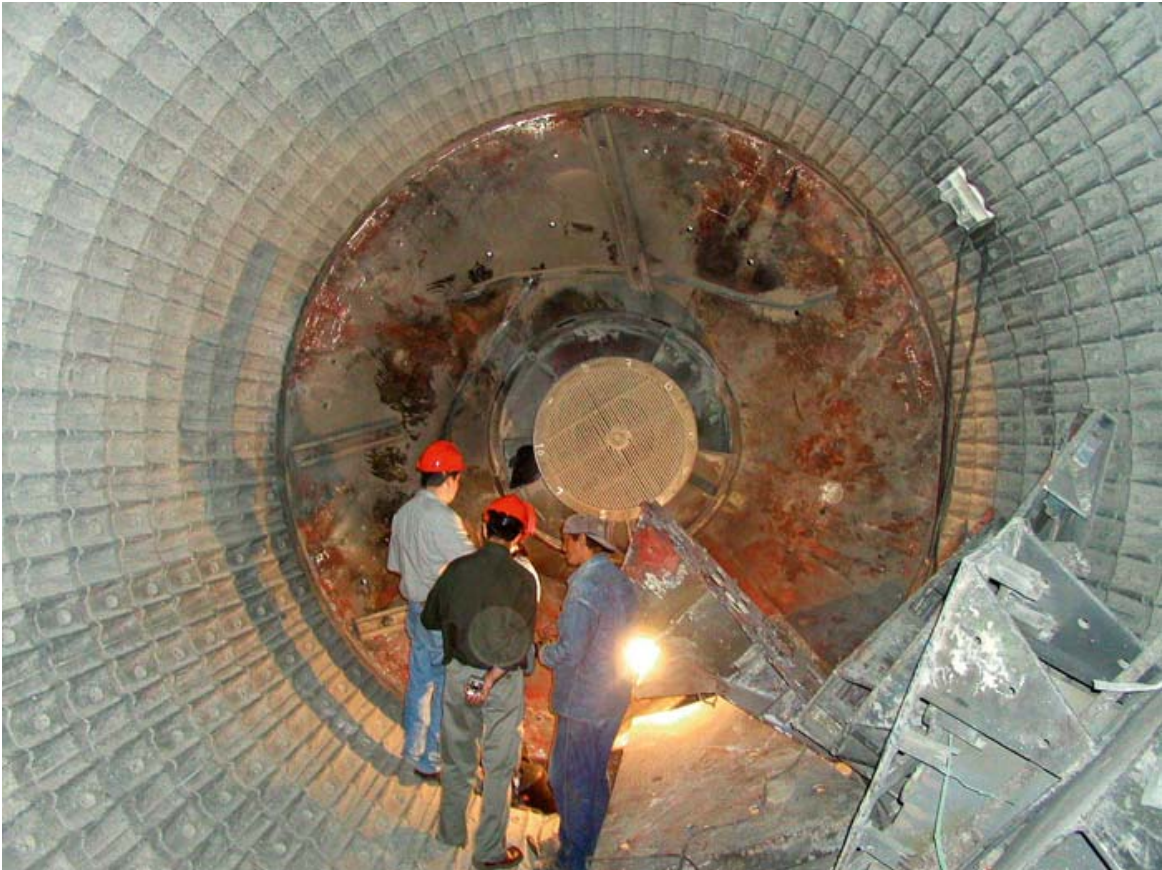
Figure 4: Outlet head viewed from inside the drum

Inside the mill, the crack structure of almost 270° around the outlet shaft is clearly identifiable.

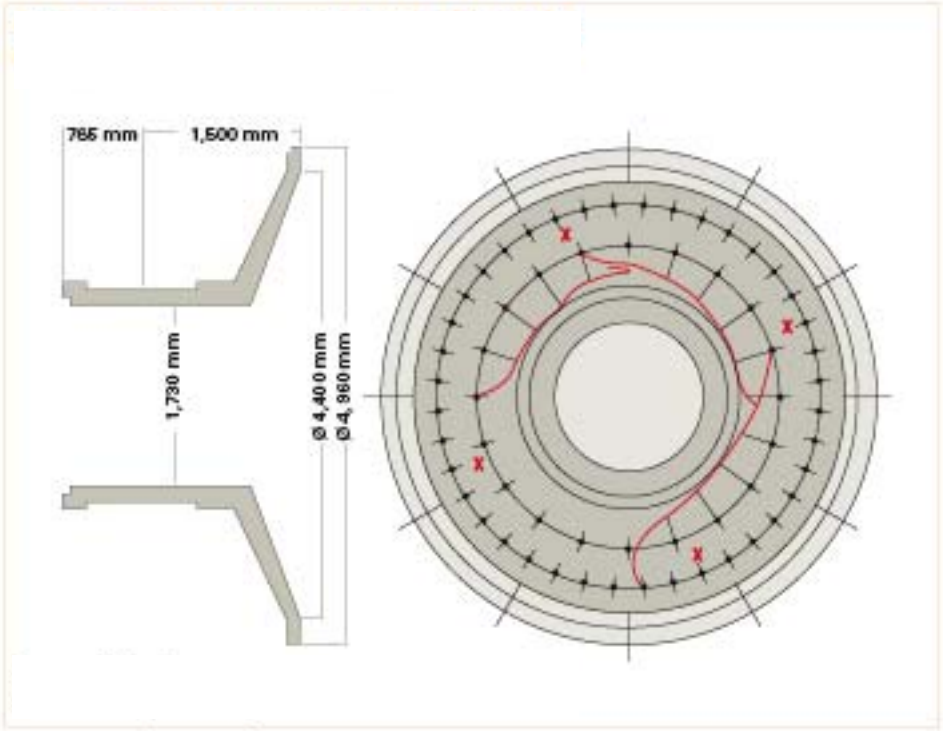
First of all the operating history of the mill had to be studied, which had been built in Eastern Europe at the end of the 1990s. This mill had already been previously operated in other countries, so that it had been erected and dismantled several times. For the erection at the owner's plant, assembly lugs were welded onto the cylinder ends and then removed afterwards. A possible explanation was that the cracks originated at the weld points of the lugs.

Figure 5: The locations of the assembly lugs (suspension eyes) with the crack propagation of approximately 270°
