## Launching of a long span viaduct

## Characteristics of the viaduct

- Length : 590 m
- Spans : 85 + 140 + 140 + 140 + 85
- Structure : lattice girder
- Piles height : 60 m
- Placing : by launch
- Value : EUR 22 m

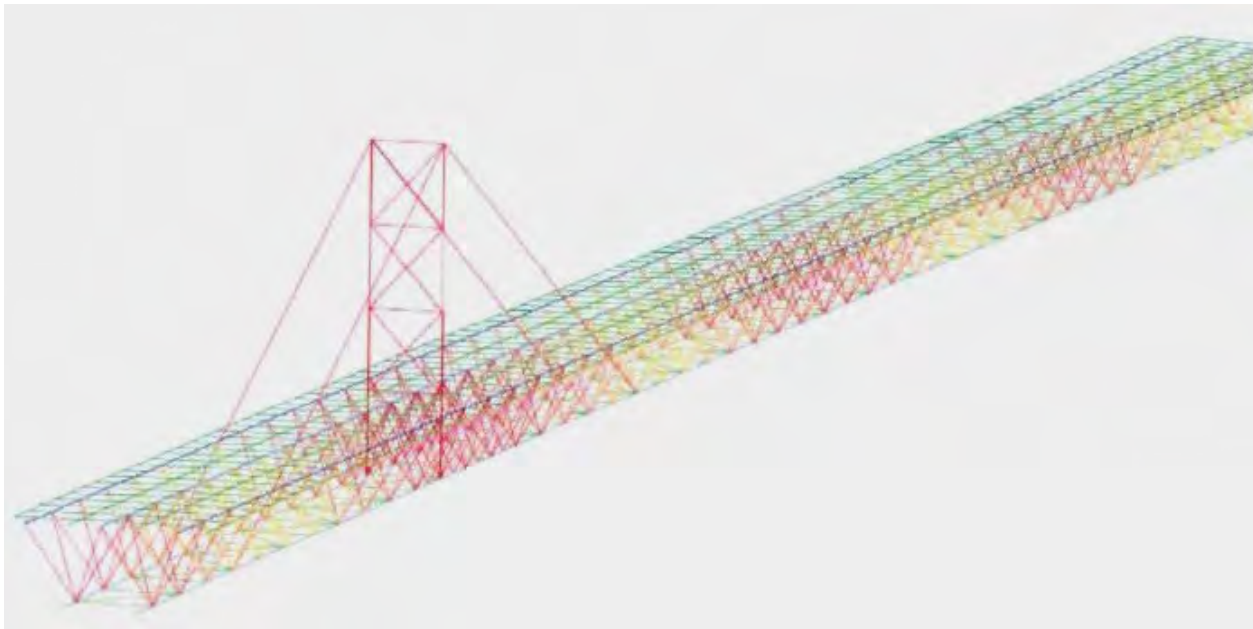
- The launch was carried out with the temporary support of a steel truss tower and a group of 8 post-tensioned cables.
- During the launch through the 4<sup>th</sup> span the girder suffered a sudden large plastic deformation.
