## Broken track cable on a cable car

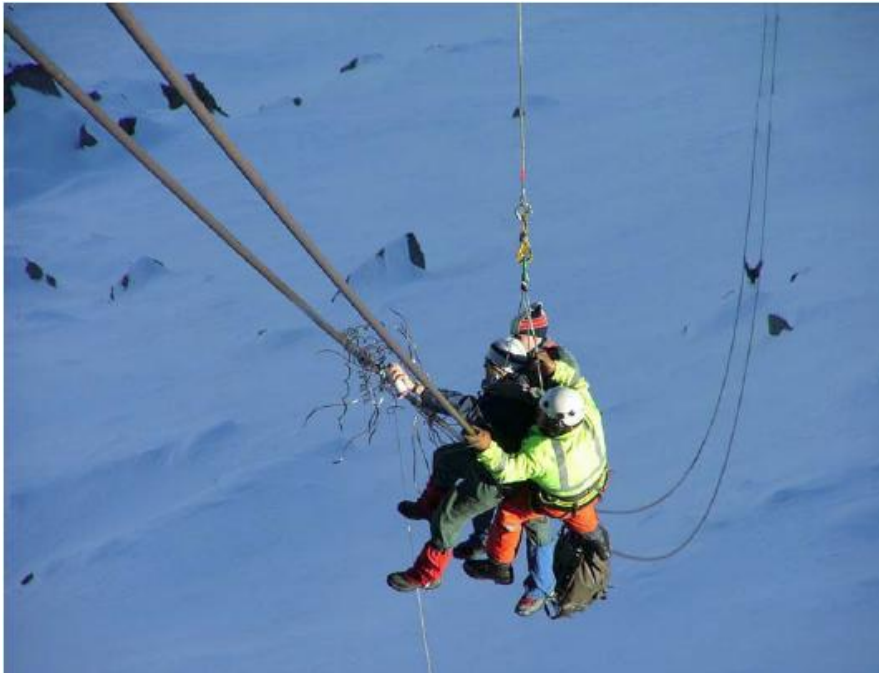
On December 29<sup>th</sup> around midday, cabin No. 1 of the cable car to the Schilthorn was travelling uphill with 53 passengers on board. When it was approximately 200 m below the summit, the staff in the top terminal heard a bang and saw that one of the track cable wires had come out. They stopped the cable car and organised the rescue of the passengers by helicopter. It turned out that all 21 Z-wires which constitute the covering layer had torn. This layer corresponds to 54% of the whole cross section of the track cable. The remaining core wires of the track cable stood firm to the increased weight so that the rescue of the passengers and the subsequent return of the cabins, could be managed without any further incidents.

Picture from the final report published by the investigation authority

**Description of damage:** Based on the examination of the incident it can be reconstructed as follows:

- By the first cable movement in 1979 an abrasion took place between the track cable and the deflecting piece of the top terminal.
- The abrasions were not discovered by the stipulated visual controls or were judged as irrelevant. In the course of time microscopic cracks occurred in the area of the abrasion from hydrogen-induced stress corrosion cracking.

- The progressive damage of the wires could not be detected by the last magnet-inductive test, due to the fact that at that time, most likely, no profile wire had broken yet.

- With time some cracks had reached a critical size which led to the spontaneous break of the affected profile wires.
- There appeared a concentration of cracks, consisting of approx. three to four adjoining spontaneous breaks.

- The broken profile wires came out of the main cable.
- Other profile wires were overstrained and have also broken.
- The released energy of the cable lead to a chain reaction with which all profile wires broke.

**Cause:** The wire damage was initiated by an earlier damage which appeared by the first shifting of the wire. The decisive damage process is based on the hydrogen-induced tension tear corrosion in the area of these damages. Microscopic cracks appeared in the wire surface and the material became brittle. This led to the spontaneous failure to all Z - wires.
