Breakdown of an evaporator during a leak test at a seawater desalination plant

Damage to a boiler and evaporator frame

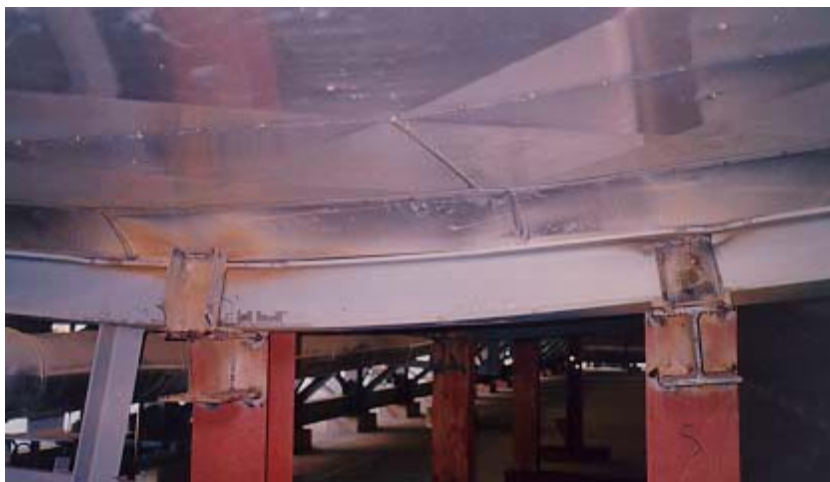
The steel frame securing the boiler was damaged along half of its length. The majority of the equipment in the boiler had to be replaced. Inside the boiler there are 180 supporting columns between the floor and the ceiling. Small cracks were found at the base of 56 columns in 15 of the 21 units. There were major cracks up to 570 mm wide on 37 columns. This is also where the most severe distortions to the boiler occurred. The weld seams were badly damaged and the supporting structure was distorted and distended. In spite of the severe damage, the entire desalination unit remained in place. It was possible to perform all the repair work on site.

water escaping as soon as the desalination unit was completely full. Consequently, the air displaced during the filling process could not escape quickly enough. Finally, substantial pressure built up inside the desalination unit, and this, together with the pressure from the water that had been pumped in, was too much for the underside of the boiler and the supporting structure. The equipment inside the evaporator (chambers, supporting structure, etc.) was damaged by the pressure. In an investigation carried out later, it was found that the pressure had risen to 3.5 bars during the filling process. This was far in excess of the design pressure of 1.5 bars.

Deformation of H-beams and fractured welds

A simple pressure valve on the upper side of the boiler could have prevented this loss – which was the result of human misjudgement – from assuming such large dimensions.

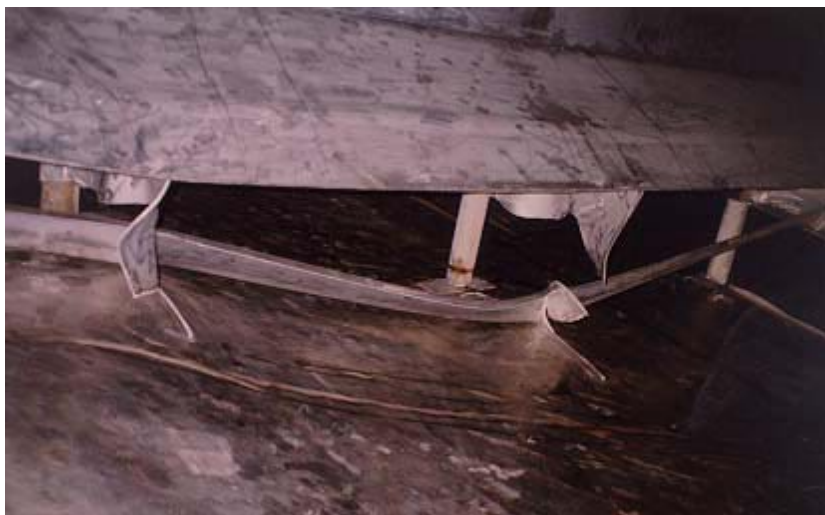
Deformation of separation wall and fractured seams
