DETAILS OF INTERESTING CLAIM

No: DOIC 64 (CAR)

Defective grout of the foundation for the bridge pylons

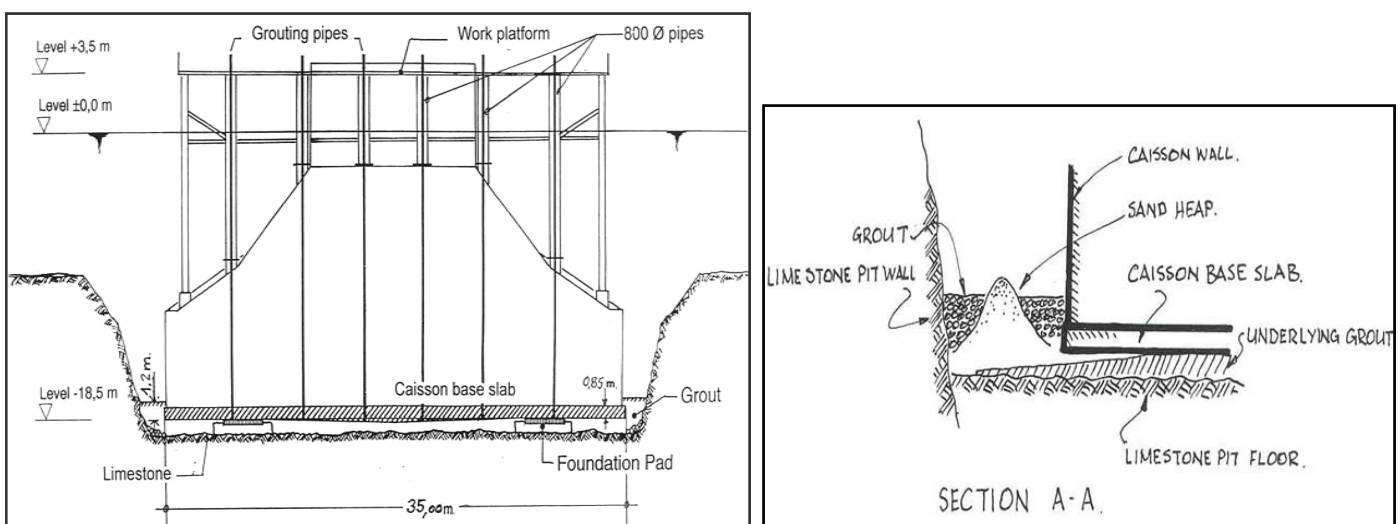
Base grouting had to be stopped for 8 hrs due to bad weather. At that time 50% of grout had been placed. Before recommencing the grouting a diver was dispatched in order to ensure that no seaweed was being mixed with the grout material. He made a video film of this inspection, which was viewed only two days later. After restarting grouting and while viewing this video a heap of sand was observed on top of the grout between the pit wall and the caisson slab at the West pylon. At that time 95 % of grout had been placed.

After careful investigation it was concluded that no sand had been washed into the trench from the seabed but that the grout had de-mixed or had been washed out and therefore the sand stemmed from the grout. Additional core drillings confirmed that there was sand at various locations below the base slab. It was feared that the grout was likely to be inadequate for its intended purpose.;

The root cause of the de-mixing or erosion of the grout could not be unambiguously determined. Adverse weather conditions could not be proven to be the cause.

Initial repair works included backfilling of grout on the outside of the caisson and drillings within the caissons cells. The final repair was based on additional investigations and the confirmed

nature of the problem and extent of defect. Jet grouting and pressure conductivity systems were applied.
