Systemic Causes for failure of geotechnical works around the world

David E Sherwood
FREng, CEng,
FICE, BSc,
Director-Bachy
Soletanche

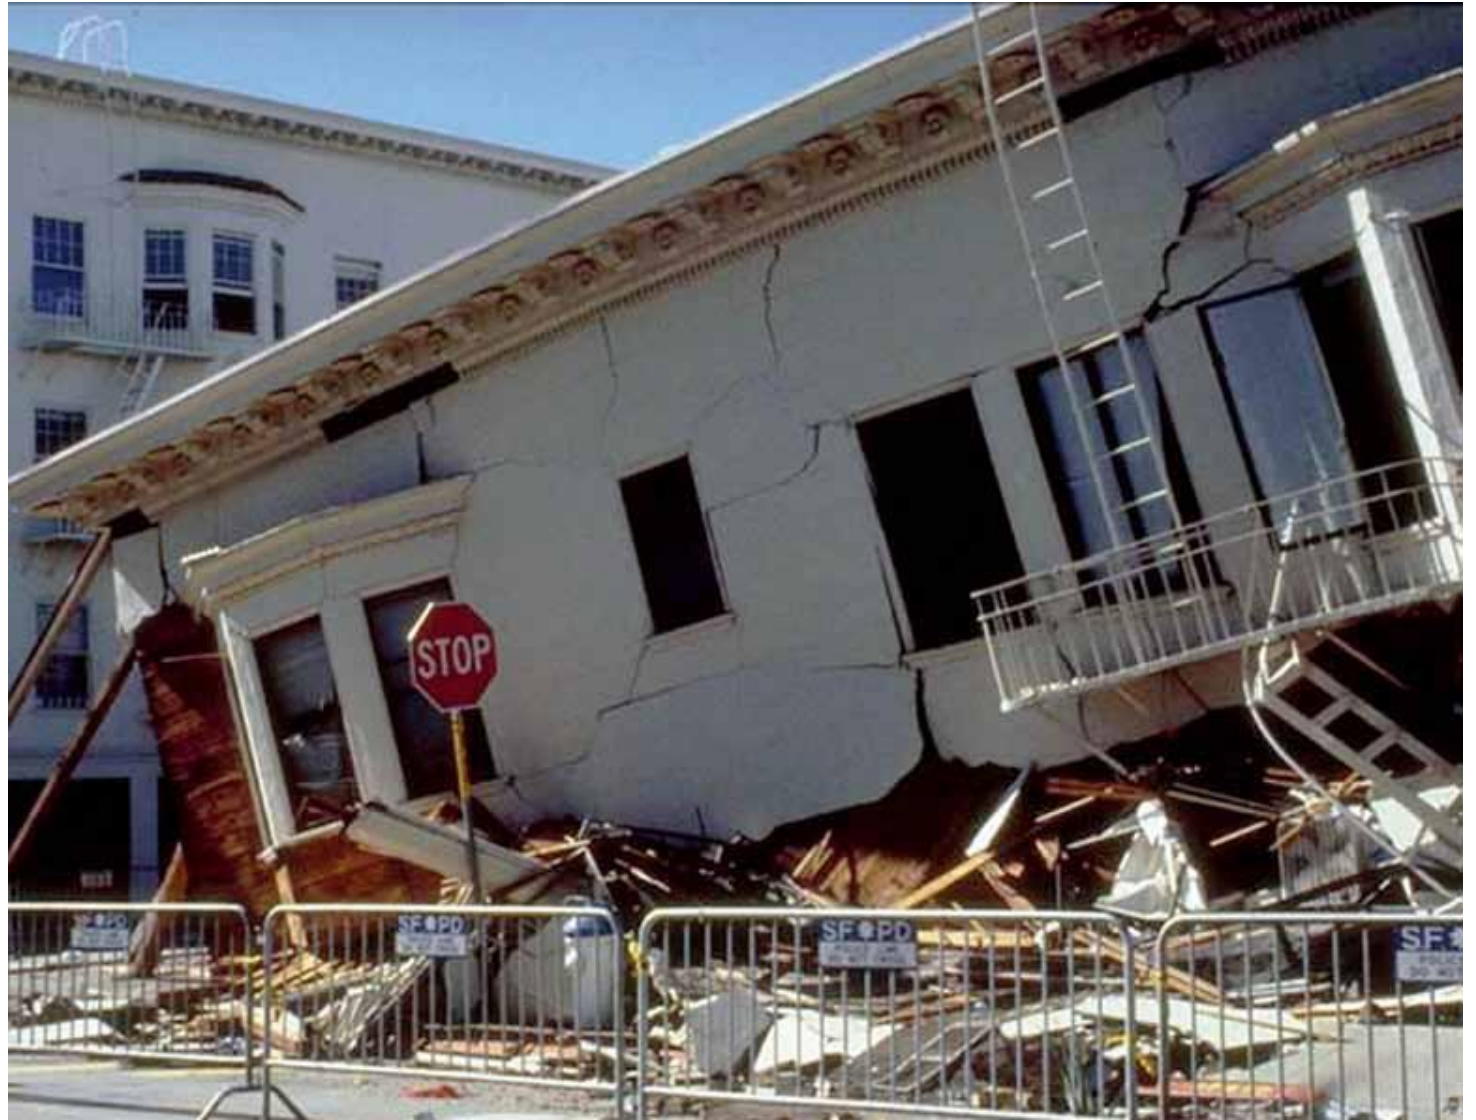
Figure 1. 1989 damage in the Marina District, San Francisco.

Major buildings that had been designed to modern seismic codes survived largely unscathed and as designed. The Marina district, a shallow bay filled in with demolition waste after the 1906 earthquake, suffered some of the worst damage in the 1989 earthquake. (see Figure 1). Open plan timber framed homes in the Bay Area also fared particularly badly. But the water and gas systems were, by 1989,

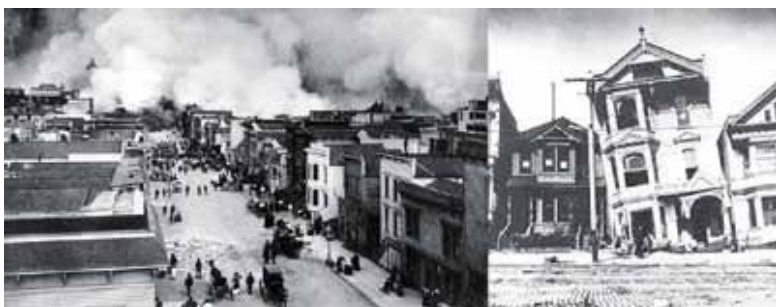
The Great San Francisco Earthquake of 1906 caused enormous devastation. The Bay Area of the city, where houses were founded on man-made fill, suffered major damage due to liquefaction both in the fills and in underlying sediments. *O'Rourke* (to be published) describes how breakages in the fire main system, caused by the earthquake, led to a complete collapse of the fire fighting system in the city to the extent the significant areas of the city, which had not been seriously damaged by ground shaking, had to be abandoned to burn.

Figure 2. Typical damage in Bay Area, San Francisco (1906)

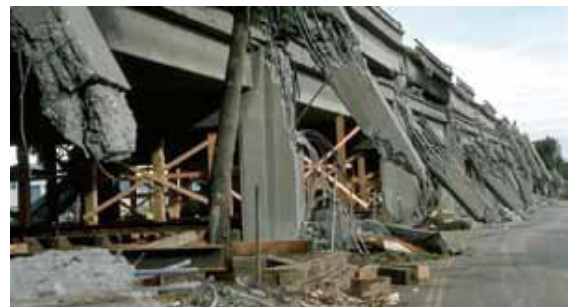
Figure 3. The Cypress Freeway after the 1989 earthquake

In strong contrast to tall buildings, major elements of the freeway system that had been constructed in mid 20th century did not comply with modern codes with disastrous consequences. Figure 3 shows the double deck Cypress overpass in Oakland where both inadequate moment joints between the

cross beams and the supporting columns and inadequate shear reinforcement within the columns themselves are evident after the earthquake.

Clearly, some lessons had been learned but were only selectively applied. There was no technology deficit here: simply a failure to apply past experience generally in what is recognised as a very challenging environment.

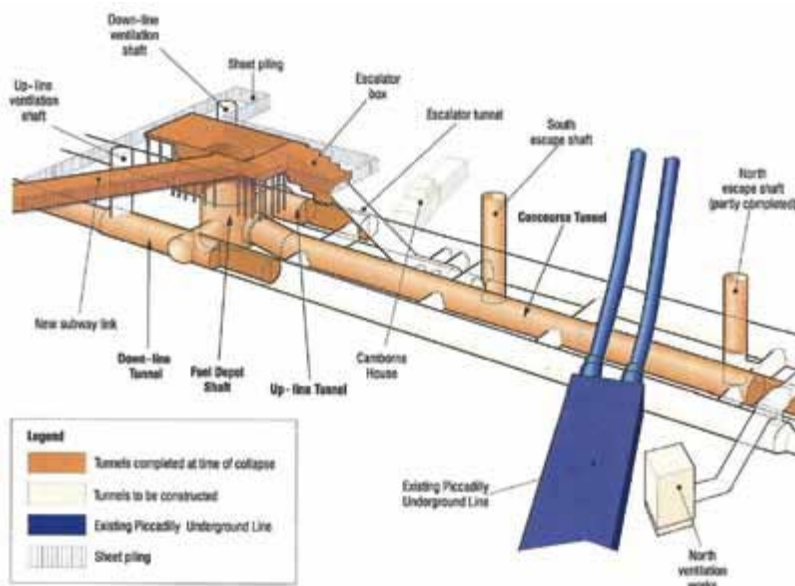
Figure 4. London Heathrow Central Area Tunnelling Works, 1994

A project for the tunnelling works, shown in Figure 4, was let on a design and build basis where the contractor was responsible both for the design of the primary support and self certification of the works. The client’s consultants were responsible for the design of the secondary (permanent) support and for the overall monitoring of the works and the surrounding area.

A collapse started within one of the running tunnels that rapidly progressively collapsed way back to the main Fuel Depot shaft, leading to loss of a large part of the works, huge settlements around the central area of the airport and disruption of the airport that lasted for several years whilst the situation was being recovered. The collapse started in the NATM lining at a narrow closure strip in its invert, where neither the lining thickness nor the quality of shotcrete was properly controlled.

A wide ranging investigation into this failure highlighted many “short cuts” that had been taken to simplify and expedite the works and a combination of all these was probably the main cause of the failure. Most damning were the fact that signs of the impending failure were obvious in the monitoring data for more than a week before the collapse but the data were not been analysed in real time and the absence of independent peer review of the contractor’s work.

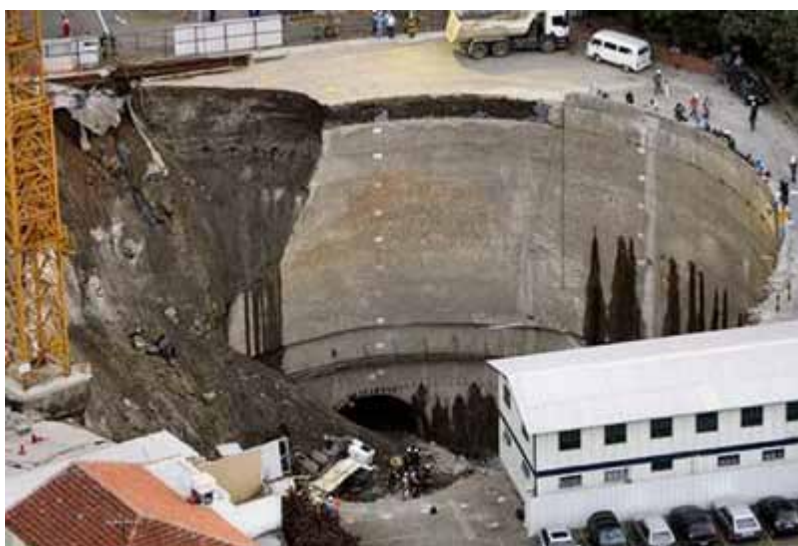
In January 2007 a major failure occurred during construction of a metro tunnel in São Paulo. The problem started with failure of the roof of a tunnel being constructed by

Figure 5. The Capri shaft after collapse, São Paulo Metro, 2007.

the NATM method and, as at Heathrow above, this rapidly propagated back to the shaft leading to enormous material damage to the construction site and facilities, neighbouring population and public infrastructure (see Figure 5).

In broad terms, one could interchange the list of causation with that from Heathrow 13 years earlier. Absolutely none of the lessons had been learned despite the similarity of the works. A report on the accident indicates poor or erroneous application of knowledge rather than a gap in the knowledge base itself. There were major organisational systemic issues in poor communications, lack of peer review, lack of back analysis to confirm design, ignorance of risk etc. that should not occur on a major project anywhere in the world today.

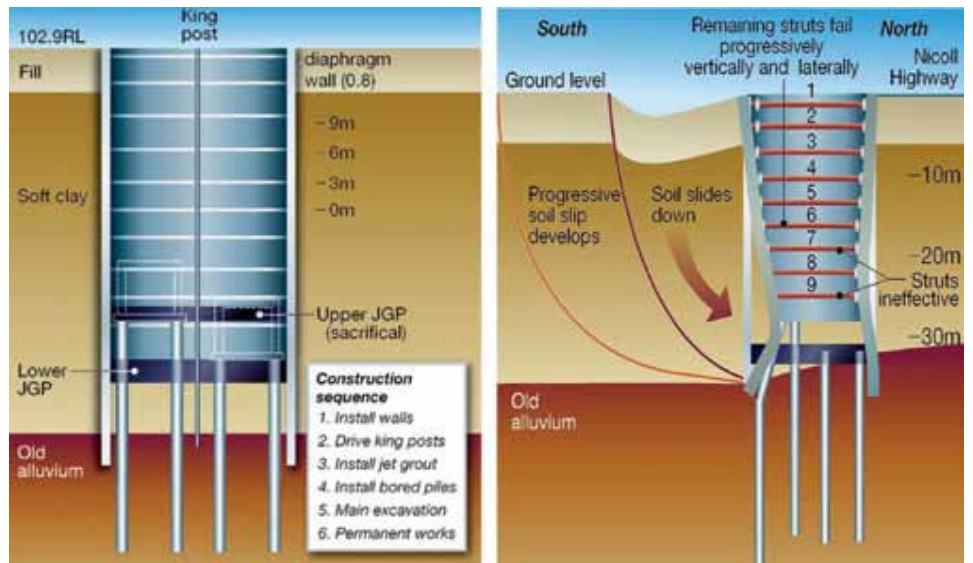
A cut and cover tunnel was being constructed within braced diaphragm walls adjacent to Nicoll Highway in Singapore. When the excavation reached about 30m deep in April 2004 there was a catastrophic failure of the ground support system. A cross section of the cut and cover at the critical section is shown in Figure 6 also with an interpretation of the mode of failure.

Figure 6. Cross Section and likely mode of failure, Nicoll Highway

A committee of inquiry set up by the Singapore Government concluded that the collapse was rooted in over optimistic design of the diaphragm walls and under design of the strut-waler connections.

It also appears that the monitoring and review regimes were not effective and the back analysis process was not rigorous enough to pick up the design errors. The back analyses carried out were more targeted on justifying why wall displacements were substantially larger than originally predicted rather than really questioning why they were as they were. But even when the revised predictions were again exceeded, no significant alarm bells seem to have rung.

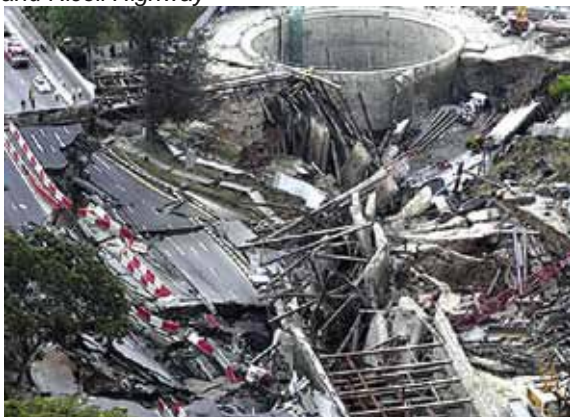
The failure resulted in the complete destruction of a large part of the cut and cover box with wide ranging collateral damage to the adjacent Nicoll Highway and other surrounding assets and structures. (see Figure 7). The project had been let on a design and build, lump sum basis at a time when the Singapore market was particularly competitive.

Figure 7. Failed Cut & Cover tunnel excavation and Nicoll Highway

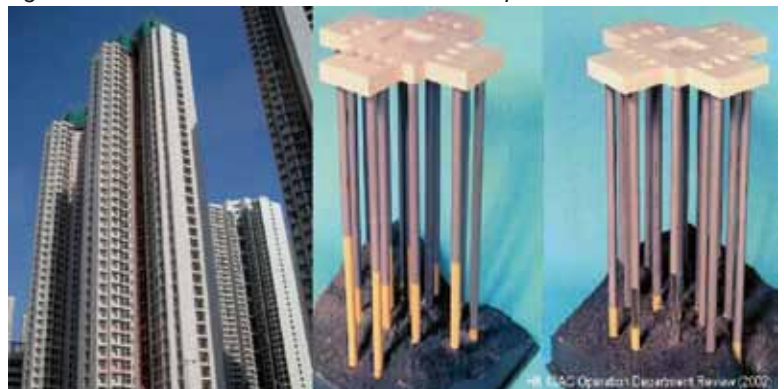
Figure 8. The tower blocks and models of their piled foundations.

two high rise buildings were constructed, each of which was founded on 18no 2.3m diameter caisson piles that were designed to be founded in solid granite. The piles were intended to be belled to 2.8m diameter at their base. Before the towers were fully completed, significant differential settlements developed. An investigation revealed that out of a total of 36 no piles, 21no were shorter than they were stated to have been by between 2m to 15m, 11no further piles were founded only in soft mud, a residue from the supporting fluid used in the piles during construction and only 4no piles were actually founded in granite as

prescribed by the contract. The results of the investigation are shown in a model in Figure 8. The lighter coloured pile sections did not exist.

The piles were specified to be fully cased and excavated by hammer grab. However, during the works the method was changed to augering and chiselling with a powerful rotary piling machine using “supermud” as opposed to casing to support the pile walls. Whilst the report does not criticise this change of method, it is critical about the fact that the change of method was not approved. In fact the results suggest that the site team were neither trained nor

experienced in this more modern method of piling and the procedures followed in cleaning and constructing piles were not appropriate. The piling contractor, faced with a challenging contract financially, resorted to corrupt practices and falsified records, presumably in the vain hope that nothing would go wrong.

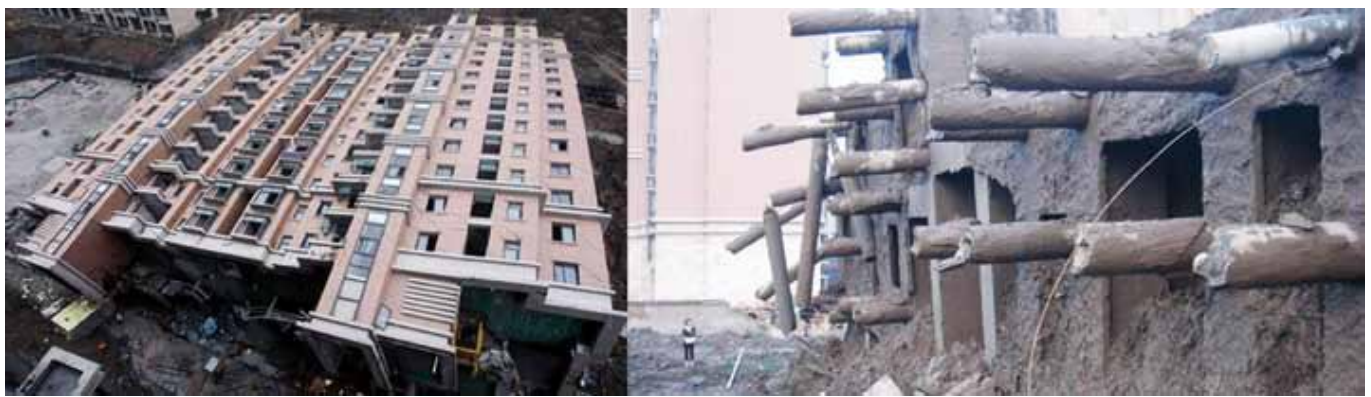
A 13 story luxury apartment building in Shanghai collapsed by toppling over, completely intact. (see Figure 9). On the right below, the pile the pile foundations can be seen snapped and broken off.

Figure 9. Toppled apartment building, Shanghai, 2009.

Apparently the construction company was in the process of excavating a 4.6m deep underground car park on one side of the building and piled the arisings in a spoil heap up to 10m high on the other side of the building. There was heavy rain in the days before the collapse and this may have been a contributing factor. The

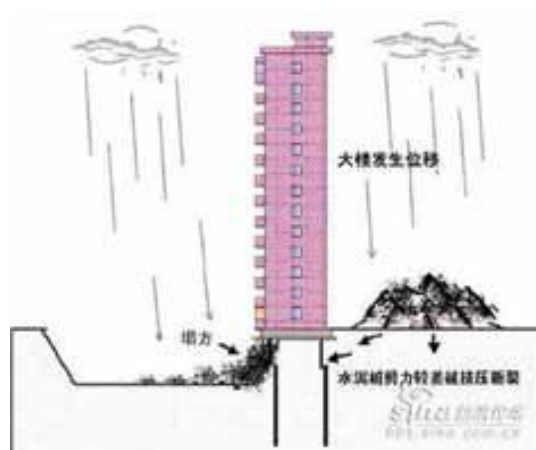
presumed failure mechanism is shown in Figure 10.

Figure 10. Likely failure mechanism. Shanghai Apartment Building.
