DETAILS OF INTERESTING CLAIM

No: DOIC 65 (CAR)

Boiler:

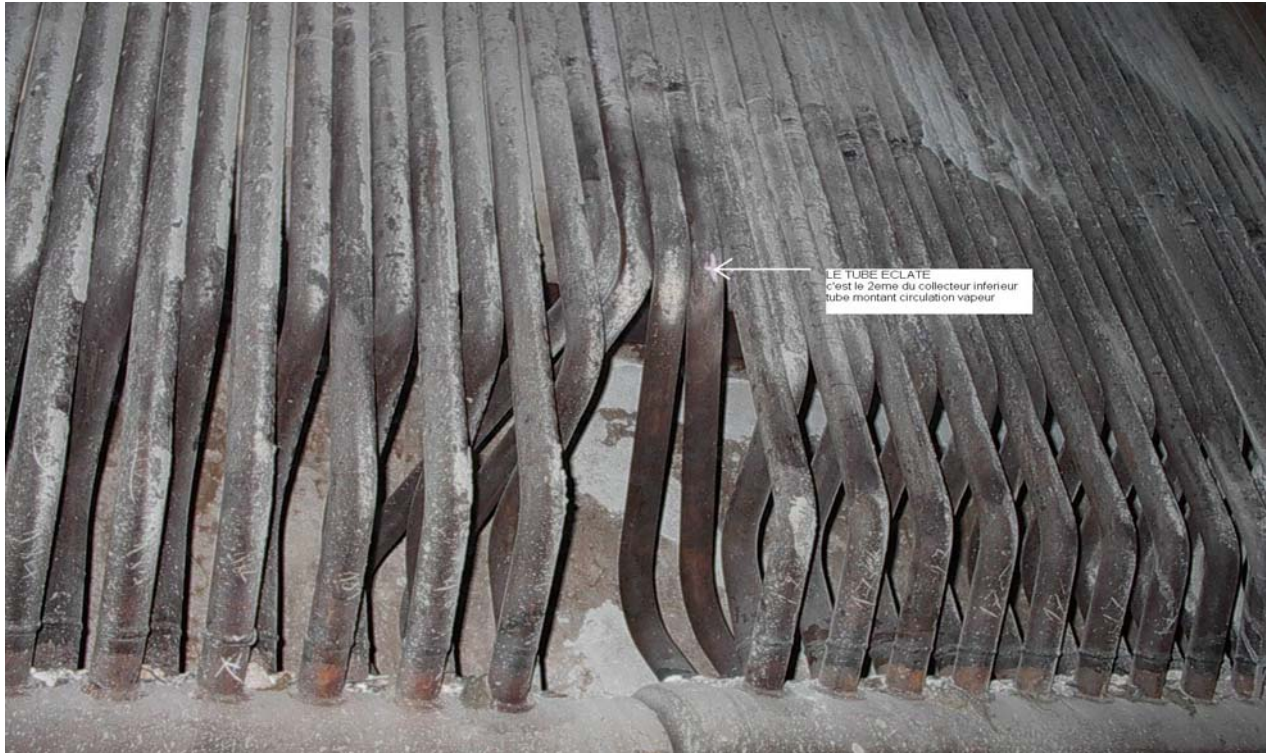
After analysis, it was concluded that the vapour flow had been stopped in the pipes. Due to the high temperature near the pipes - they were located near the burners - they were overheated. One pipe even burst out; the others suffered metallographic modifications. After further investigation about causes of the phenomenon, the Western contractor discovered that a main horizontal collector pipe was connected to the vertical pipes at the bottom of the boiler. This pipe was not reported in the documentation and drawings available and there was also no information on any level control systems.

This pipe had been installed in order to collect condensate vapour, but no drain pipe has been observed.

The contractor had to conclude that during hot start - fast stop /fast starts tests, condensed vapour had reached a high level and the horizontal collector was full of water. The vapour flow was restricted or purely stopped, so no vapour flow was circulating in the pipes, which were overheated.

- One pipe broken,
- Several pipes with metallographic change, which were considered as totally damaged
- Several pipes with small metallographic modification

Due to the specific pipe configuration (quantity and geometry), an exchange pipe per pipe was not possible and a complete layer change had to be programmed (three on six)

As the exchange could not be done on the inner side of the boiler, the wall had to be cut, insulation to be dismantled, pipes to be cut then the new pipes assembled and the wall rebuilt.

- Visual inspection of existing pipes networks and compatibility with existing documentation
- Installation of a drain on the collector
- Modification of the hot start, fast stop /fast start processes to avoid a too high condensate.
