Microchip Plant Flood

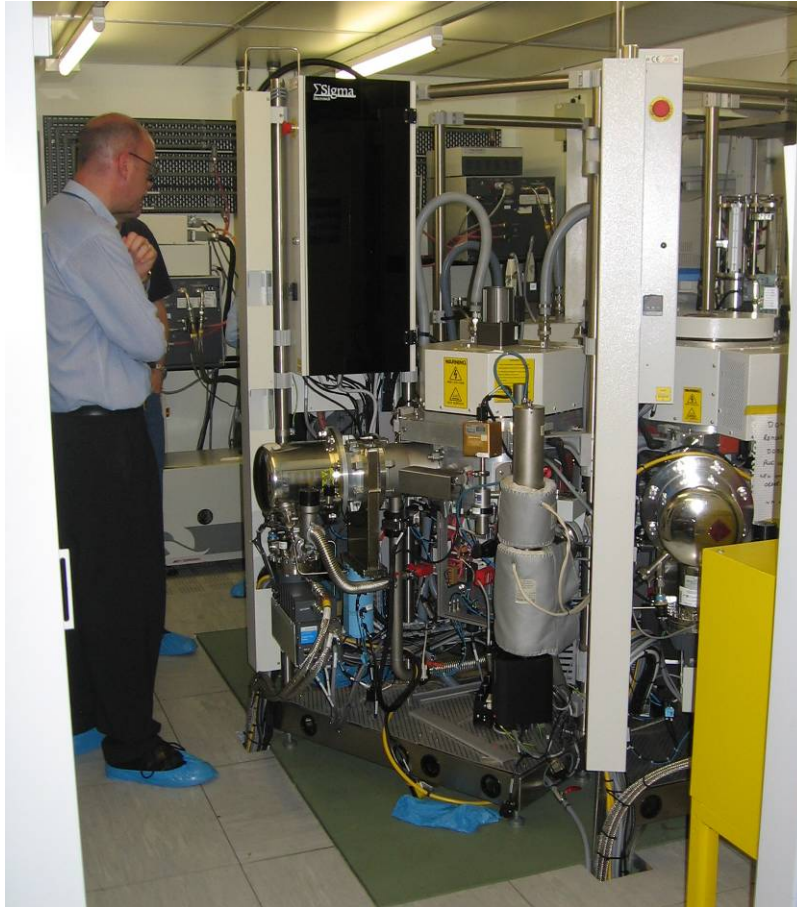
Amount of Loss	USD 18.6 m – Material Damage, Business Interruption and Professional Fees
Cause	Flooding – During exceptional rainfall flood water flowed into the basement facilities and services area serving a microchip plant causing a sudden and uncontrolled loss of power.
Short description	Although the microchip FAB on the ground floor was not flooded the sudden loss of power due to the flooding in the basement meant that many tools were damaged by being shut down in an uncontrolled way or by suddenly losing their services. Many tools were repaired but some including steppers had to be replaced. All production stopped in July and production was resumed gradually during the next few months with full production not resuming until the following January.

Comment	The plant was located in a low lying area close to the boundary of an identified flood zone. The basement was surrounded by an old flood wall but the owners had not recognised it as such and therefore left an access way through it open through which the water was able to enter the basement
