DETAILS OF INTERESTING CLAIM

INTEGRATED COMBINED CYCLE GAS TURBINE

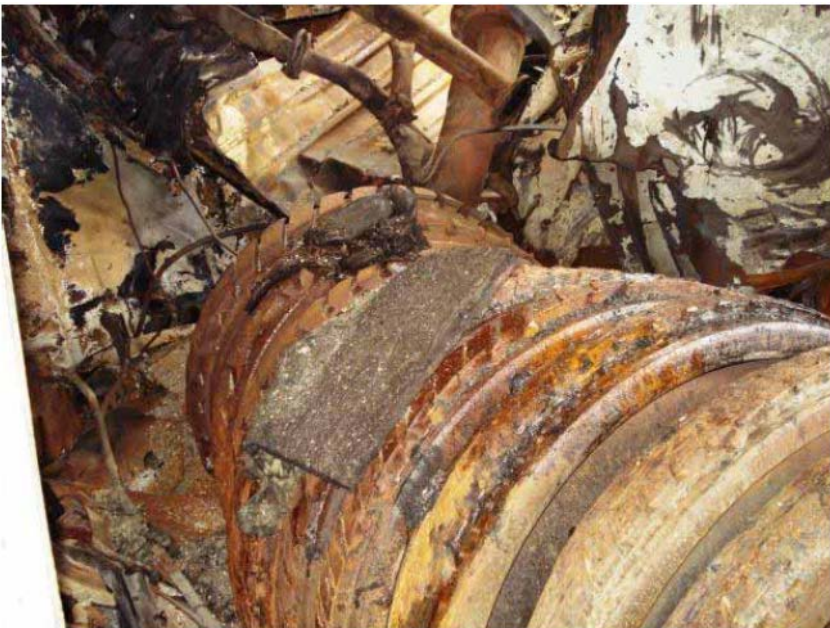
**Remnants of
the compressor
rotor**

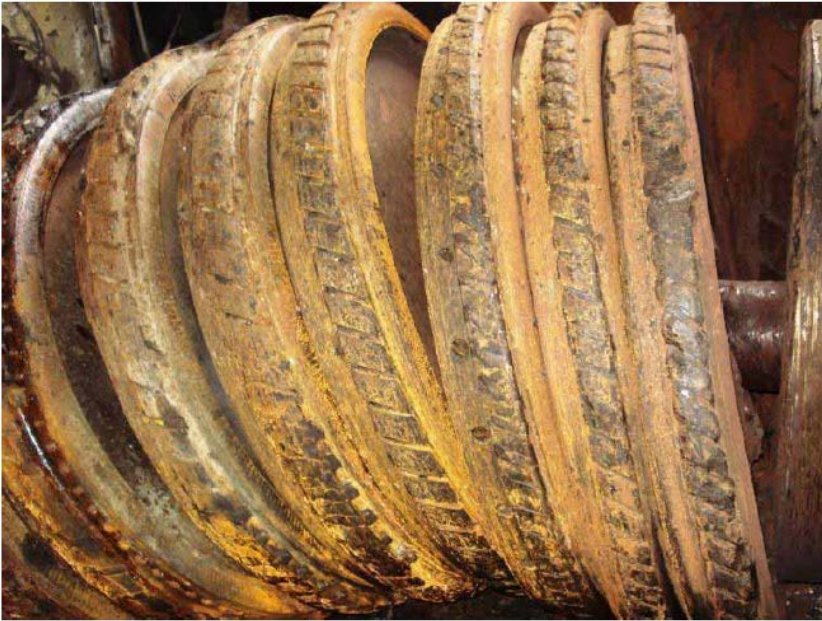
**Remnants of
the turbine
rotor**

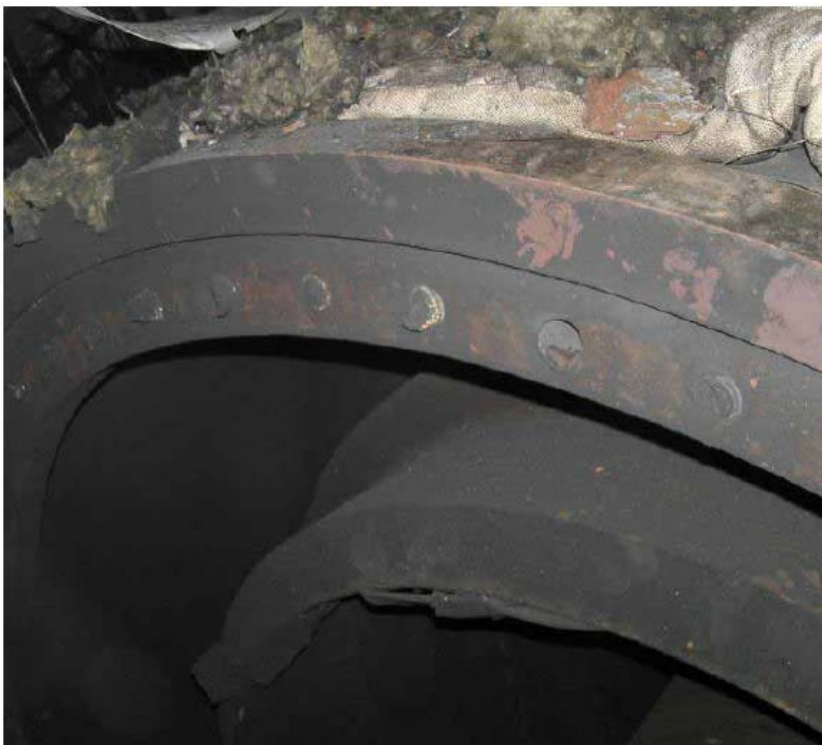
**Turbine centre
casing with
sheared bolts**

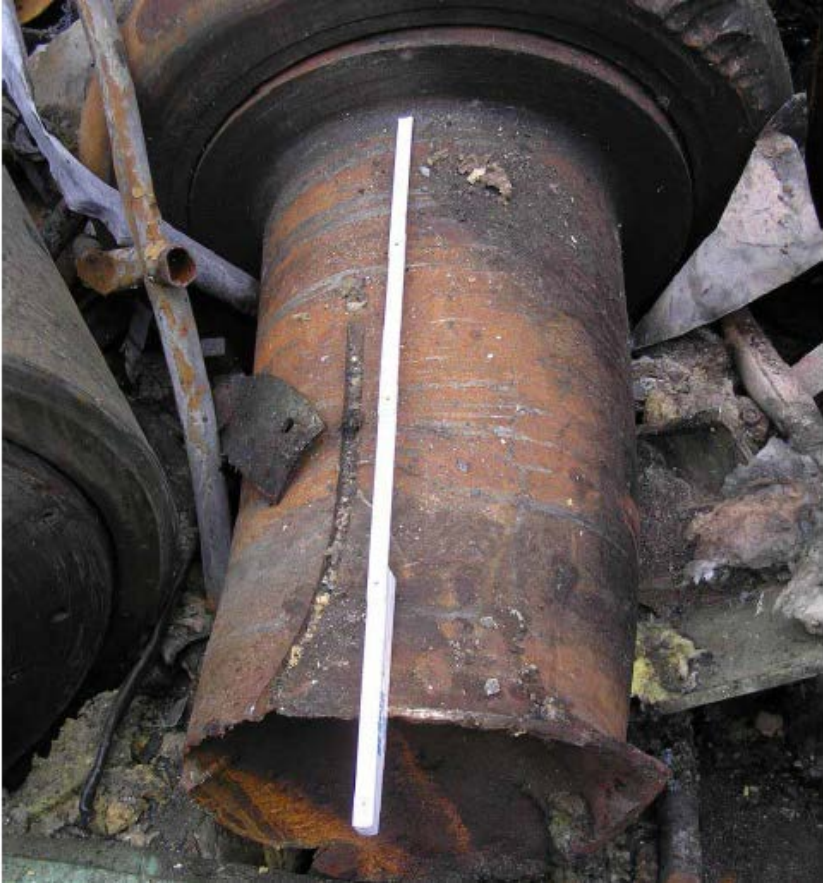
Broken shaft

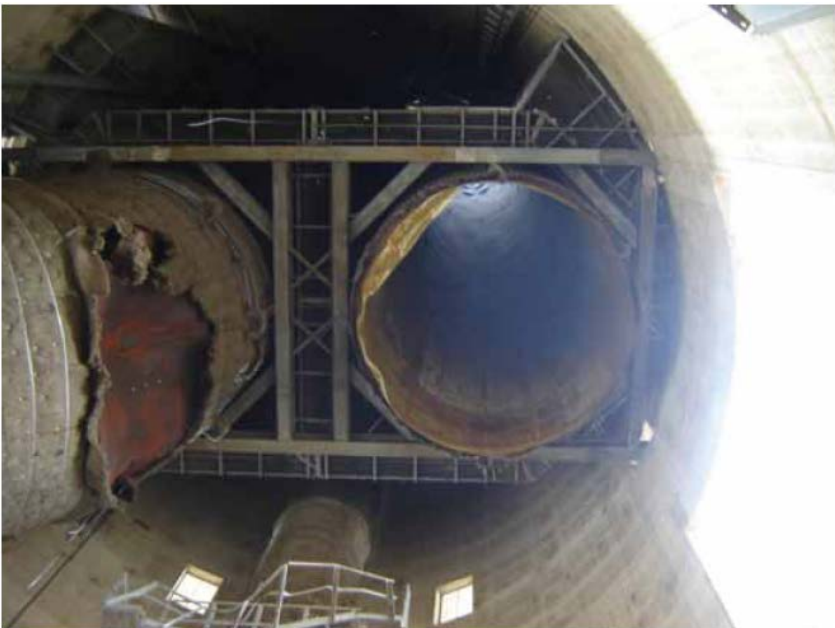
**Damaged ducts
within the base of
the flue gas stack**

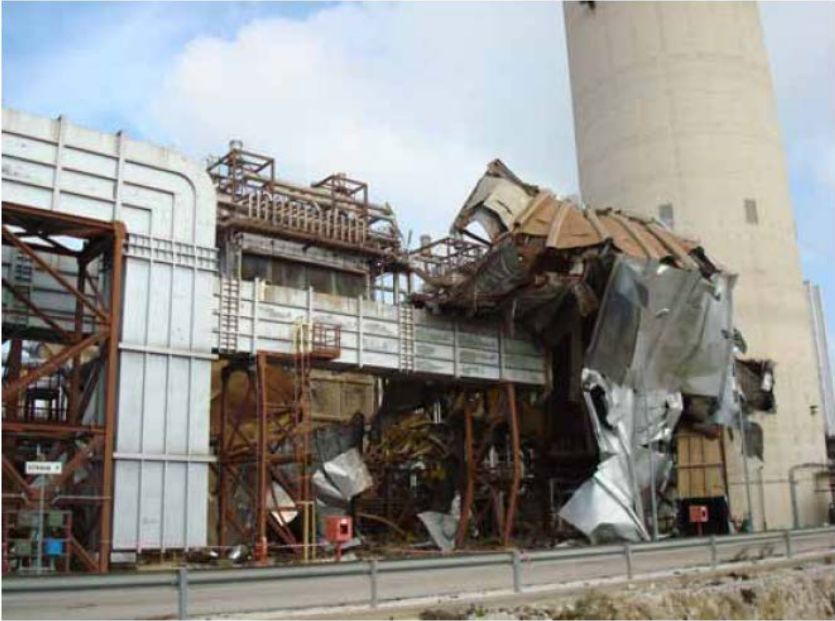
Damaged flue gas duct

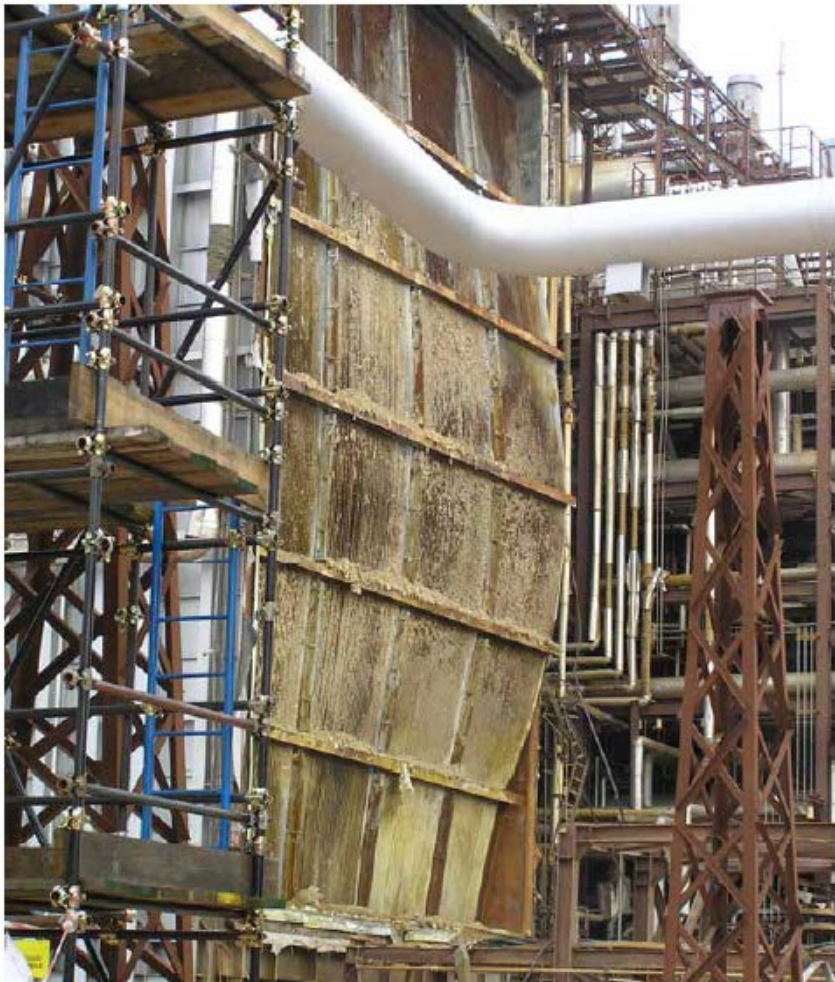
Bulged water wall tubes to boiler

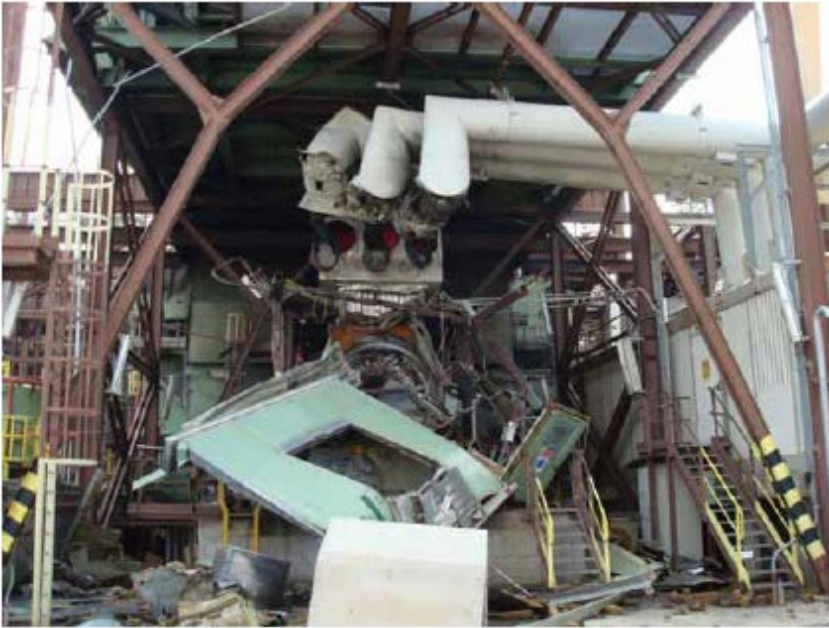
Damaged generator

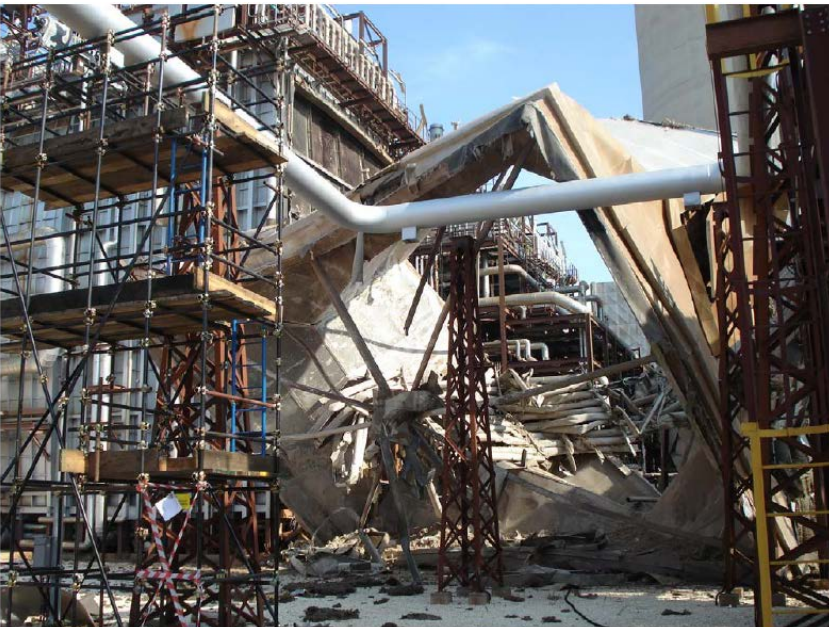
**West side view of
the boiler**
