**International Association of Engineering Insurers
42nd Annual Conference - Istanbul 2009**

Combustion Turbines: Critical Losses and Trends

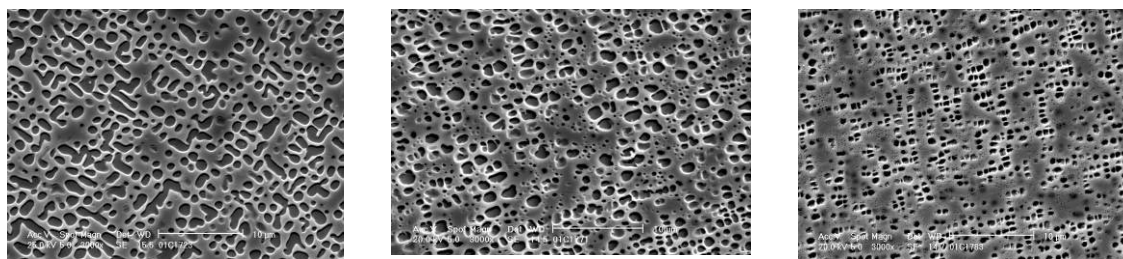
Figure 5: Microstructure of the gamma prime of a turbine blade. To the right a component with a normal microstructure. In the middle some coarsening and spheroidization can be seen indicating a small service damage and the structure to the left shows clearly long term temperature damage. Courtesy of The Technical Research Centre of Finland.

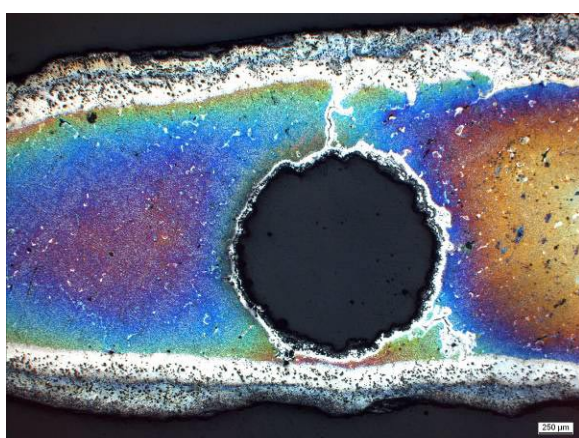
Figure 6: A magnification 10x of a gas turbine blade with a cooling hole. The structure has changed due to long term excessive temperature leading to internal oxidation of the protective layer (seen as the white region in the picture) on both sides of the blade and cracks on both sides of the cooling hole. Courtesy of The Technical Research Centre of Finland.

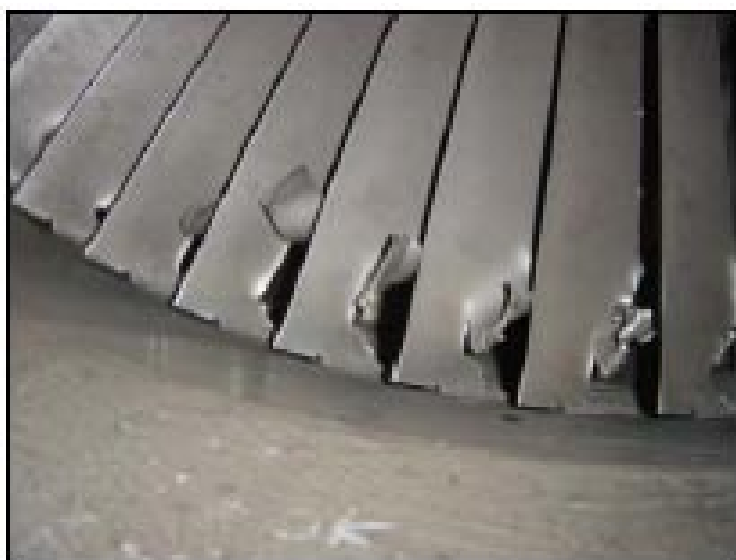
Most turbines are today equipped with two or more holes for endoscopy. The reason for these is, of course, to be able to inspect the most stressed parts of components for damage like FOD (Foreign Object Damage) or IOD (Internal Object Damage). A typical FOD is presented in figure 7.

Figure 7: Endoscopy of a compressor section in a gas turbine with foreign object damages (FOD)

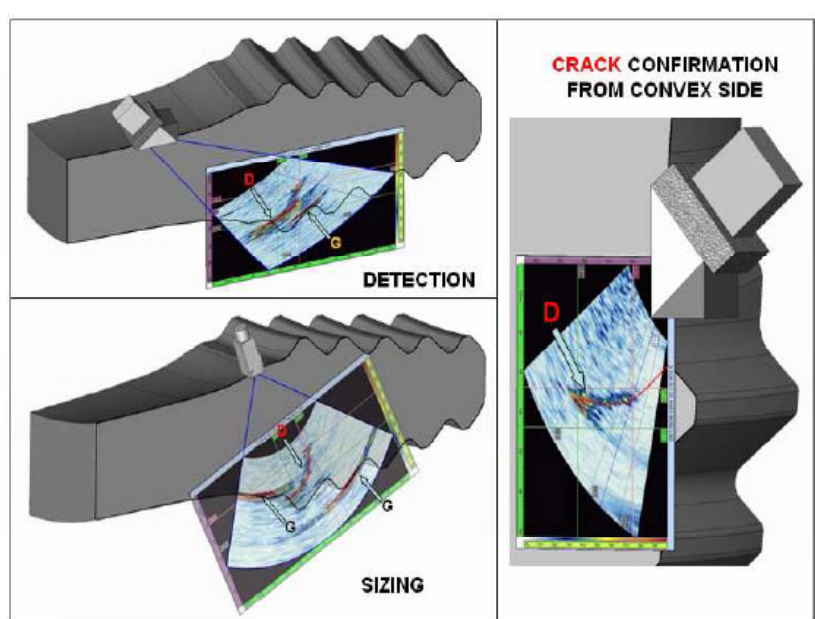
Figure 8: Example of Phased Array inspection features of a turbine blade for crack detection and sizing. P. Ciorau et al., 2008
