Breakdown in a Reverse Osmosis desalination plant due to entrance of fine particles

Turbo Pump in a Reverse Osmosis Desalination Plant

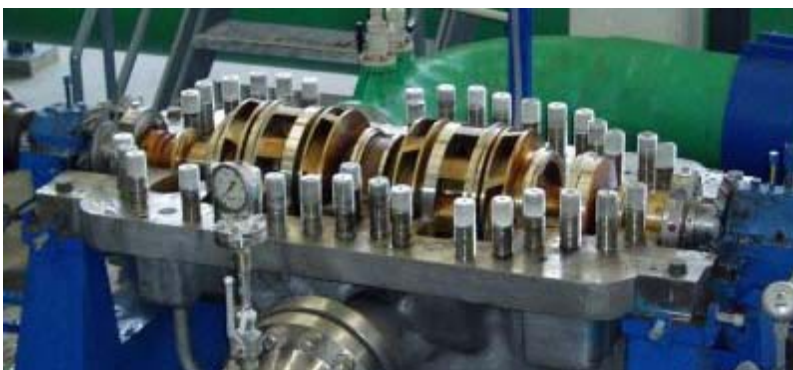
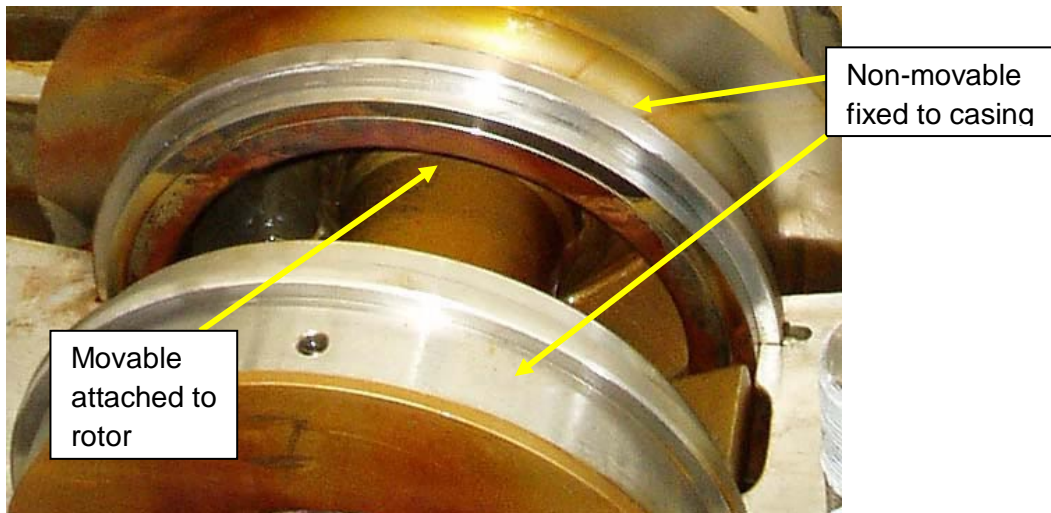
Rotor and interior of turbo pump after opening of casing

The rotor was displaced, grooves and flutes testified to foreign objects, most probably sand particles, having entered the pump. As this damage only occurred to this single pump a failure of the sand and fine filters could be discarded and it was concluded that some sand particles had been hidden in the system, probably having entered there in the past and now flushed into the pump as a consequence of the restarting and the corresponding turbulence.

As a preventive measure and in order to prevent similar events the whole system was flushed carefully and cleaned again. No similar loss occurred thereafter.

The pump was transported to the manufacturer's premises, analysed and repaired, using spare parts already available in the RO plant.
