## Sayano–Shushenskaya hydro power station accident – 2009

(extracted from Wikipedia and

The 2009 Sayano–Shushenskaya hydroelectric power station accident occurred on 17 August 2009, when turbine 2 of the Sayano–Shushenskaya hydroelectric power station near Sayanogorsk in Khakassia, Russia, broke apart violently. The turbine hall and engine room were flooded, the ceiling of the turbine hall collapsed, 9 of 10 turbines were damaged or destroyed, and 75 people were killed. The entire plant output, totalling 6,400 MW and a significant portion of the supply to the local electric grid, was lost, leading to widespread power failure in the local area, and forcing major users such as aluminium smelters to switch to diesel generators. An official report on the accident was issued on 4 October 2009.

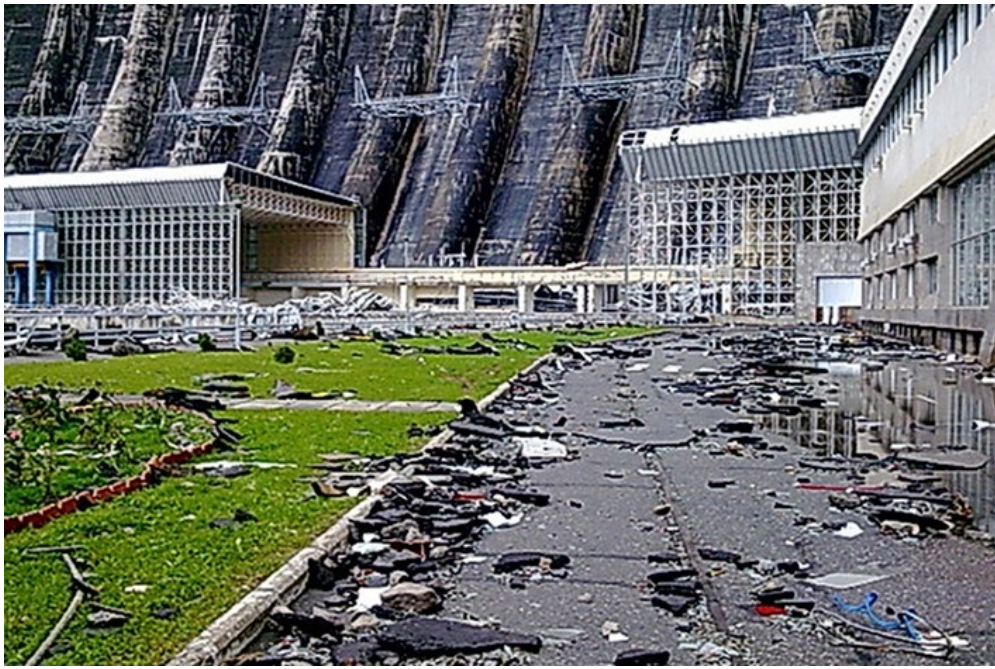
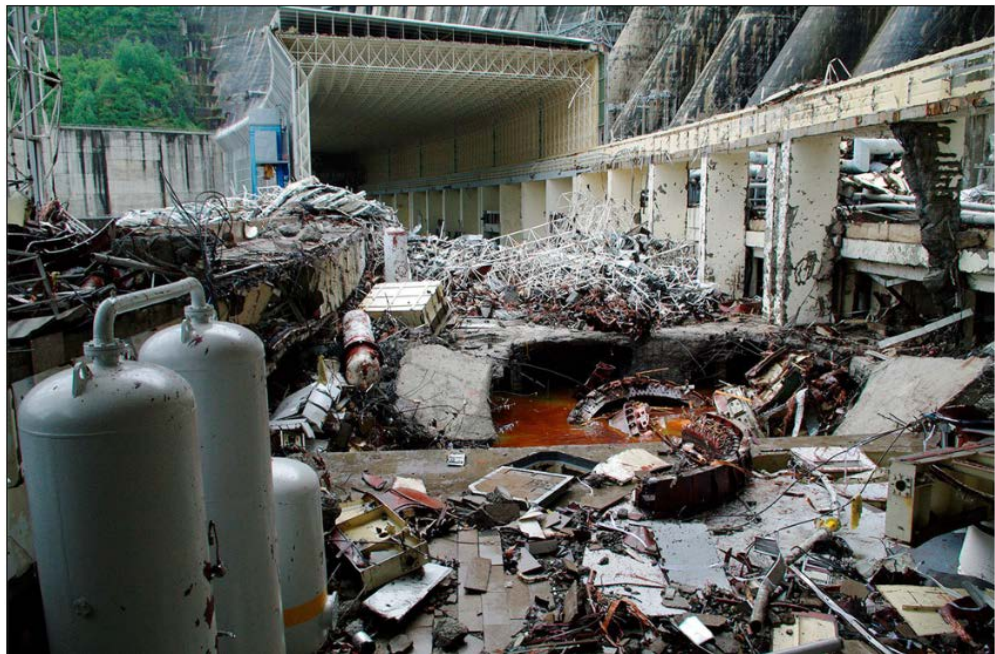
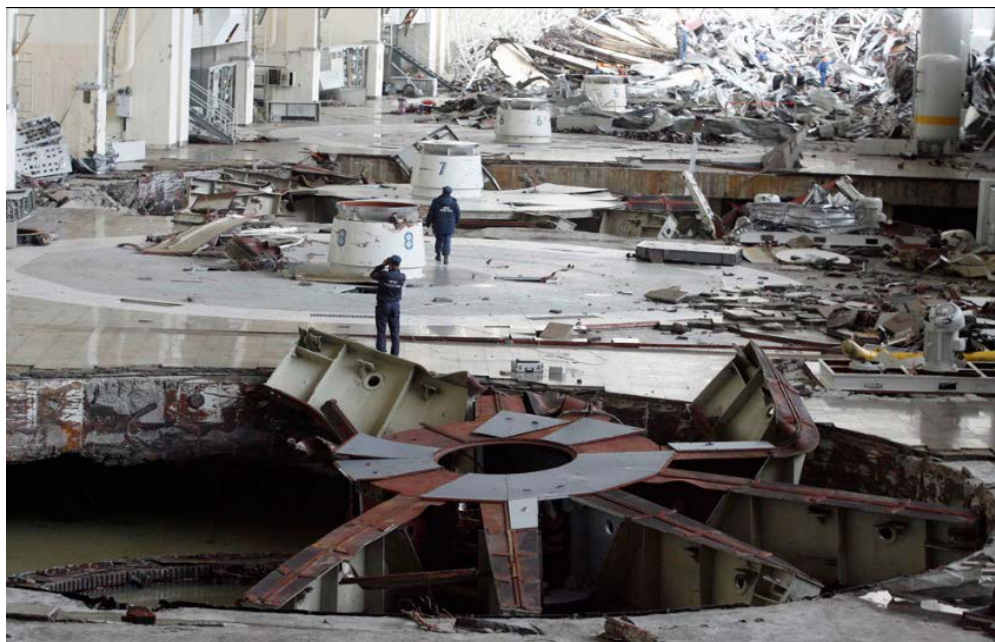
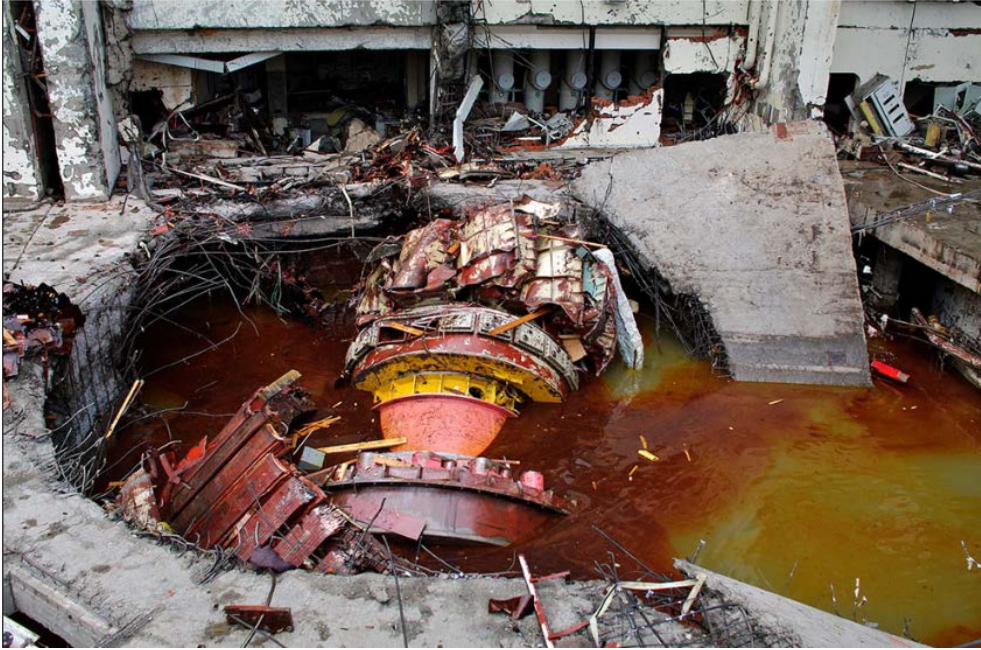
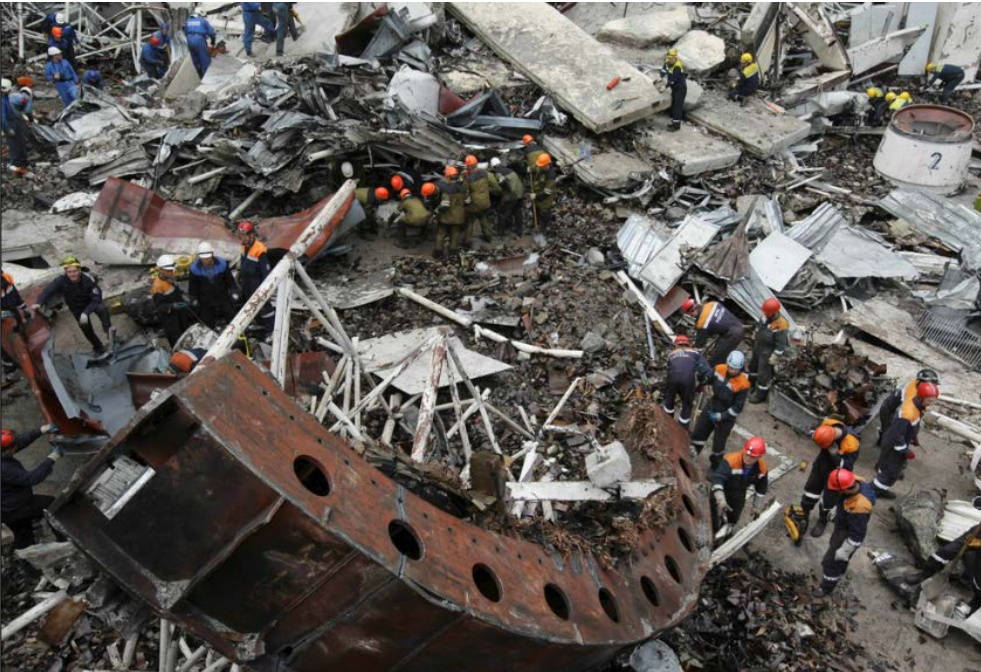
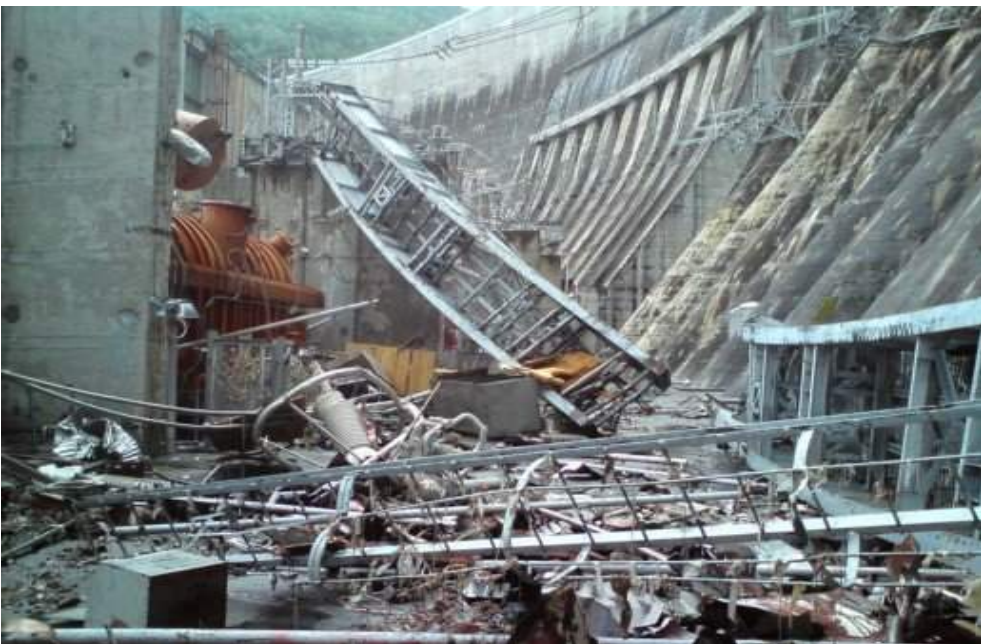
### After the accident:

The official report states that the accident was primarily caused by the turbine vibrations, which led to the fatigue damage of the mountings of the turbine 2, including the cover of the turbine. It was also found that at the moment of accident at least six nuts were missing from the bolts securing the turbine cover. After the accident 49 recovered bolts were investigated, of which 41 had fatigue cracks. On 8 bolts, the fatigue damaged area exceeded 90% of the total cross-sectional area.

On 17 August 2009 at 8:12AM local time, turbine 2's output power was reduced by the turbine regulator and it entered into the non-recommended powerband II of 265–570 MW. Shortly after this, the bolts keeping the turbine cover in place broke, and under water pressure of about 20 bars, the spinning turbine with its cover, rotor, and upper parts started to move up, destroying machinery hall installations. At the same time, pressurized water flooded the rooms and damaged plant constructions.

Overall, damage concerned all units and surrounding areas. Besides unit 2 also turbines 7 and 9 suffered from severe damage, while the turbine room roof fell on and damaged turbines 3, 4 and 5. Turbine 6, which was in scheduled repair at the time of accident, received only minor damage, as it was the only one of the station's 10 turbines that did not receive electrical damage due to shorting of transformers:

- Turbine 6: Flooded
- Turbine 5: Flooding and electrical damage
- Turbines 3 and 4: Moderate electrical and mechanical damage. Some damage to the concrete structures around them.
- Turbines 1, 8, and 10: Severe electrical and mechanical damage. Some damage to the concrete structures around them.
- Turbines 7 and 9: Completely destroyed, with extreme damage to the concrete structures around them.
- Turbine 2: Destroyed completely, including the concrete structures around it.
