DETAILS OF INTERESTING CLAIM

No: DOIC59 (EAR)

Rotor of a gas turbine

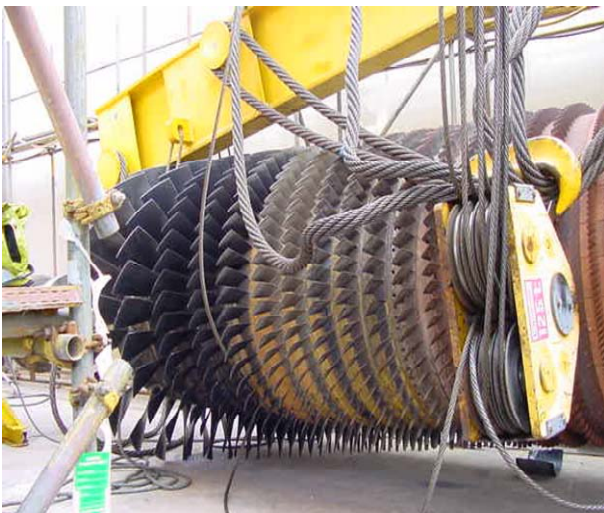
The rotor of massive weight sank to the ground with resultant damage to various parts of the rotor. The supports - prepared to receive the rotor - were hit by the coupling flange on one side and by turbine blades of row 1 on the other side and were pushed away a few metres. The balancing beam and the steel ropes of the lifting equipment fell onto the rotor additionally damaging the area of compressor stage 1. The crane trolley hit compressor blades in the area of the stages 14 to 16. On the turbine side, several blades of four rows were affected, and the straightness of the rotor was doubtful.

Compressor section with beam on top

Inspection and repair of the rotor involved a complete disassembly of the blades in order to allow detailed checks on the rotor as well as on the blades. It was necessary to send the rotor and the blades back to the manufacturer.

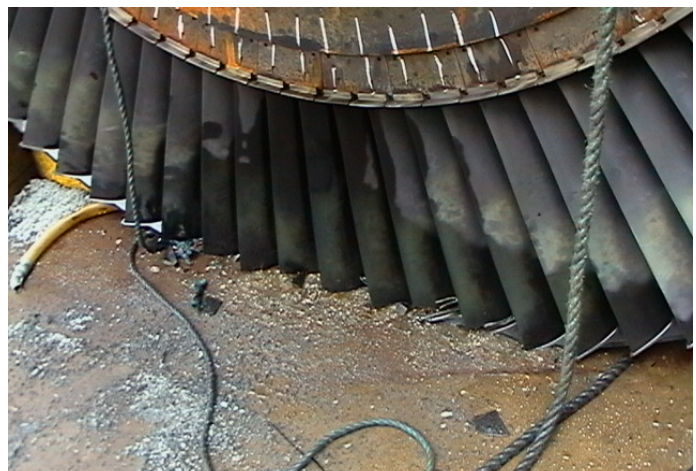
Turbine end hitting the ground
