Short paper on an interesting case of damage

Supplied by Generali Versicherung, Austria (June 2009)

Erection of a thermal waste utilisation plant

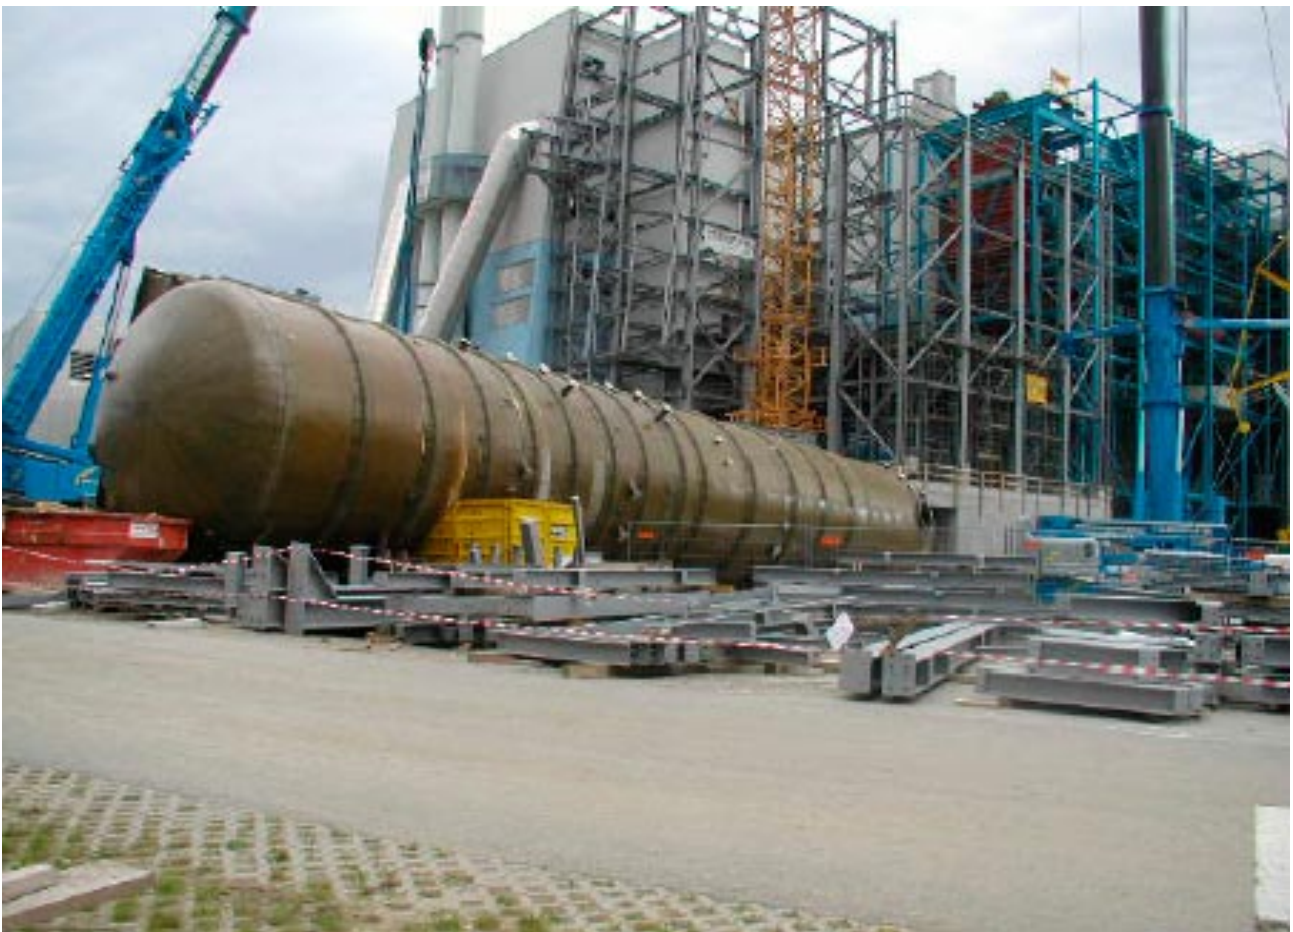
Damage occurred to a large flue gas scrubber. At first, two cranes lifted the scrubber and propped it up. After the scrubber was standing upright, the supporting crane was detached. The scrubber was lifted for positioning by the main crane up to an altitude of 4.5m above the floor. While performing this action, an ear of the scrubber for attachment of the ropes broke off. As a result, the other ears were overloaded and went off as well. The scrubber fell down and toppled over, destroying a container and further steel construction works.

Scrubber vessel with the two cranes after the occurrence

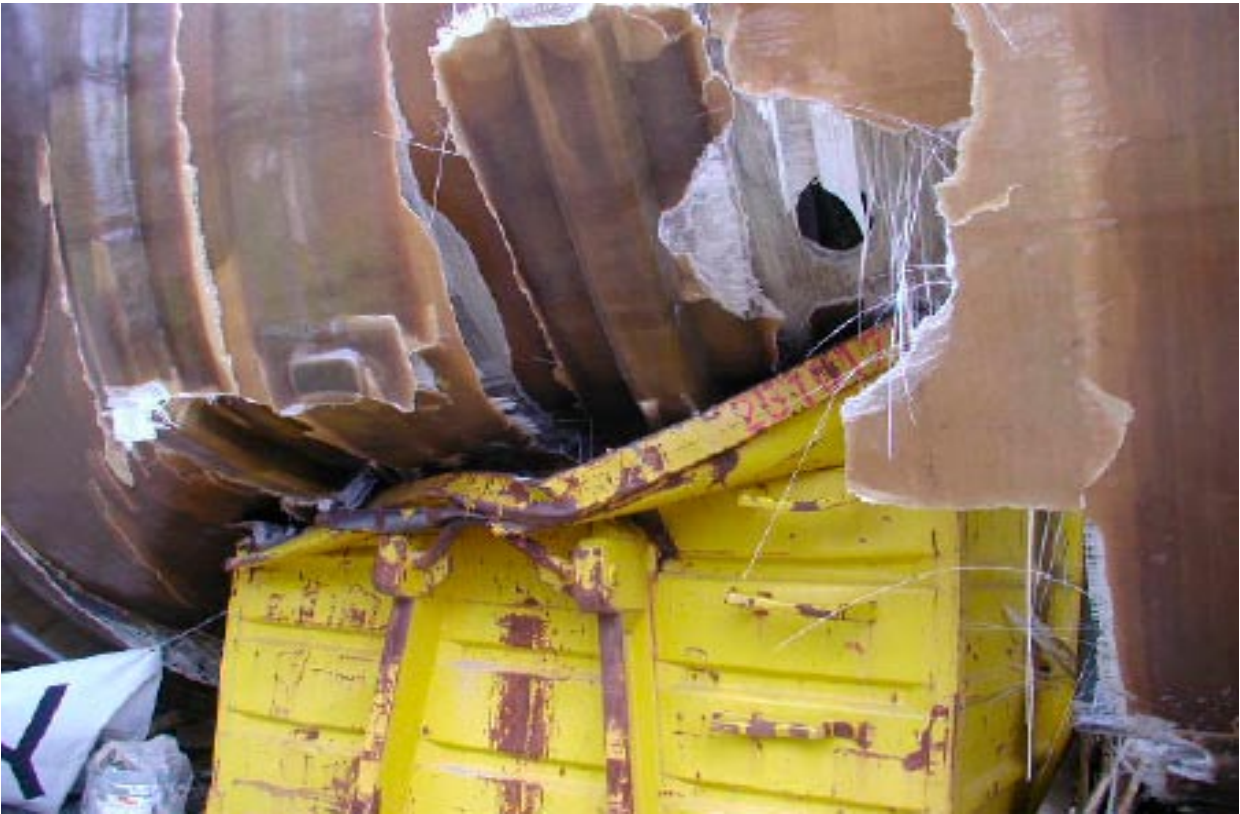
Damage of vessel and container
