## **Short Paper by Infrassure**

### **Verifying design criteria during construction works**

Landslide damaged motorway and embankment during extended maintenance period

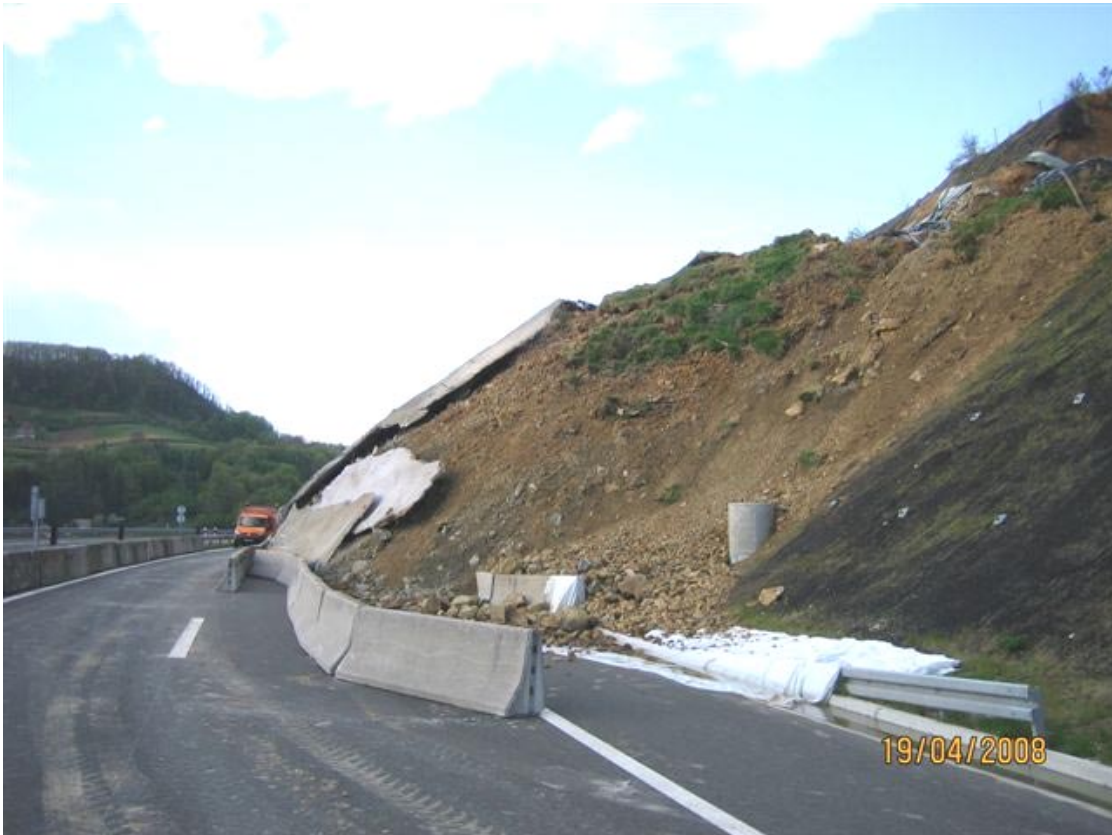
Works were carried out as designed; deviations from the assumptions of the soil report were observed but considered as normal. Due to insufficient local soil information anchors were too short (within the slip circle) and therefore ineffective. Moreover, the anchoring of the slope soil was calculated on that samples was only sufficient for an inclination of 1:1.334 but in reality and following the soil conditions actually encountered the inclination was 1:1.15. Minor slides during construction in the area affected went unnoticed; the need to reconsider the design parameter was not seen by the contractor nor the principal's survey engineers or soil mechanics.

Situation shortly after the landslide occurred

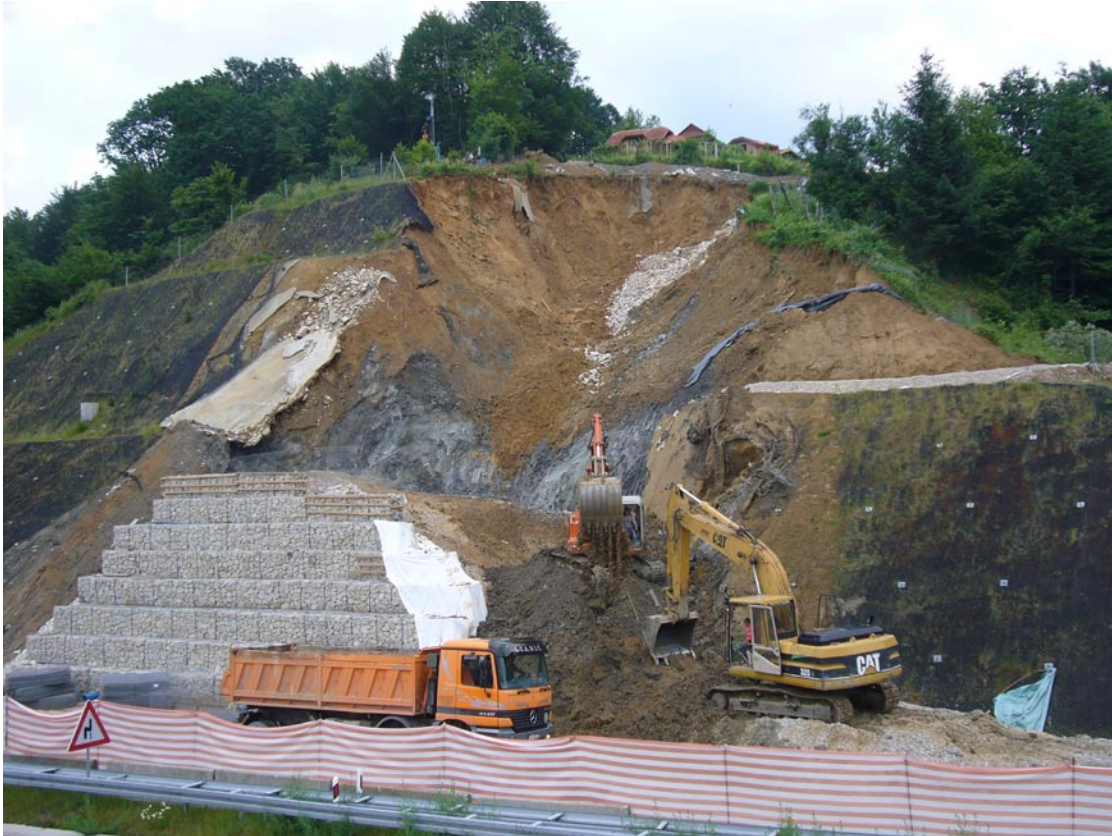
During reconstruction, note third party property above

The construction of a motorway in South East Europe included tunnels, bridges and comprehensive work on slopes. An embankment had to be cut into a hillside with a slope above the motorway being safeguarded with soil anchors and then stabilised with wire netting a stone layer and spray concrete. After 22 months of operation a landslide occurred along approx. 30 meters. Ground material was spilled onto the motorway and damaged side rails. The road had to be cleared, crash barriers renewed and the slope reinstated on a different design which meant considerable increased costs.
