DETAILS OF INTERESTING CLAIM

No: DOIC 57

Wheat Silo Collapse

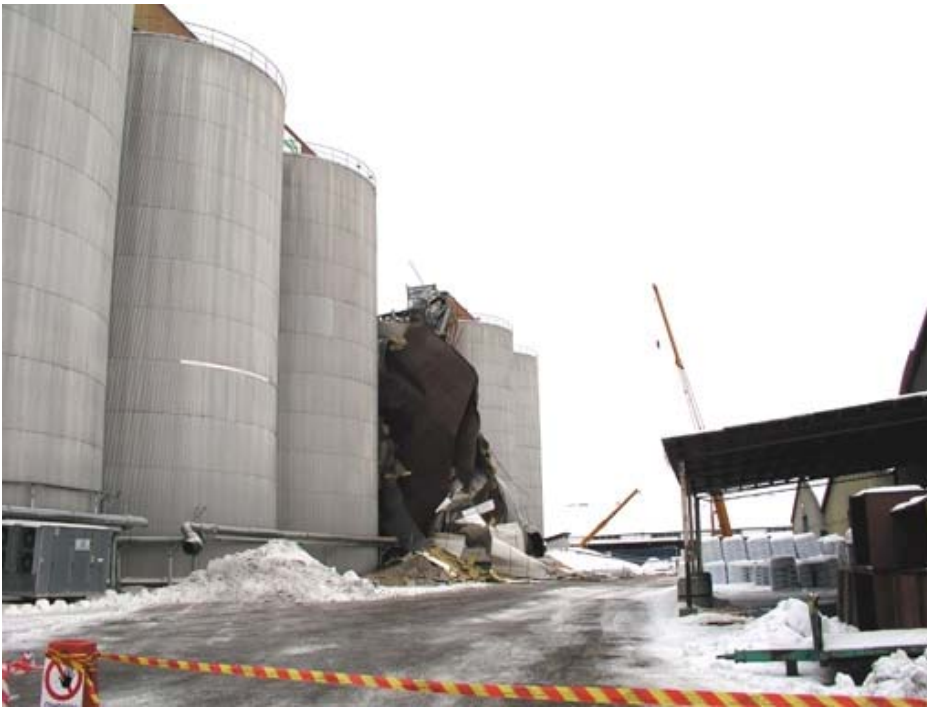
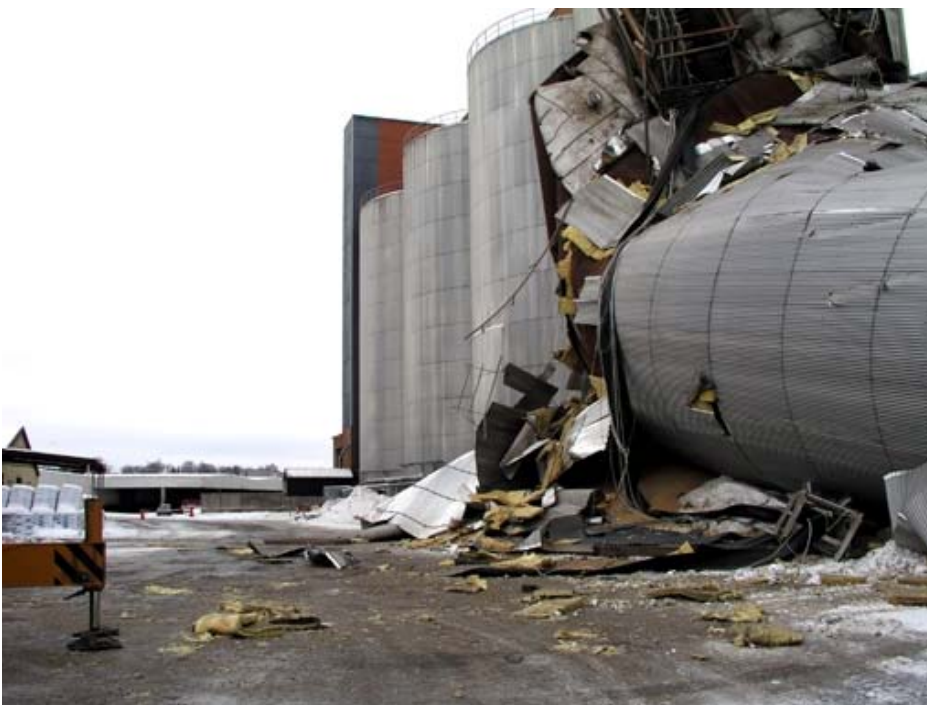
A 32-m steel silo collapsed. The diameter of the silo was 18 m. The silo had a volume of about 8,000 m³ and held around 5,800 tons of wheat. It had been part of a row of eight similar silos before the accident. The silo was of fully welded design, and the plate thickness varied between 15 mm at the base and 6 mm at the top.

The silo fell against an empty grain silo, and then they both collapsed against a third silo. Silo 1 and the empty silo were totally destroyed, and the third was seriously damaged. The collapse of Silo 1 was caused by plates buckling in an area where the thickness was 10 mm.

None of the above damage mechanisms seems likely in this case. Instead, the collapse may have been due to biological activity.

The variations in temperature indicate that there has been a centre of biological activity, which can cause asymmetrical discharge due to grain forming into lumps, and can also generate moisture that

migrates towards the external walls. Asymmetrical discharge increases the risk of buckling, and moisture at the external walls can create a rough surface to which the grain can freeze. Computer calculations show that the risk of freezing on the silo walls is small in normal winters if the wall insulation is dry and unbroken. If the insulation is locally wet or torn, the risk of freezing increases considerably and causes asymmetrical discharge conditions with a consequent increased risk of buckling. The positions with low temperatures indicate that local freezing did in fact occur. Of all the possible causes of damage checked, it would therefore appear that local freezing is the most likely explanation.

The progress of the collapse, which took some time, showed typical buckling behaviour. The steel wall buckled but did not tear. When buckling started, the tensile stresses in the steel in the buckling zones were greater than the elastic limit of the steel, and deformation occurred.

- The usable volume of the remaining silos on the damage site has been restricted.
- The calculation checks for safety against buckling and subsequent collapse should be made on older silos.
- The conditions inside the silo should be monitored and subjected to adequate checks.
