DETAILS OF INTERESTING CLAIM

No: DOIC 61 (CAR)

Outfall structures in the container terminal of harbour

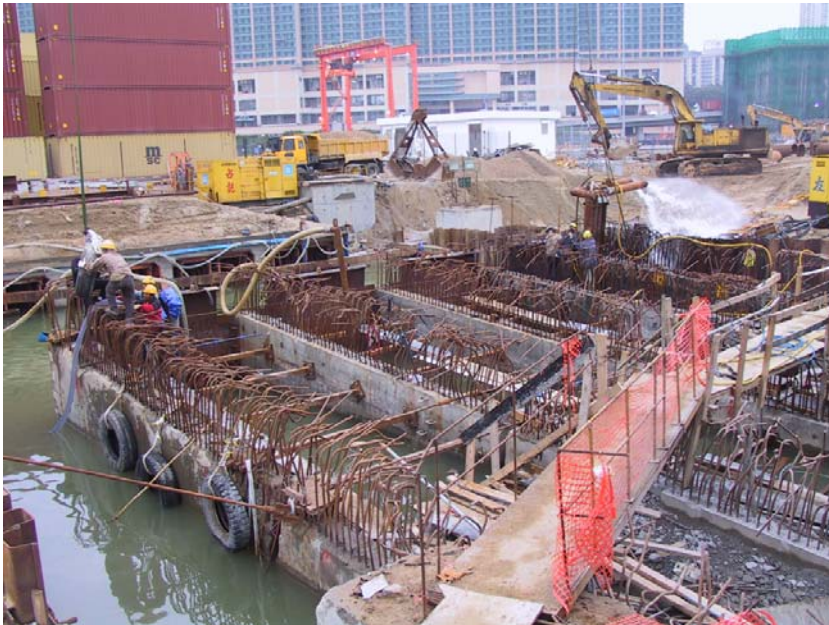
In order to execute these modifications in the dry the contractor's method involved sealing each cell within the outfall unit and pumping out water from within each cell one by one. It should be noted that in order for negative buoyancy to remain, only one cell at any given time was to be drained. However, after removing the soffit and walls between the individual cells, a high tide occurred which reduced the safety factor and this, in combination with a pump inadvertently left running overnight within one of the flooded cells, the outfall element became buoyant. With water pressure acting on one end of the outfall structure; the landward side at this stage was being drained, the structure floated and displaced at one end, tilting and slipping on the underlying sand bed and coming to rest out of position but without being damaged itself.

Whilst the claim for repositioning after excessive settlements had been correctly declined, the tilting and sliding of the outfall structure was caused by human failure and/or faulty workmanship. The structure had to be split into two elements and floated separately into the correct position after repairing and preparing the backfill underneath, using divers.

Tilted outlet structure

A clear method statement should be presented before works are executed and ways should be found to guarantee its correct implementation. Preparation of method statements should consider all external factors which are present and which might potentially influence the works to be undertaken. In this example, repositioning has to be declined if it is found that movement was due to gradual influences, whilst the same has to be indemnified if caused accidentally. In this case the human error had to be considered as a break in the original chain of causation or as a supervening event.
