Slide No 108
Collapsed middle section of
underground car park

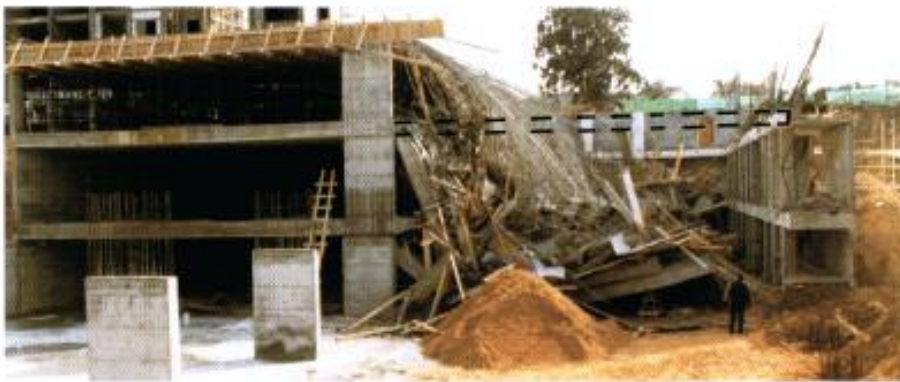
Slide No. 109

- ← Level of initial collapse during concrete pouring of 3rd/top floor
- ← 1st floor failed under the weight of the 2nd and 3rd floors

Amount of Loss	CHF 485,000
Cause	Faulty design of hollow rib ceiling
Short description	During concrete pouring of the 3rd (top) floor, the 2nd floor collapsed. The weight of the fall of 3rd and 2nd floors consequently caused the first floor ceiling to collapse as well.
Comments	<p>Investigations clearly revealed faulty design of ceilings:</p> <ul style="list-style-type: none"> • The main armoring is not concentrated within the area of the ribs • The usual connections between the bottom layer of concrete and the ribs in the absence of stirrups are totally missing. • The bottom layer of concrete of 4 cm is too thin.

The system does not conform with the national code and in future insurers will decline insurance of this specific ceiling system. The ceilings already built using this "system" should be load tested and/or demolished for safety reasons.

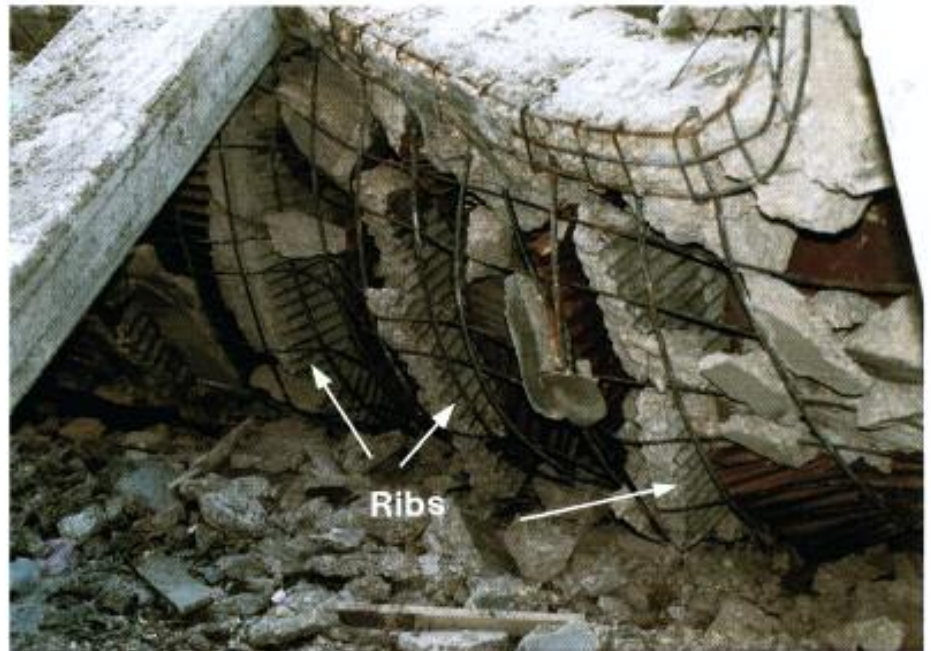
Slide No. 110

Underside view of the collapsed ceiling.
Clearly visible: Missing stirrups and main armoring are equally distributed instead of being concentrated under ribs.
