DETAILS OF INTERESTING CLAIM

No: DOIC 54

Road collapse

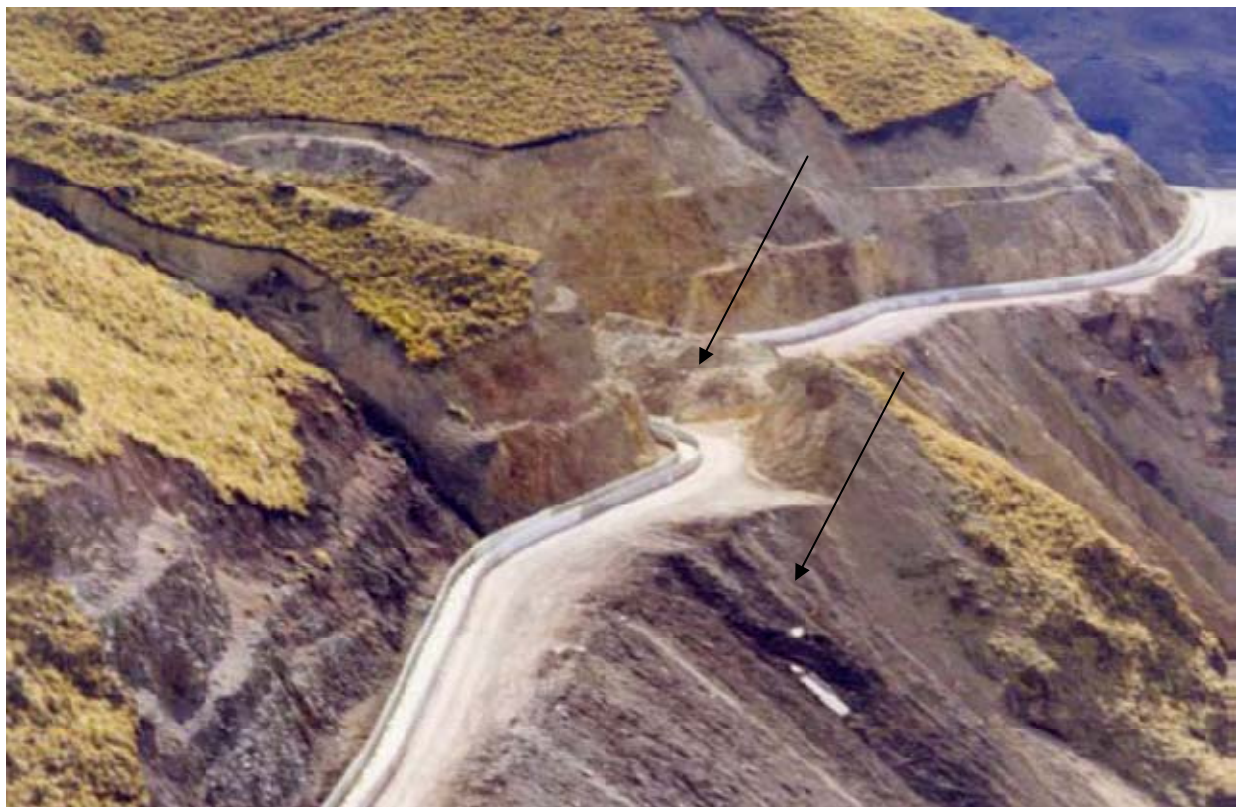
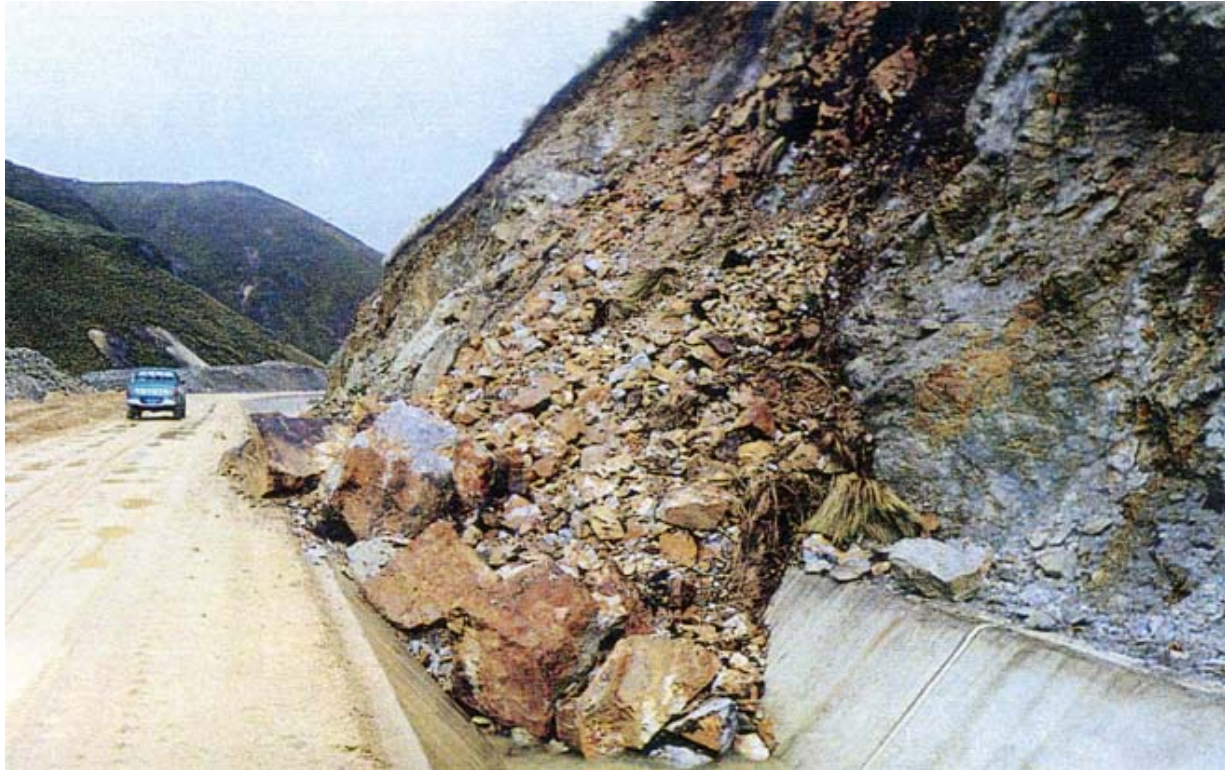
Defective design of cut slope angle

Investigation revealed the following: - Cut slope angles were not adequately adapted to ground conditions. - Insufficient installations of gabions to protect canal and road structure.

- Insufficient benching of exceptionally high slopes.
- Drainage of slopes against watercourses and/or rainfall inadequate.
