Engineering Insurance

Claims Review

Contractors' All Risks

Road Construction

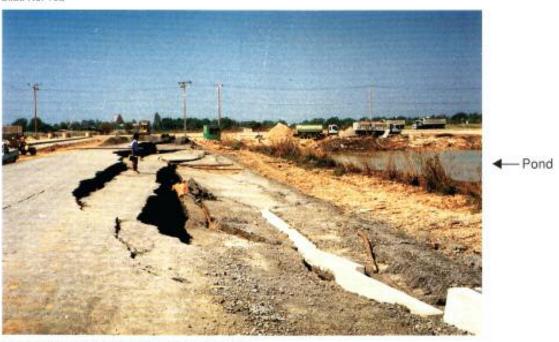
Slide No. 103

Subsided road embankment in close vicinity of a pond

The lane of the highway closest to the pond subsided considerably

because of a ground failure.

After excavating only 30 cm of soil, 2.05 m of embankment rest on water saturated terrain.

Due to this overload, a 130 m long part of the road slipped towards the

pona.

The proximity of the pond should have been an alarming signal and incentive to calculate the stability of the structure. The expected change of soil quality, especially with the presence of ground water in that area, would have called for a soil improvement treatment prior to putting up

embankment.

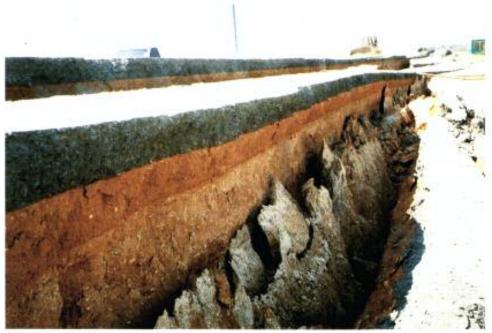
Backfilled embankment after soil collapse. Destroyed asphaltic layer fell into opening gaps.

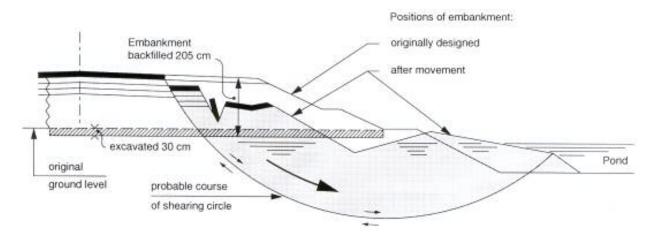
Cross section showing movement caused by soil collapse.
