Topped huge mobile crane

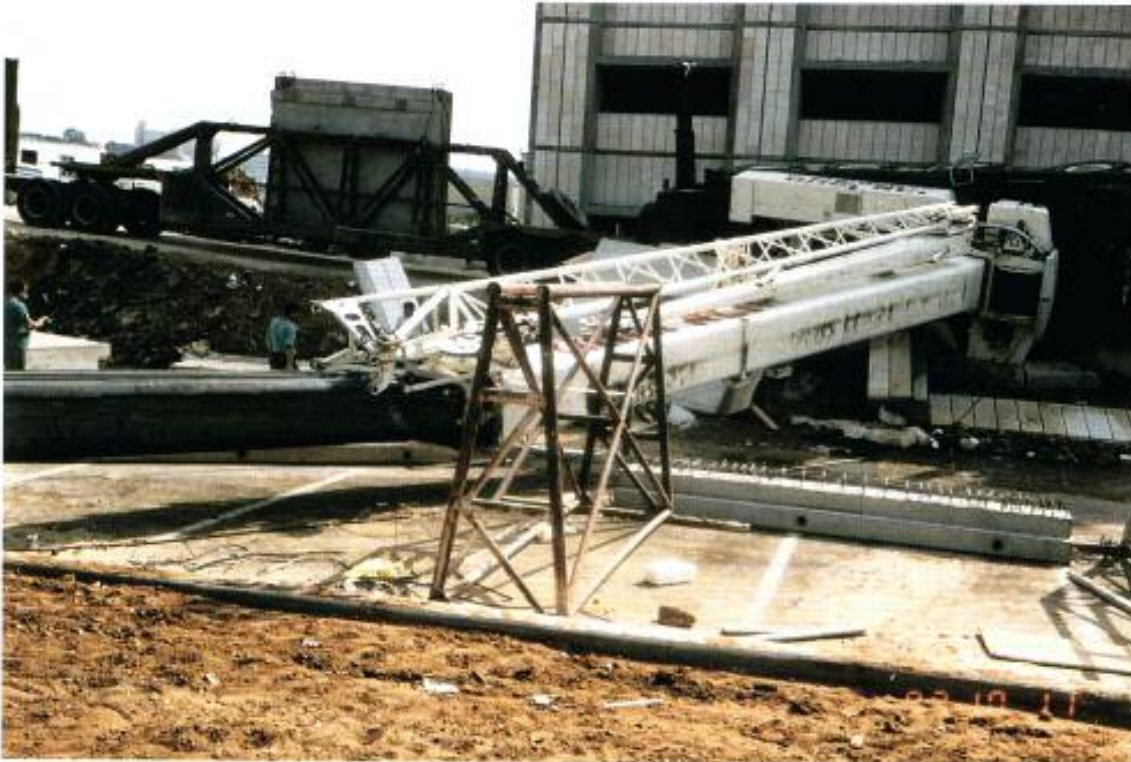
Slide No 55

Amount of loss	Swiss Francs 510,000.-
Incident	Toppling mobile crane
Cause	Outriggers were positioned on weak supports on filled ground
Short description	When the crane was under load, the wooden planks on which the outriggers were positioned sunk into the filled ground and the whole crane toppled over. The boom landed on a third party car and the crane itself was badly damaged to the extent of structural total loss.
Comments and loss prevention	Despite the high frequency of such occurrences, plant operators still underestimate the importance not only of positioning on adequate planks but also of checking on actual ground conditions to avoid settlement.

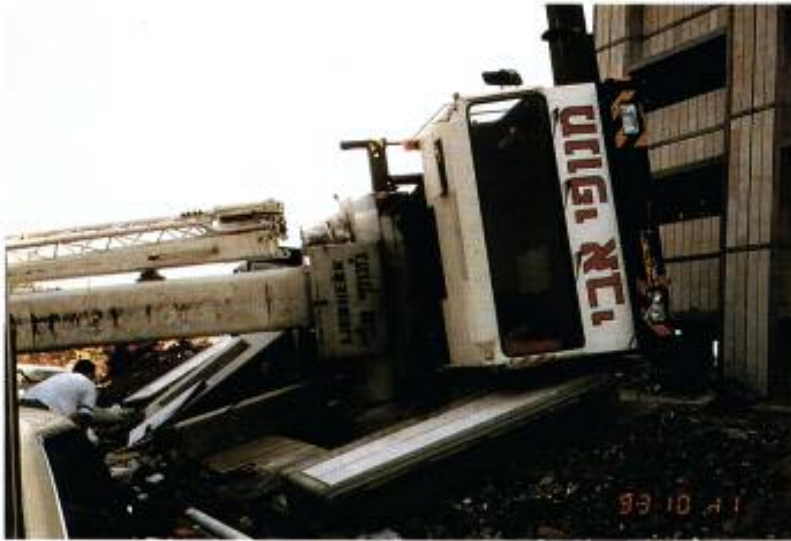
Slide No 56

Clearly visible weak wooden planks on soft ground

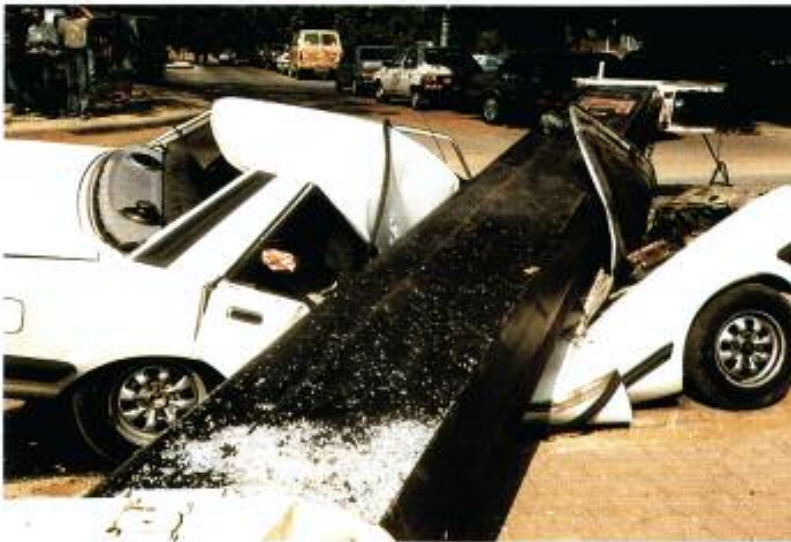
Slide No 57

Third party car hit by crane beam
