**IMIA.  
Wind Turbine Generators.**

**Claims.**

**Codan Insurance / September 2007  
Risk Engineer Truels Kjer**

**Claims involving the main components of the turbine.**

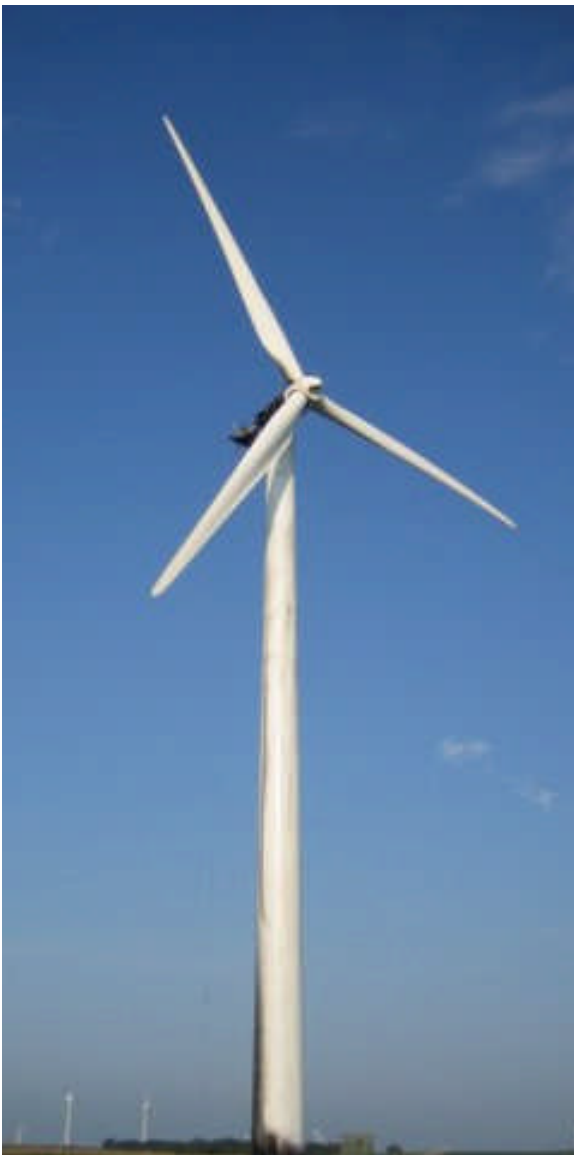
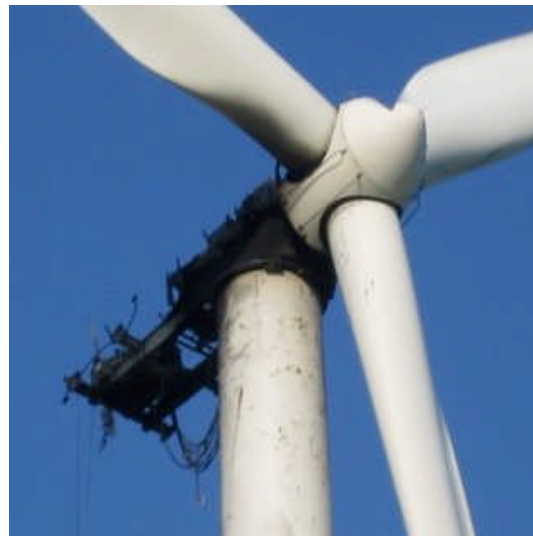
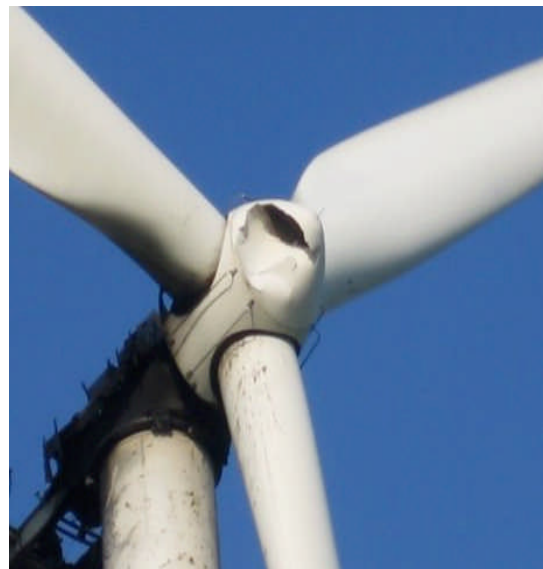
*Root causes.* Pitch system.

Due to mechanical/electrical problems with the pitch system the turbine went overspeed. Oil from a broken component was ignited when the oil hit the disk brake which due to overspeed was activated.

*Damaged parts.* Nacelle, at least one blade, upper section of the tower.

The burned nacelle.

Notice the nosecone. Due to the overspeed an implosion have occurred.

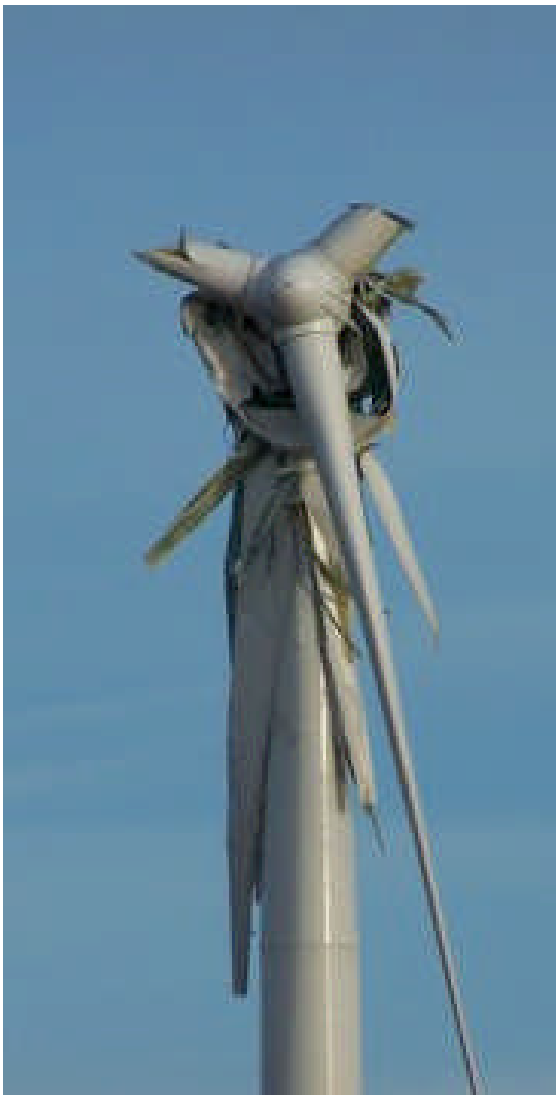
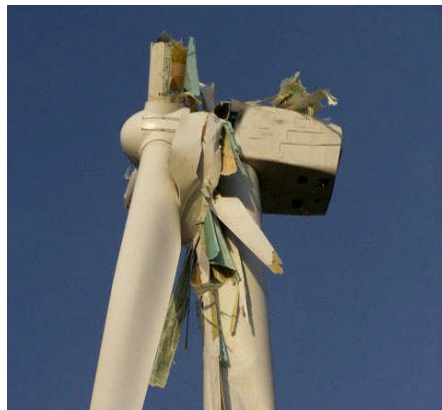
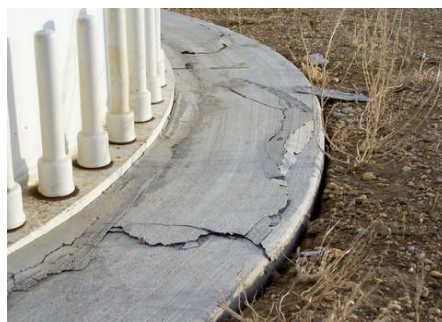
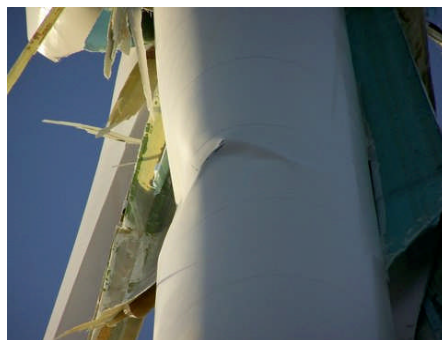
*Root causes.* Pitch system.

Due to problems with the control system of the pitch system the turbine went overspeed.

*Damaged parts.* Nacelle (repairable), 3 blades, upper section of the tower, foundation

The damaged turbine.

Notice the cracks in the foundation and damaged upper tower section.

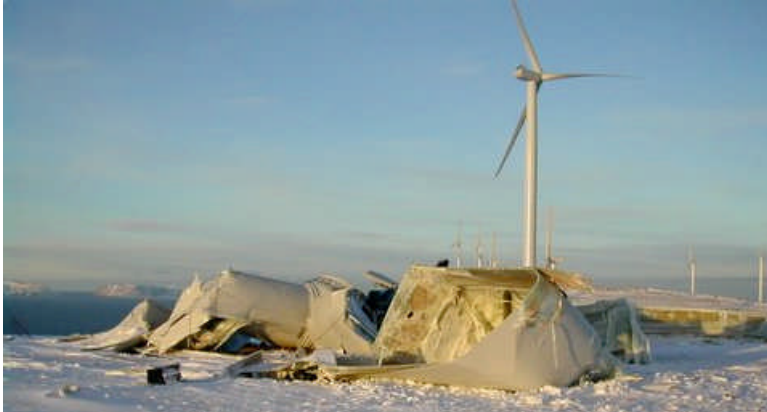
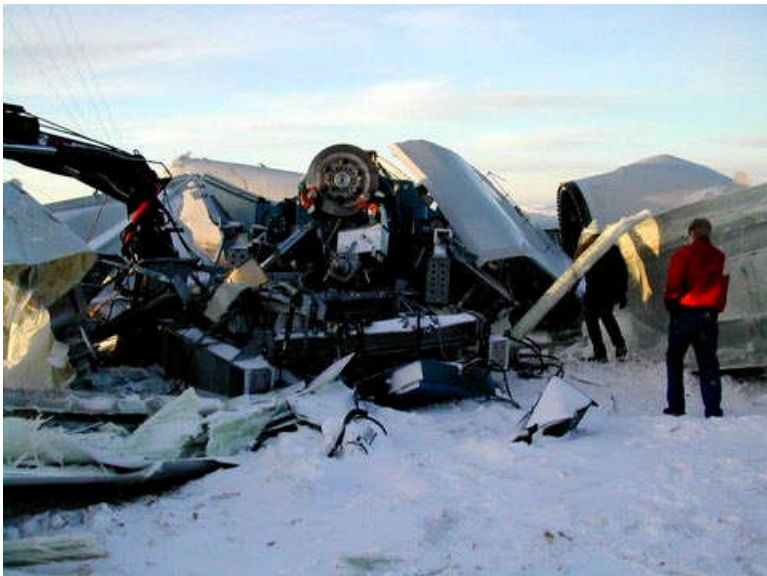
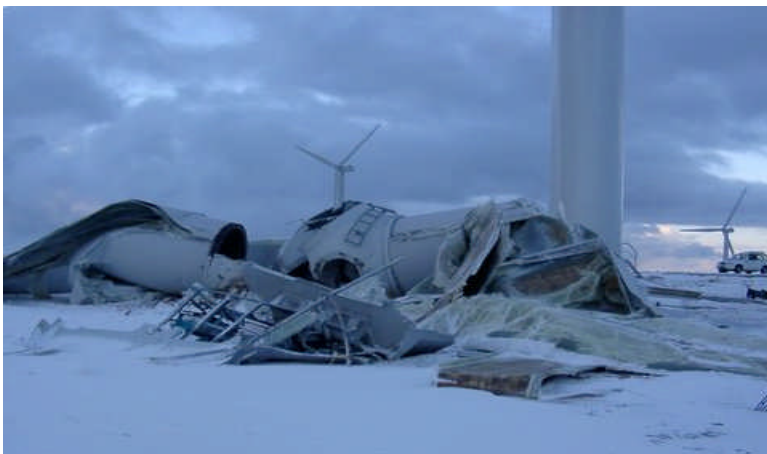
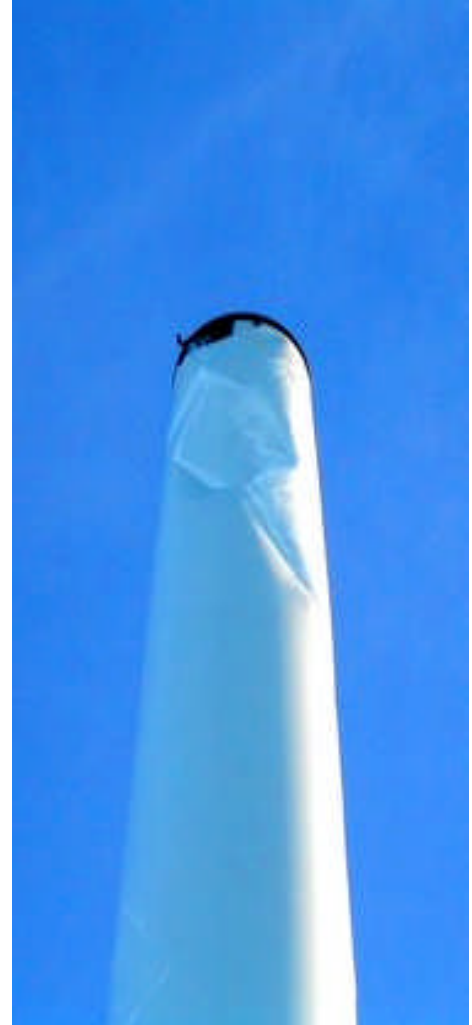
*Root causes.* Bad workmanship. Pitch system.

Due to human interference with the control system of the pitch system the turbine went overspeed. During this one of the blades hit the tower and the whole nacelle broke loose and fell to the ground.

*Damaged parts.* Nacelle, 3 blades, upper section of the tower.

The damaged turbine.  
Notice the marks on the tower from one of the blades. When the nacelle crashed to the ground it was totally destroyed.

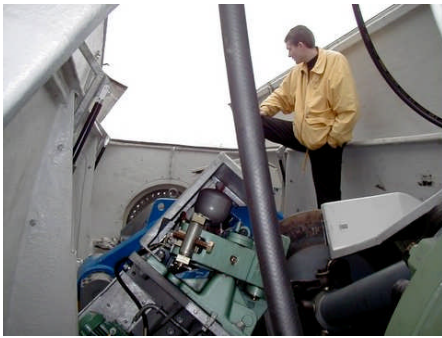
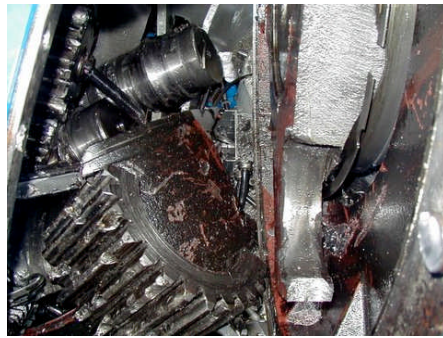
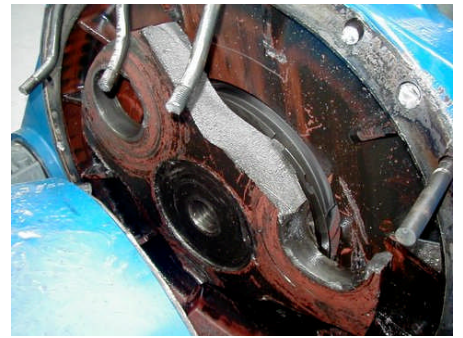
Damaged gearbox in a 750 kW turbine, resulting in damage of the generator, hydraulic system and the control system. Of some reasons the turbine was not stopped at time and the planetary stage locked resulting in server damages not only on the gearbox but also on the other components in the nacelle.

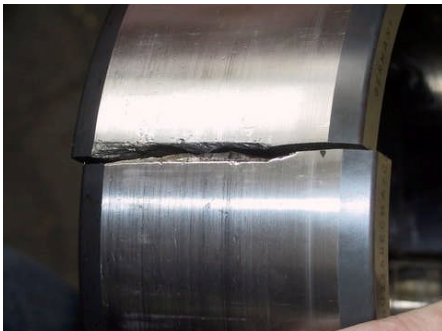
Broken bearing from one of the two helical stages.

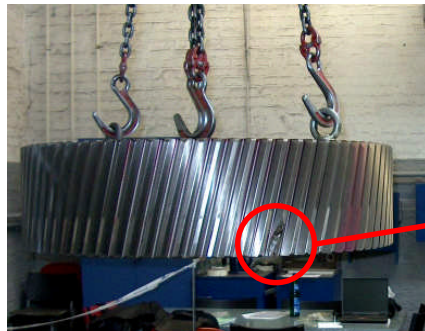
Broken tooth on the low speed gearwheel in a 2 MW gearbox.

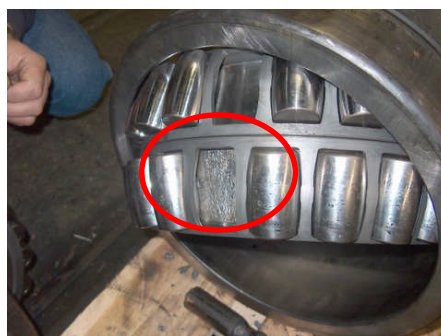
Pitting (wear) on one of six bearings from the planetary stage.

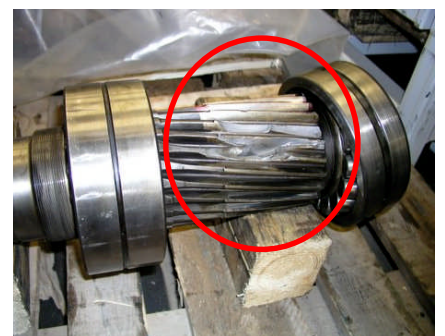
Broken tooth on the pinion in a 750 kW gearbox.

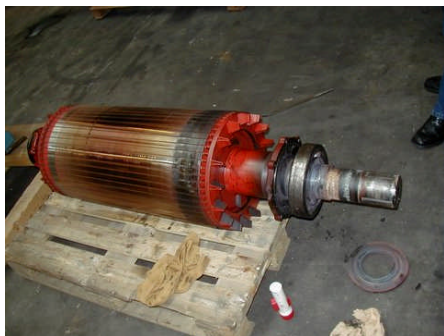
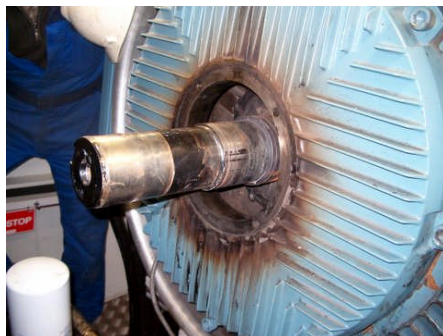
Hot bearing from a 1 MW generator. Root cause could among others be lack of grease, unsuitable grease or loos connection between bearing and shaft.

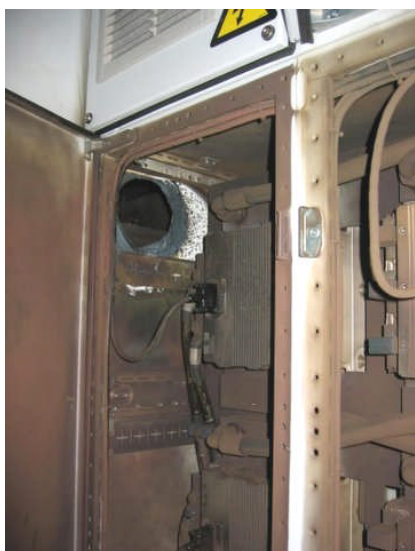
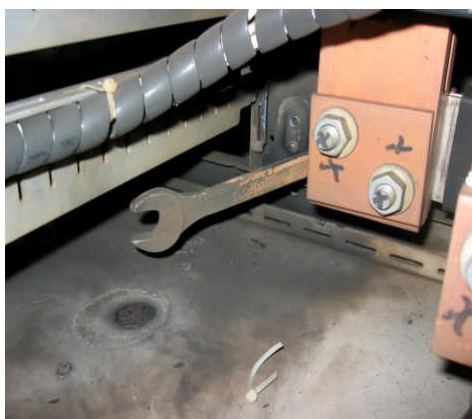
Short circuit in a power panel. Root cause was a forgotten tool. It was traced back to the manufacturer.

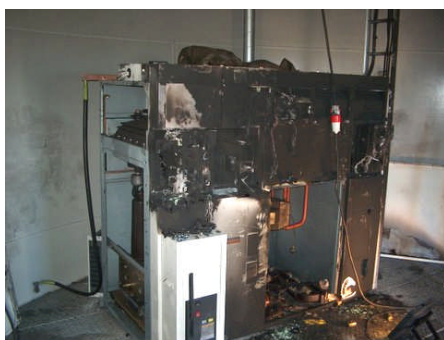
Short circuit in a power panel. Root cause was a bad connection on a high power cable.

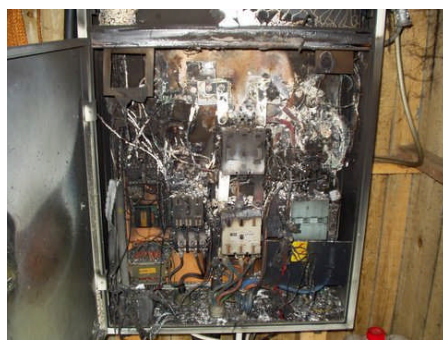
Short circuit in a power panel. Root cause was lightening.

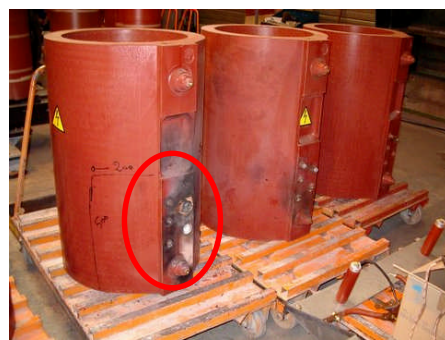
Short circuit in the transformer. Root cause was probably high temperature due to insufficient cooling.
