## Breakdown of a bridge deck during incremental launching operation

Breakdown of a bridge deck during incremental launching operation

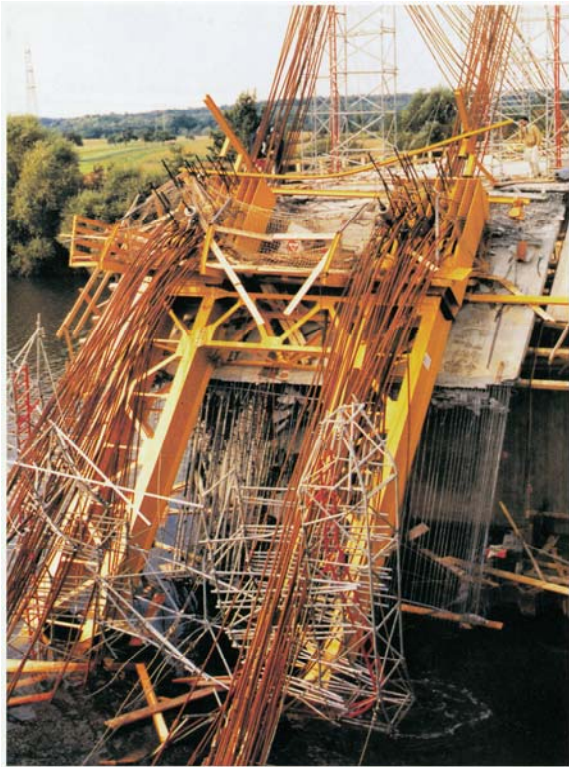
(3) Faulty design

When the loss occurred on August 30, 1988, the first section (increment) of the bridge deck was already moving over the end span, the launching nose was halfway over the other abutment, and the auxiliary pylon about 6 m behind the first river pier. There was an explosion-like bang, whereupon the bridge deck on the river span broke between the first river pier and the auxiliary pylon and crashed into the river. As a result, the deck above the end span with the mounted launching nose rose and, due to its enormous dead weight, buckled over the river pier. Then the launching nose crashed onto the abutment and was severely deformed by the impact. The pylon skidded along the deck and landed in the river.
