## **Collapse of Section of Motorway Tijuana - Ensenada**

Date of Loss 28th December 2013

- Loss of around 300 m motorway at Km 93.00 partly out of the "Right of Way" in about 60m of width.
- Settlement of approximately 30m
- Date of the incident: 28 December 2013 at 2:00 a.m.
- No fatal injuries.
- Insured: BANOBRAS.

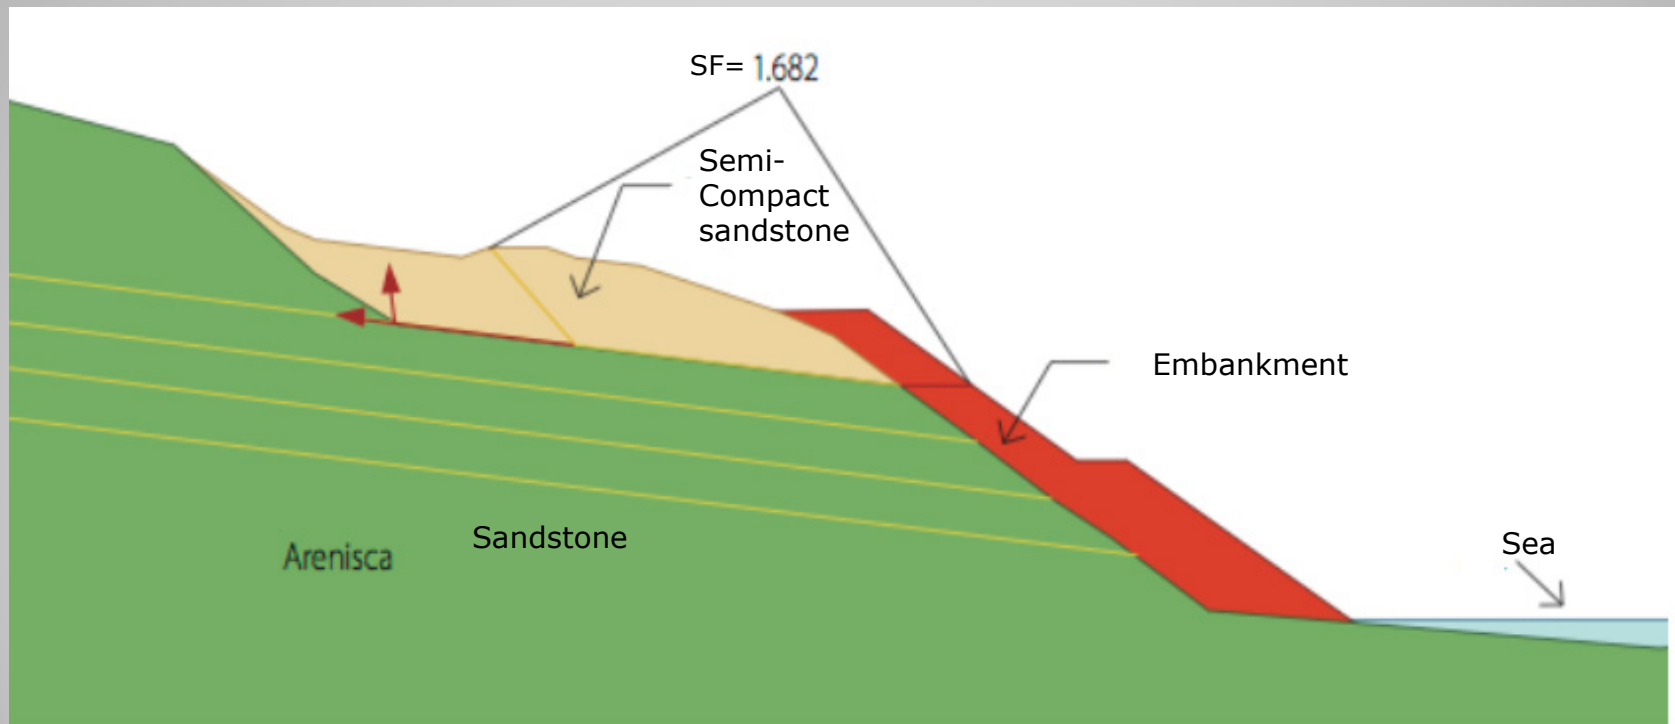
- Retaining Walls
- Gabions

All these are not long lasting because of lack of bearing capacity of underlying soil stratas.

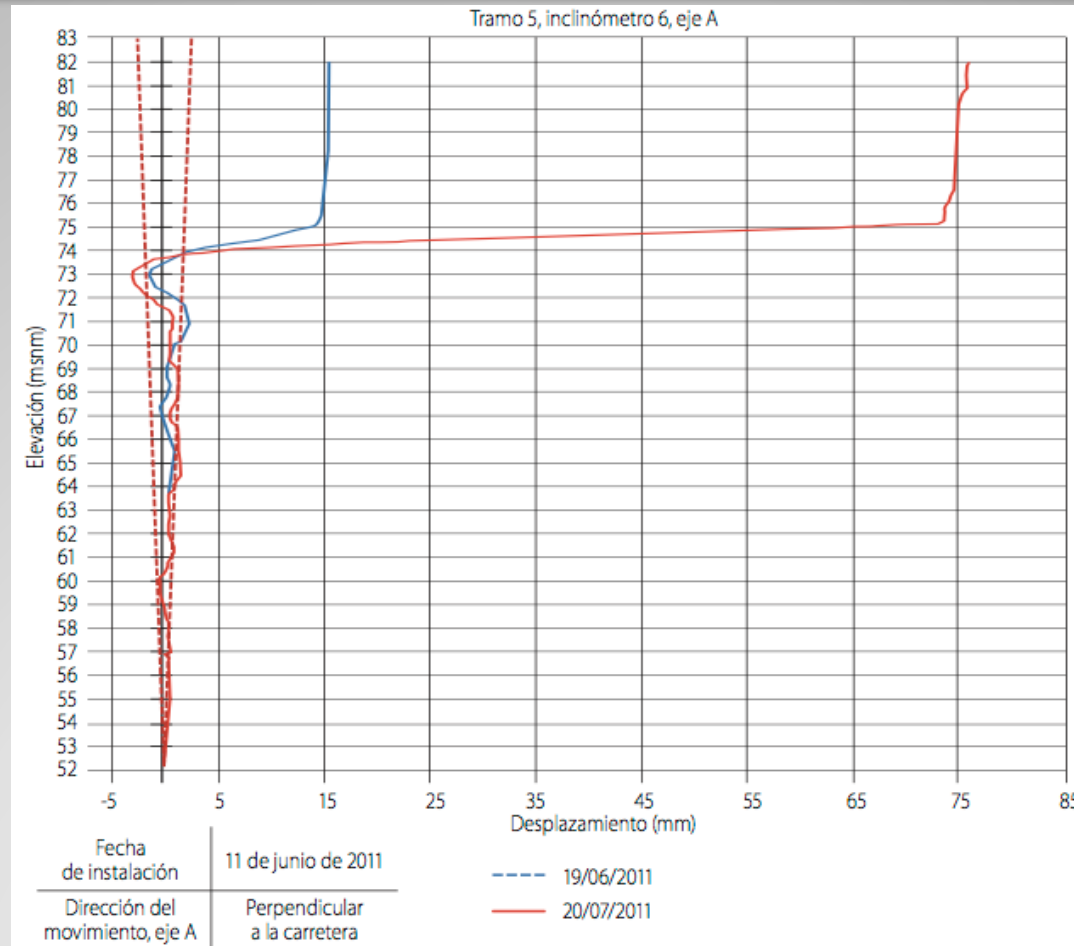
- Installation of inclinometers at that place some years ago (2012).
- Special problems at the site of the incidence Km 93,00
- Show of stability problems.

**Record of displacements registered with the inclinometer installed in the unstable zone**

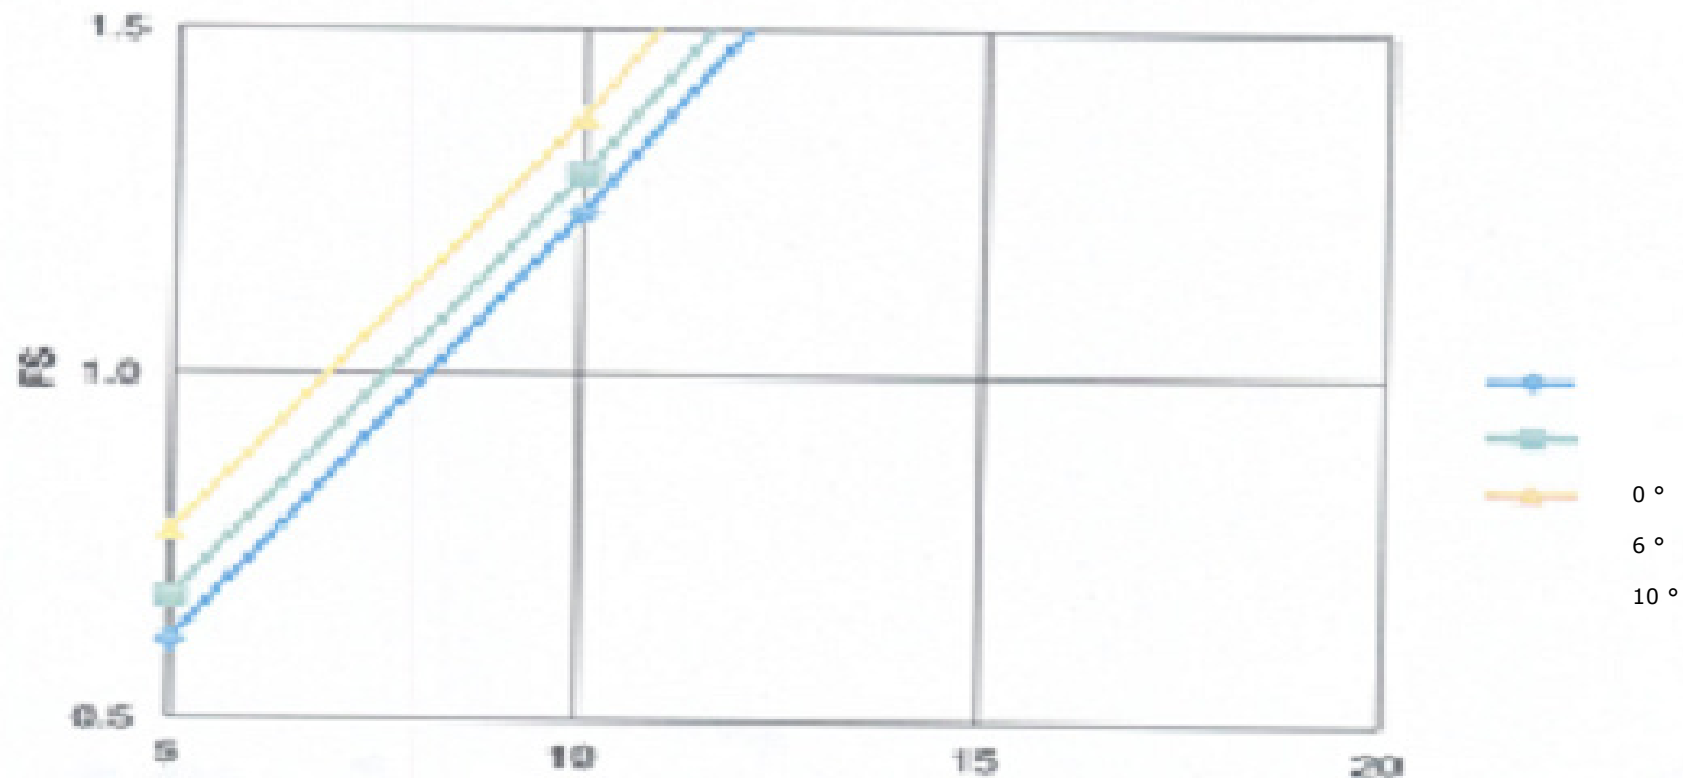
Figure: Relation between angle of friction of slope deposit and safety factor with respect to dry slope

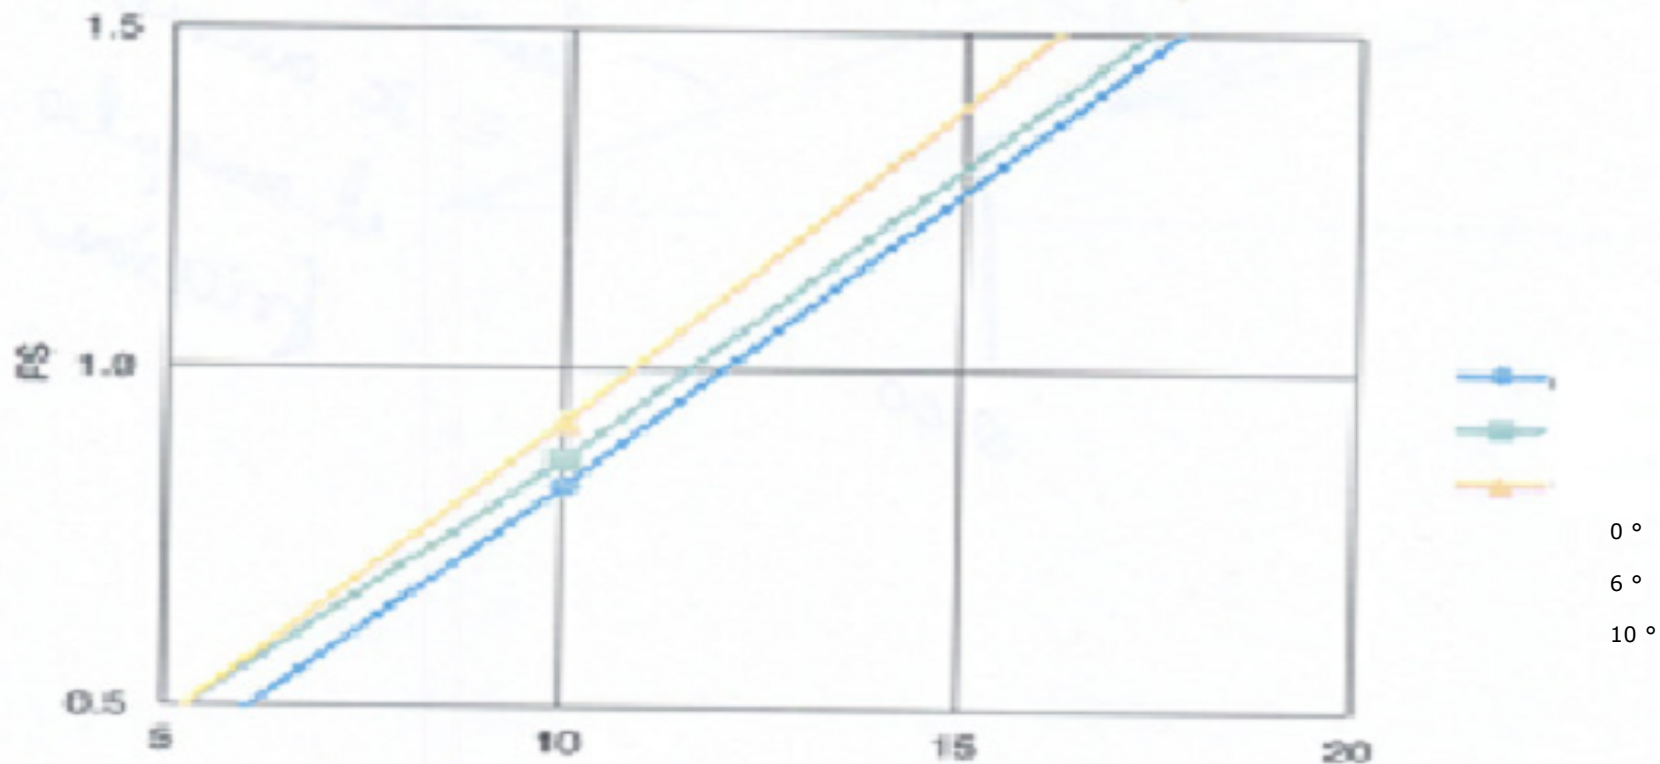
Figure: Relation between angle of friction of slope deposit and safety factor with respect to level of humidity

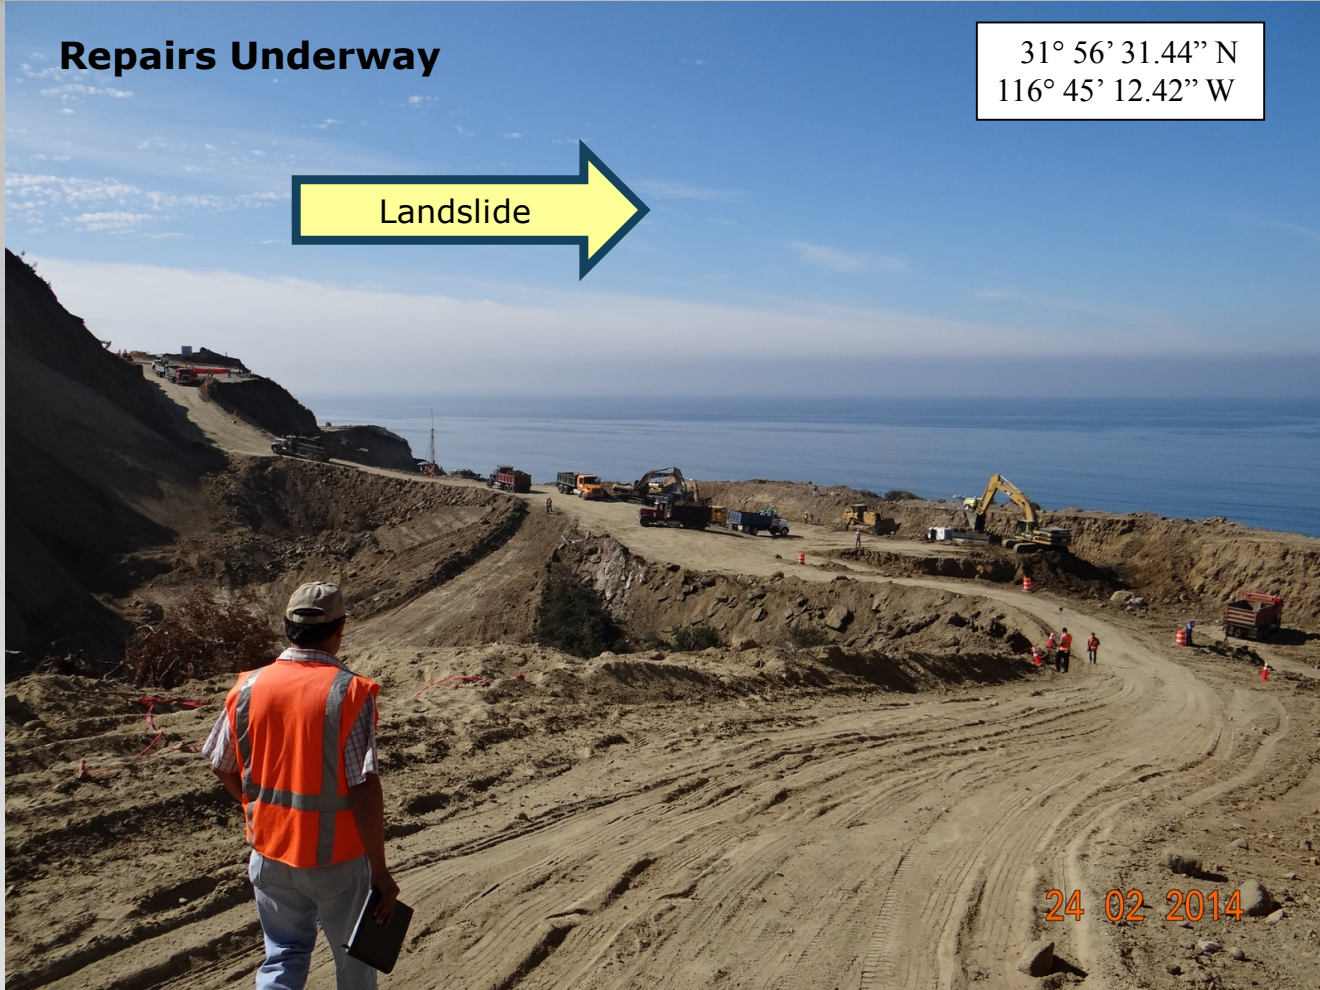
**Repairs Underway**

Landslide

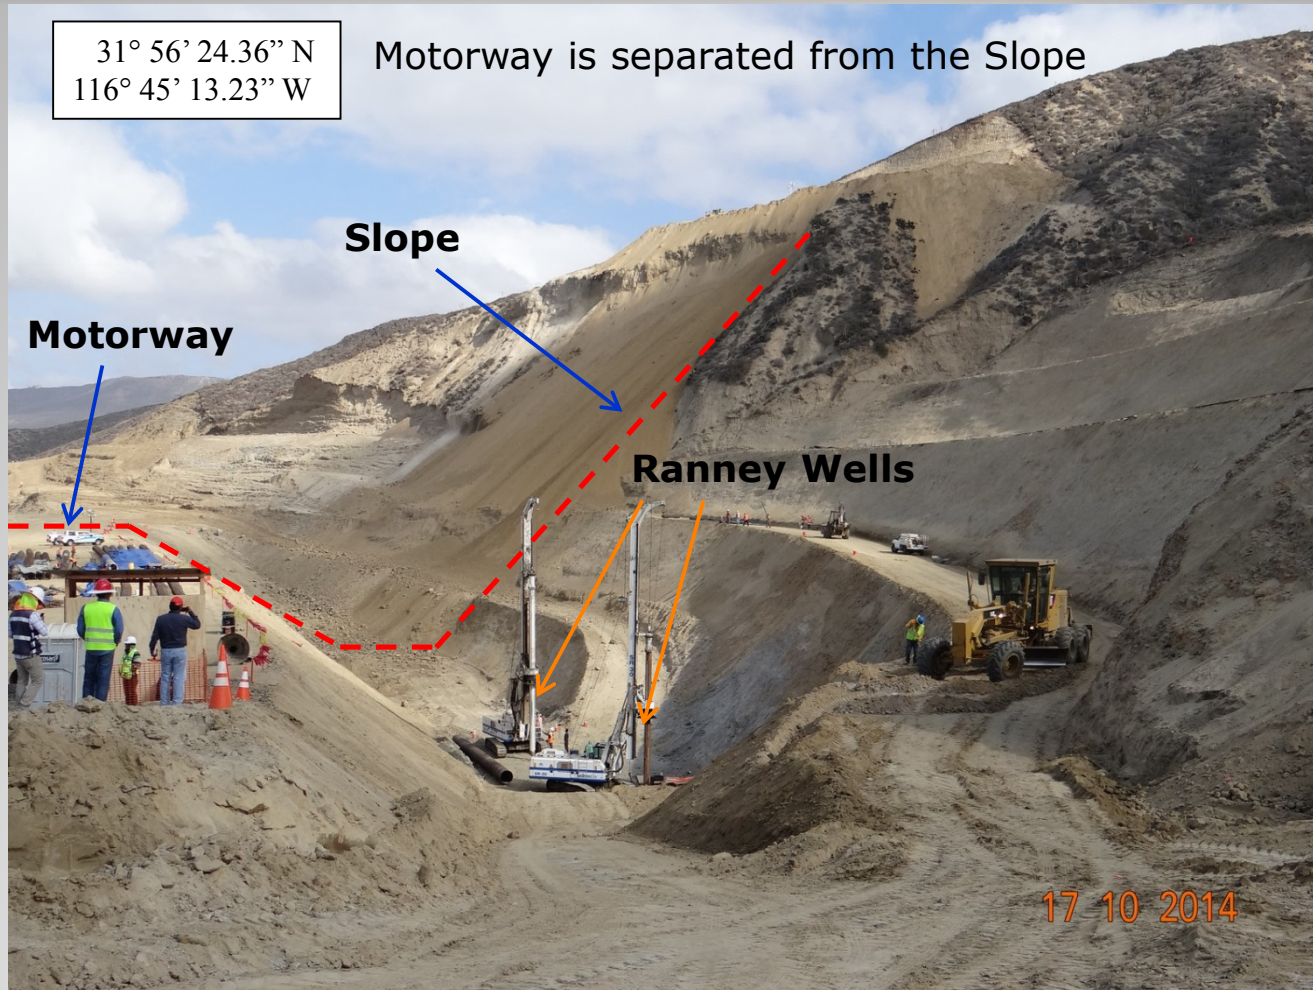
Motorway is separated from the Slope

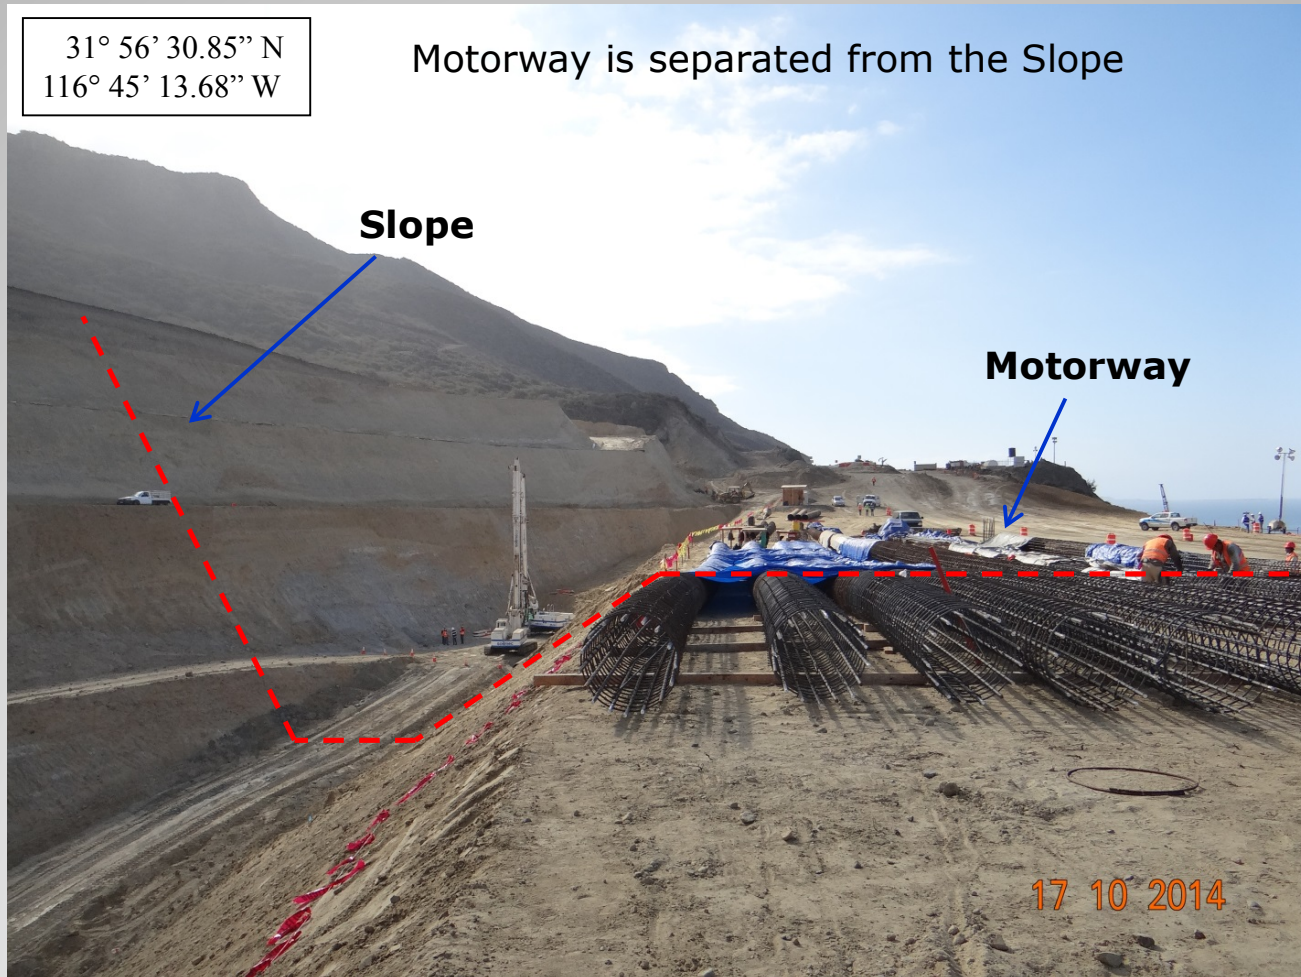
Motorway is separated from the Slope
