# UNPREDICTABLE GROUND CONDITIONS AND FORESEEABLE LOSSES IN **CONSTRUCTION ENGINEERING**

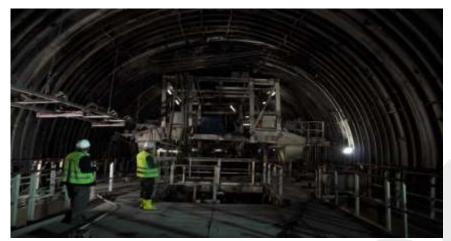
The ring designer, who was called in for assistance, attributed the cracking of the segments to the overestimation of the parameters of the ground presented in the geotechnical report, used as input for the design of the segments. However and instead of insisting on the execution of additional ground investigations, he decided to upgrade the strength of the segments based on arbitrarily postulated values for the parameters of the ground. Having repeated this improvised exercise twice in vain, as from the early July 2012, the ring designer ordered the almost continuous application of additional stiff support to the rings, comprising of steel ribs, anchors and shotcrete, as to enable the continuation of the TBM drive at any price.

Fig. 2: Continuous application of stiff support as to enable excavation with the TBM

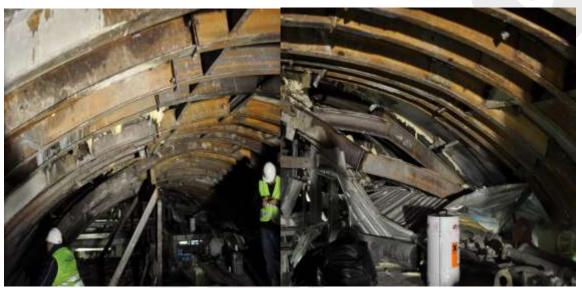
<u>Photos 2 & 3</u>: Partial collapse of the tunnel benches amongst stiff support resulting to the squeezing and damaging of the TBM

As a result of the damages sustained by the TBM and also by the works (partial collapse of the side and crown areas and destruction of the segmental rings over a length of 12m), the excavation of the tunnel was ultimately abandoned by the contractor.

- (c) insufficient grouting of the annular gaps behind the rings in conjunction with the defective design of the segmental rings
- (d) Insured's conscious decision, despite the numerous interim incidents and also the instruction of the owner to abandon the works, to continue the excavation at any price by instructing their designers to seek for fragmentary solutions to the original design (i.e. arbitrary upgrades of the ring's strength and almost continuous application of various types of additional stiff support).

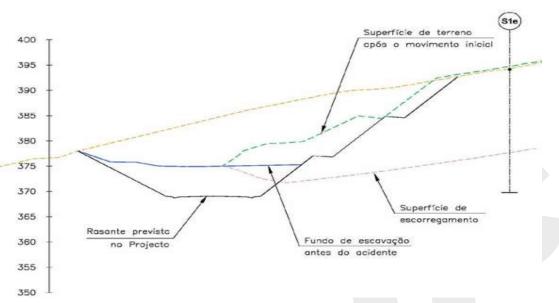
Fig. 2: Cross section of the landslide

In view of these ascertainments, it was reasonably concluded that the recent landslide was due to the reactivation of older displacements caused by the excavation and removal of a huge portion of the footing of the hill side, previously acting as a counterweight.

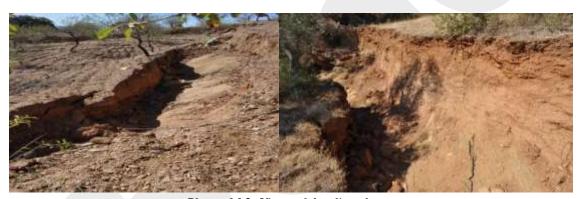
Whereas the excavation work was still in progress, a landslide took place encompassing several parts of the hill side within the area bordered by the length of the earth cut and the some 300m upwards positioned rural road. Besides from moving several meters downhill, the hill side was also vertically settled between 1.5m to 2.0m giving rise to the manifestation of a transitional crack running along the border of the rural road, measuring some 2m in width and 3m in depth.

Photos 1&2: Views of the slipped area

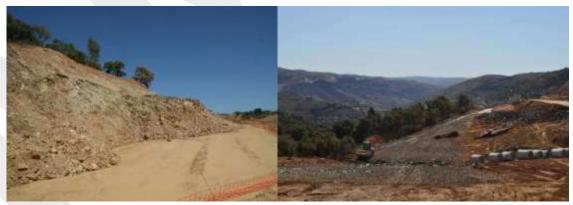
<u>Photos 3 & 4</u>: (a) earth mass fell on the already completed sub base of the motorway under construction, (b) works for re-routing the affected stretch of the motorway.

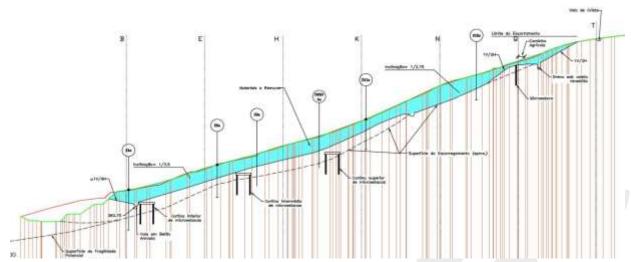
Fig. 3: Cross section depicting the concept of the stabilization works.

Being uncertain about the residual stability of the hill side following the captioned incident, the contractor decided to abandon the excavation in this area and instead to re-align one km long section of the route of the new motorway some 40m downstream as indicated in photo 3b. This solution provided also for the removal of the displaced earthmass and also the execution of stabilization works, comprising of the installation of 3 subsequent retaining walls made of anchored micro piles to be placed along the hillside as indicated in Fig. 3, below.
