Verifying design criteria during construction works

CAR – Extended Maintenance Period
Design Exclusion LEG 2

Landslide damaged motorway and embankment during extended maintenance period

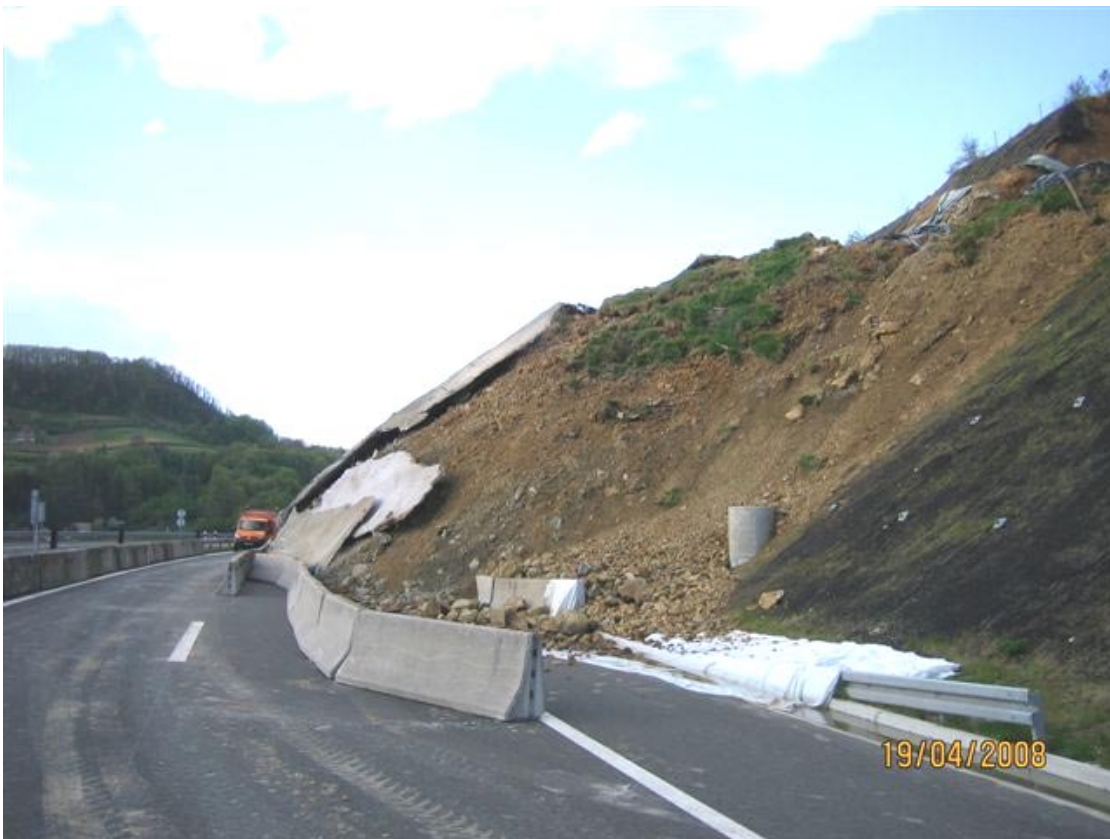
Situation shortly after the landslide occurred
