**MACHINERY BREAKDOWN LOSS
FOR
COOLING TOWERS**

A. SARKAR

THE NEW INDIA ASSURANCE. CO. LTD., INDIA

CASE STUDY – COOLING TOWER

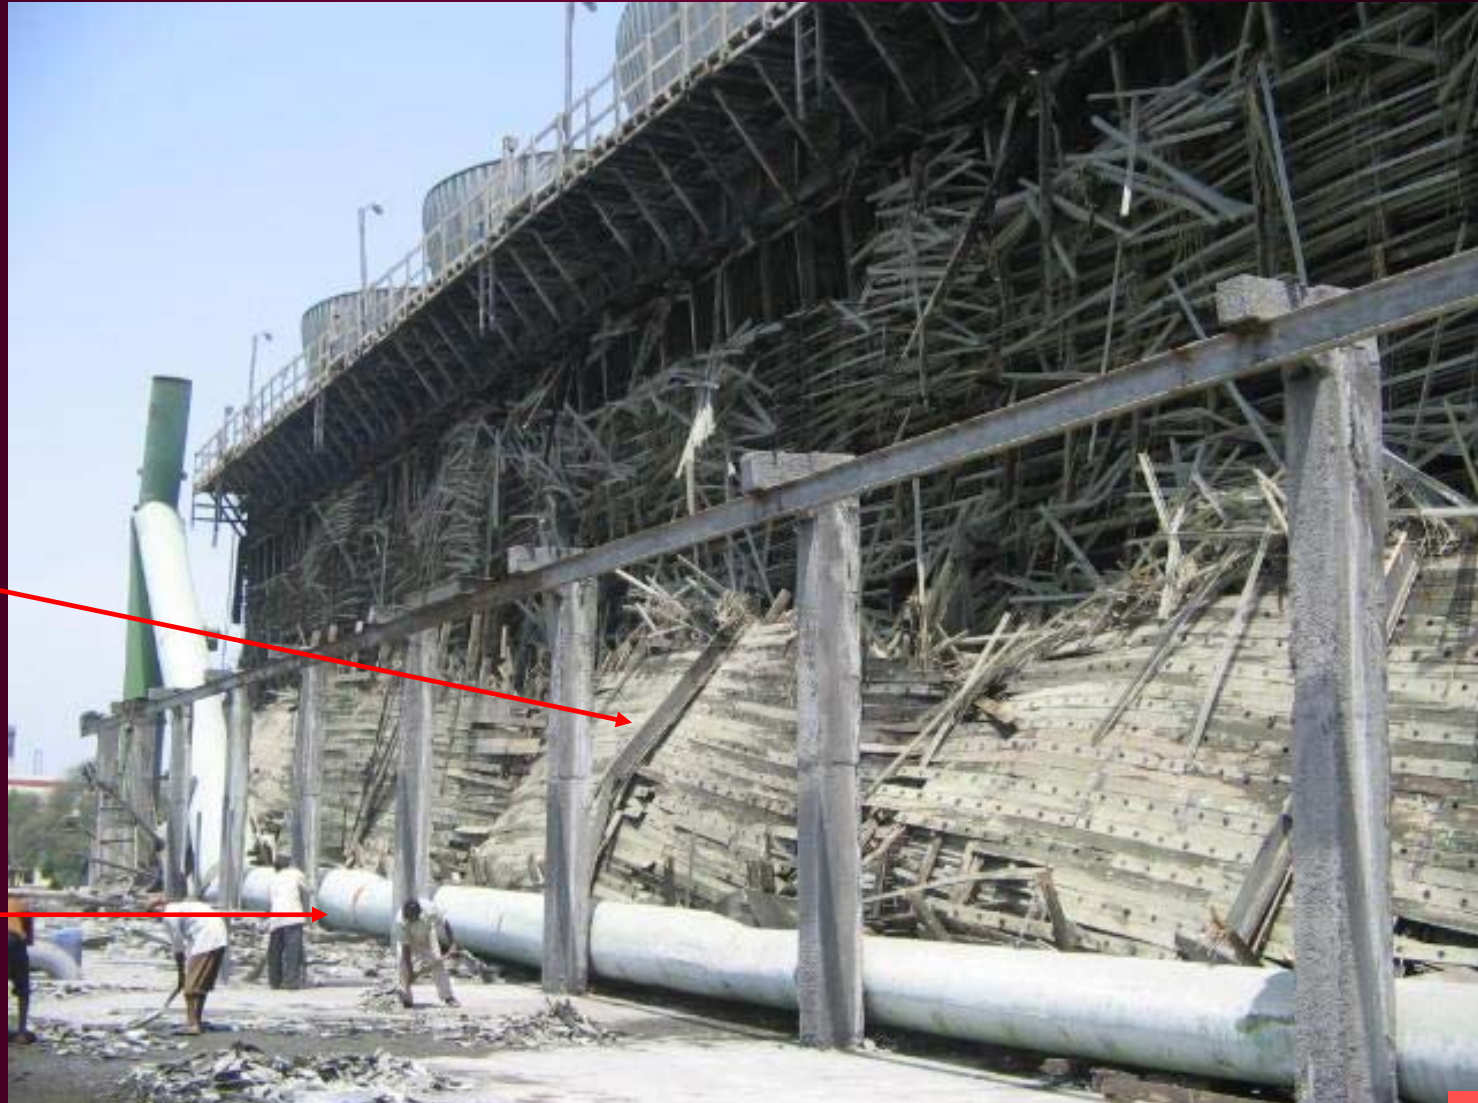
- ✓ The field operator noticed heavy sound emerging from the Cooling Tower. Immediately he noticed gushing of water from the Riser bottom.
- ✓ Before the operator could intervene the riser and distributor along with complete wooden structure on front side collapsed. It also flooded nearby area due to heavy water coming out of the damaged riser bottom.
- ✓ Immediately after the incident the water return to the cooling tower was cut off **and emergency shutdown was taken for the plant.**

**Collapsed deck
along
with
structure
below it**

**Distributor
lying at
ground**

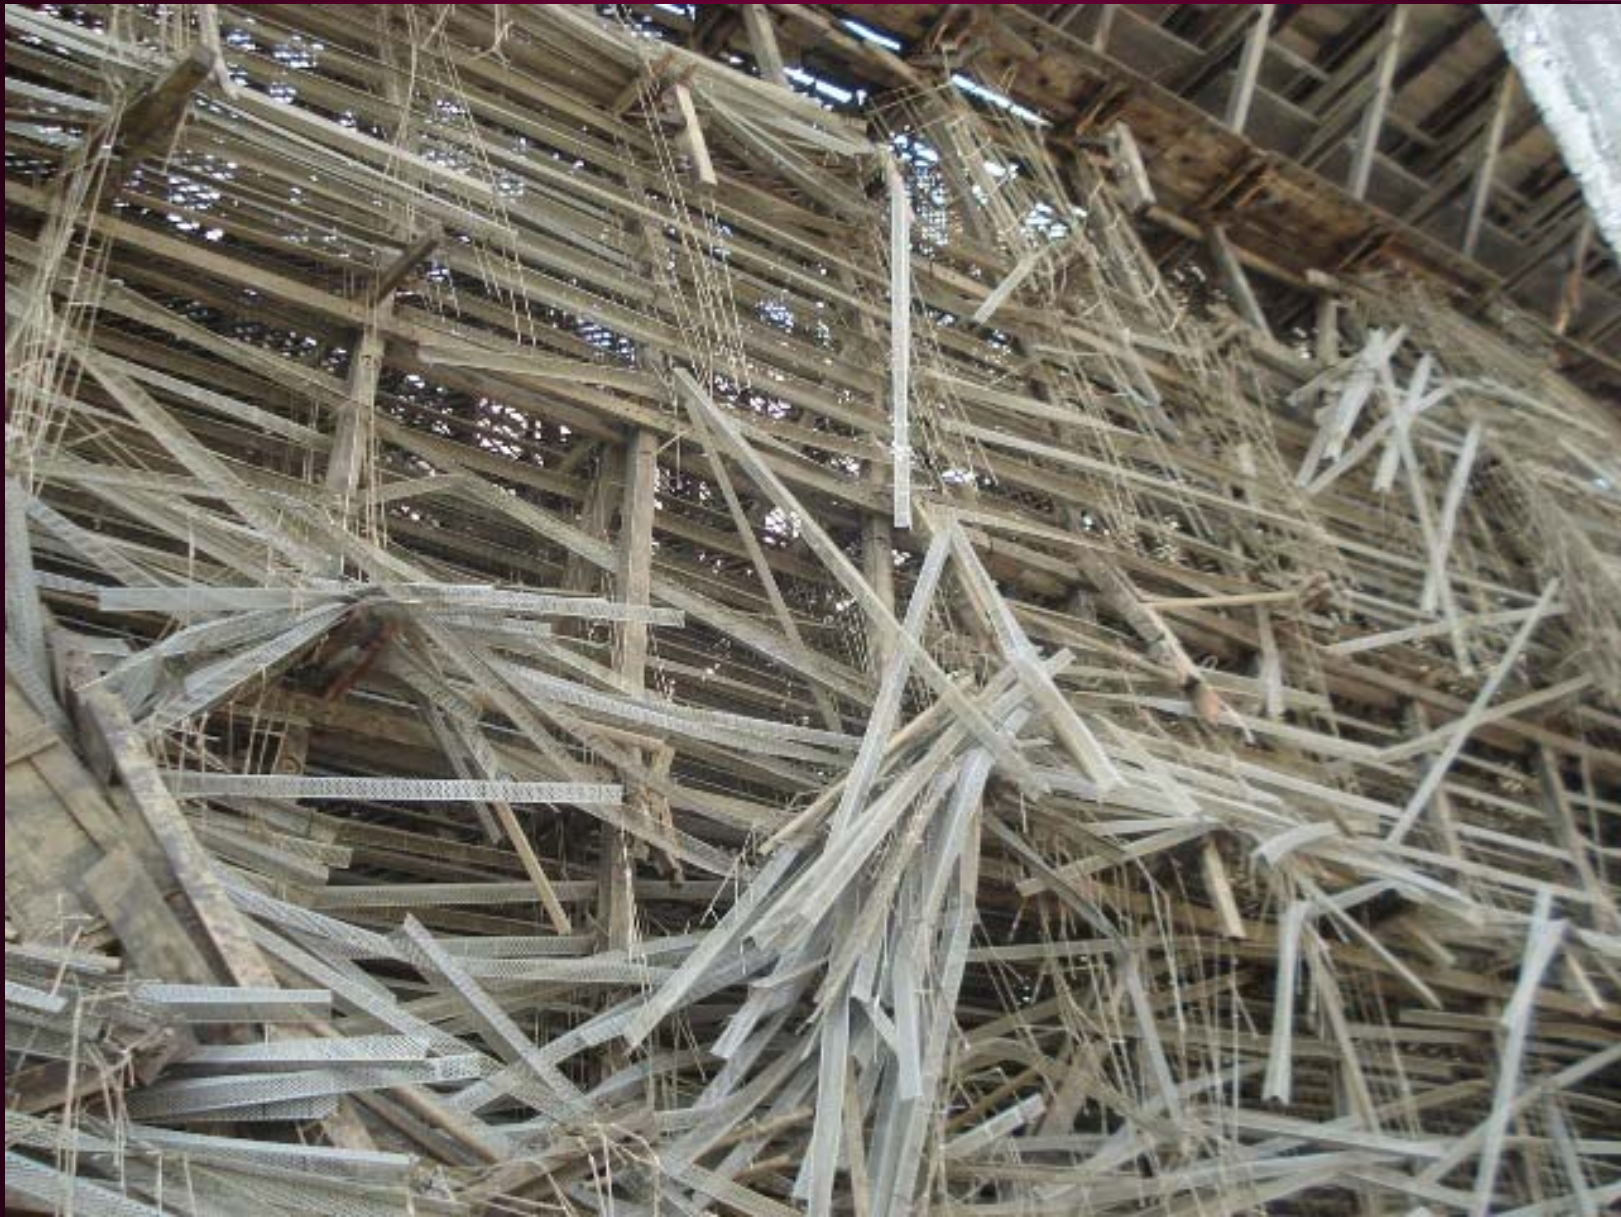
Damaged splash bars and fill material below the deck

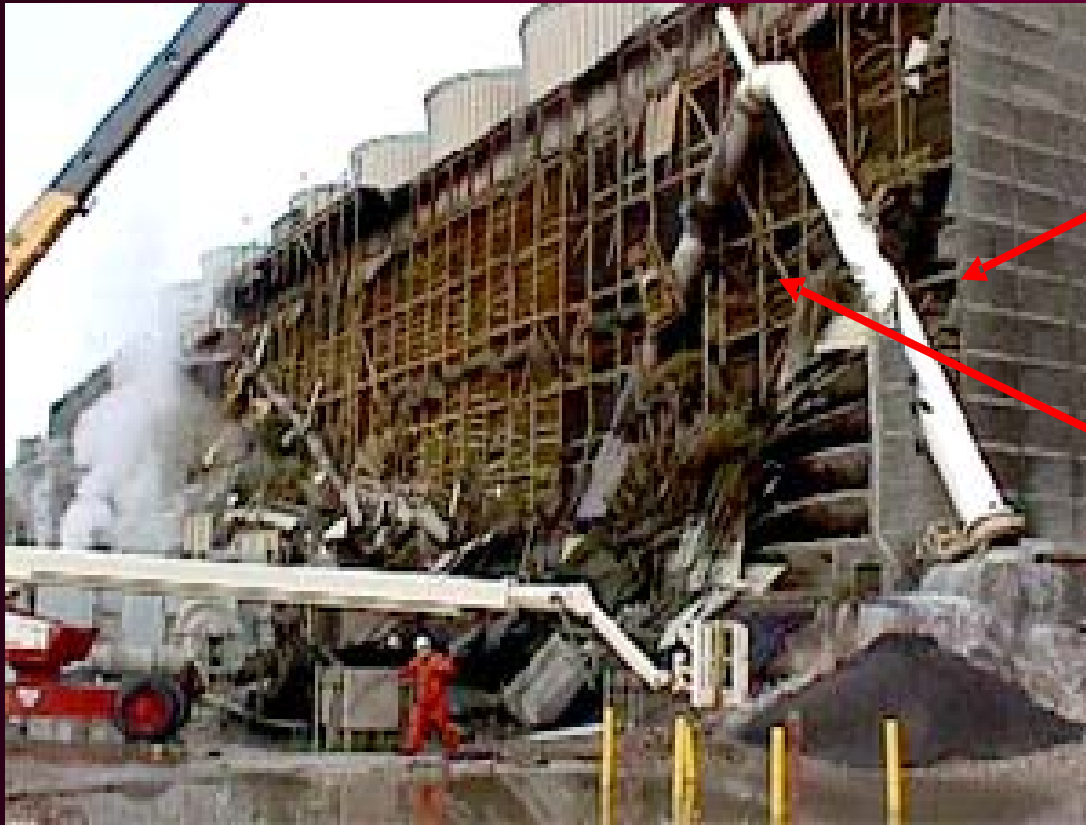
- ✓ The shear weight of the huge distributor pipe (Approx. 80 meters in length, Diameter ranging from 52” to 24”) running over the deck along with the weight of water in it can lead to collapse in case of failure of the wooden support structure.

Riser which was possibly pulled by the collapsing Distributor

Collapsed Distributor

Fig: This picture is showing a damaged air cooler where possibly the collapsing distributor pulled the riser also. (Picture for reference only, not an actual photograph of loss site.)
