IMIA Short Paper by Infrassure (March 2011)

Guarantee on repairing works and entrepreneurial risk MB in IAR – new for old instead of actual value

Short circuit between secondary bars of an 85 MVA arc furnace transformer

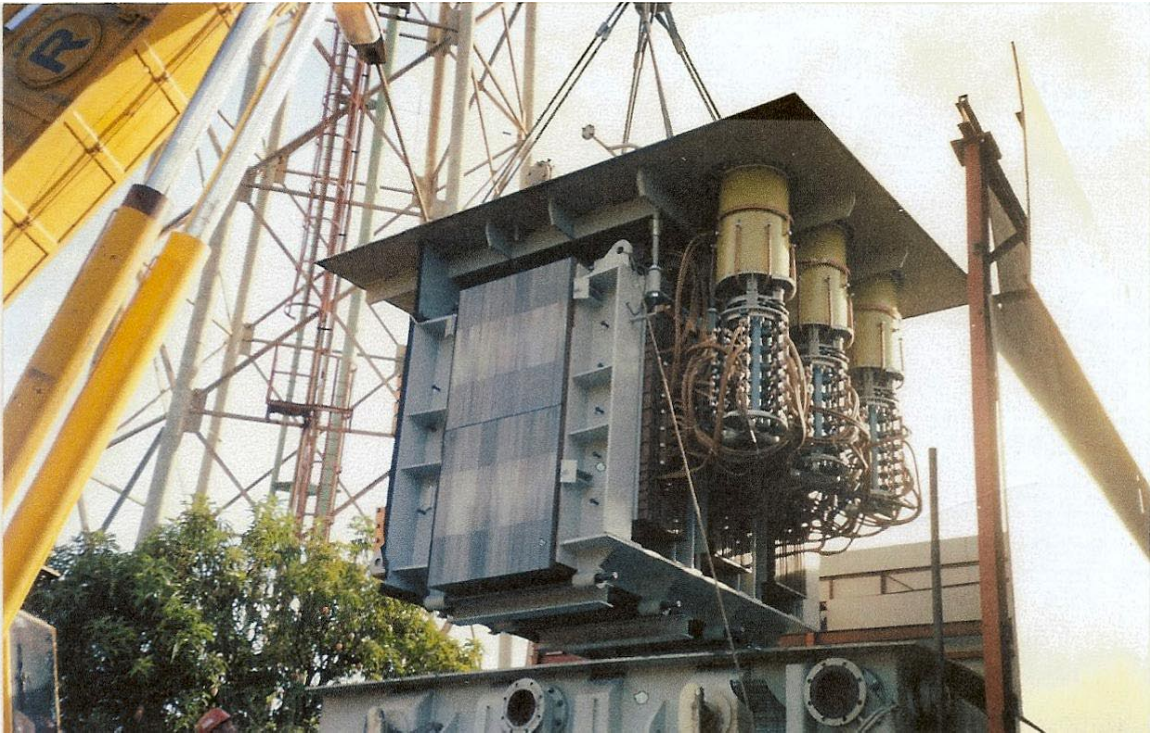
Picture 1 shows the disassembling activities

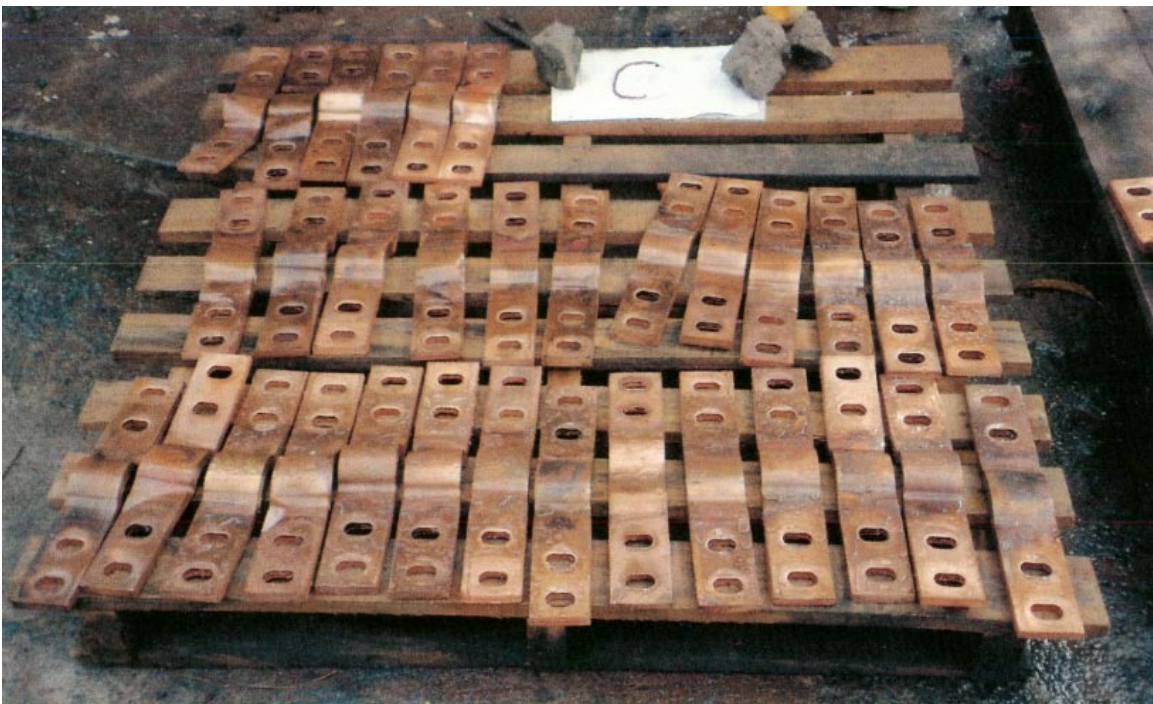
Picture 2 shows bar links to phase C

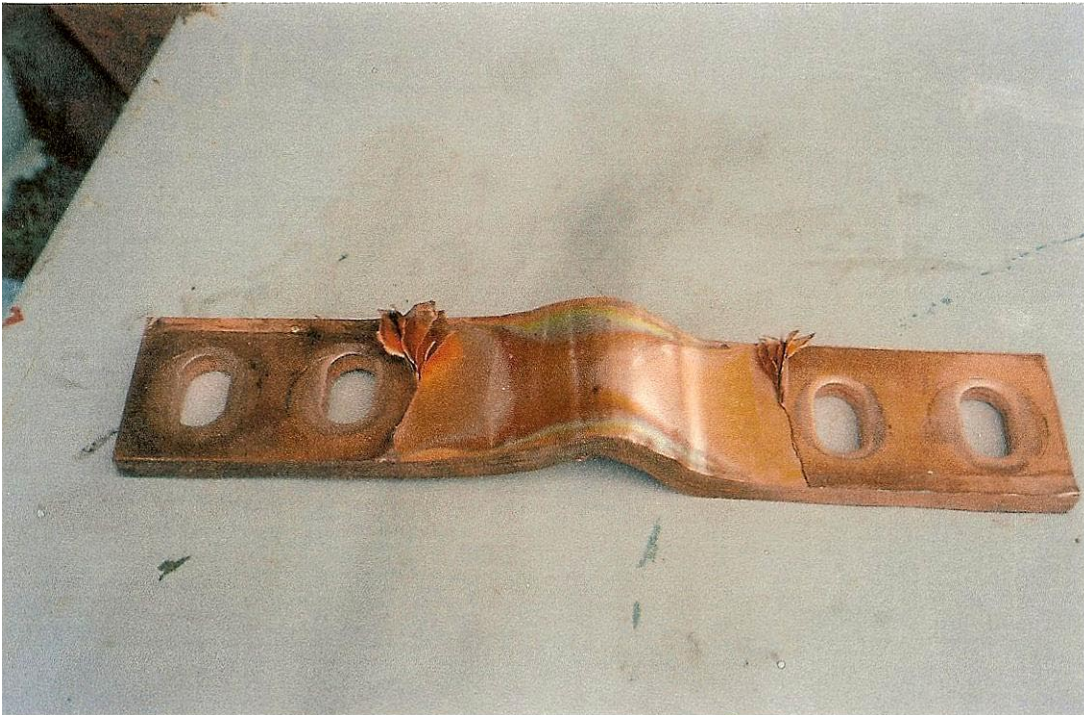
Picture 3

After the analysis of the bars it was discovered that one of them had signs of burning and rupture of the superficial copper sheets that make up the parts.

Pictures 3 to 5 show the bar and copper sheets that produced the short-circuit

It was observed that the bars were bolted to a surface by bolt heads with sharp, cutting edges which could have been the cause of the deterioration of the laminates and subsequent short circuit. In addition, the specialists advised that the bars were not long enough, which could have contributed to the acceleration of the rupture process.

After the second inspection, specialists determined that the winding was not affected and that repair was possible in situ provided new bars were redesigned and supplied. This repair would include certain electrical tests but not those which would guarantee there would not be further short circuits. Nevertheless specialists argued that the transformer would be returned to the same operational condition (14 year old equipment) as before the damage, possibly even better, as the faulty part was exchanged resp. modified and improved.
