Steam turbine disruption in an bio mass burning power plant (India)

by Milind Bhatawadekar

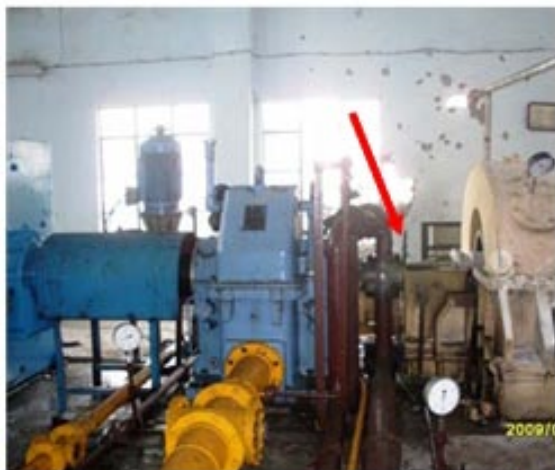
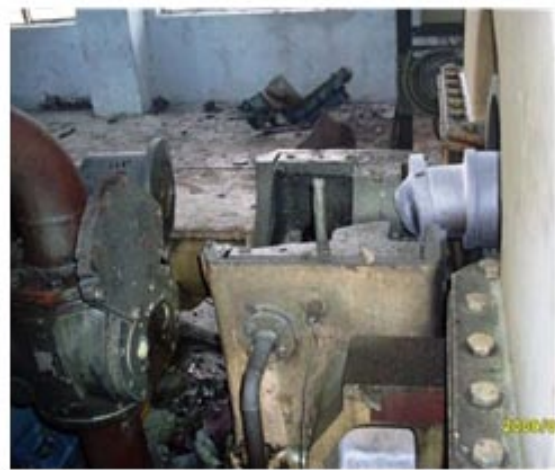
Rear bearing pedestal and coupling area

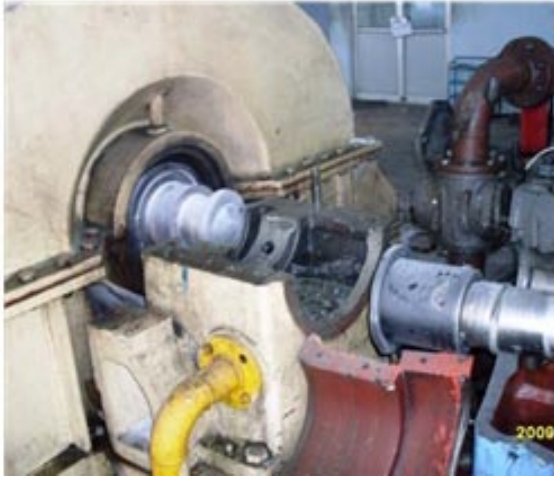
Turbine rotor shaft broken near journal

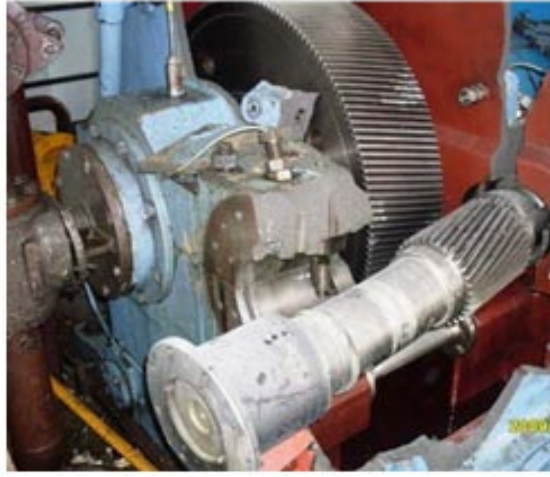
Damaged casing, gears and shafts
