# **RALCO HYDROELECTRIC PROJECT CHILE**

## **Damage to upstream cofferdam**

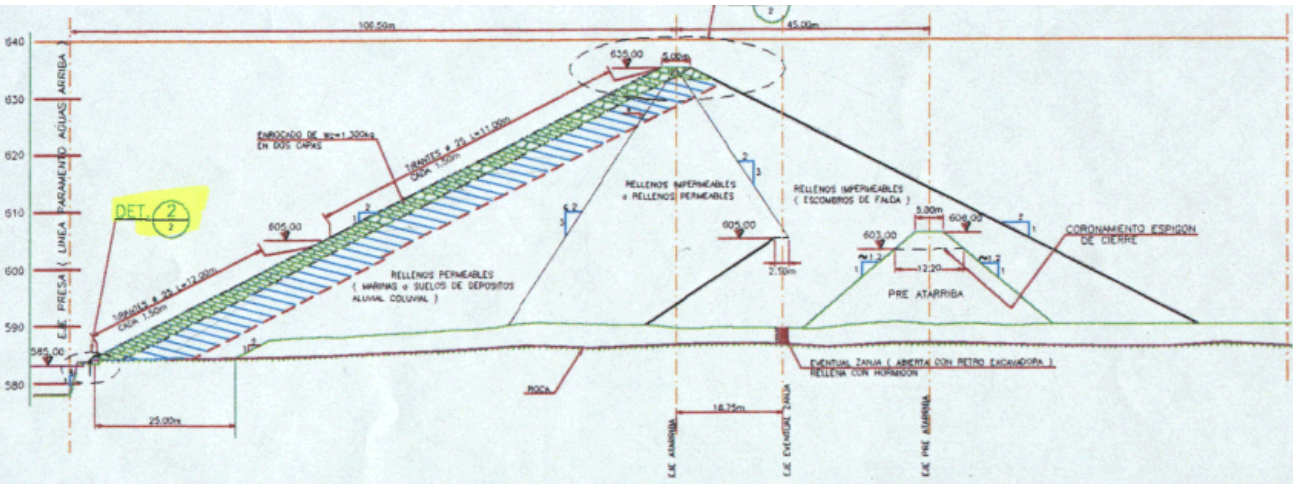
- 27th May 2001:
- crest level 635 m except 10 m x 2 m access way
- Rock protection level 628 m
- Other work, included but not limited to:
  - Anchoring of the rock protection mesh to abutments
  - Completion of crest at access way
  - Preparation and protection works of crest and downstream abutments

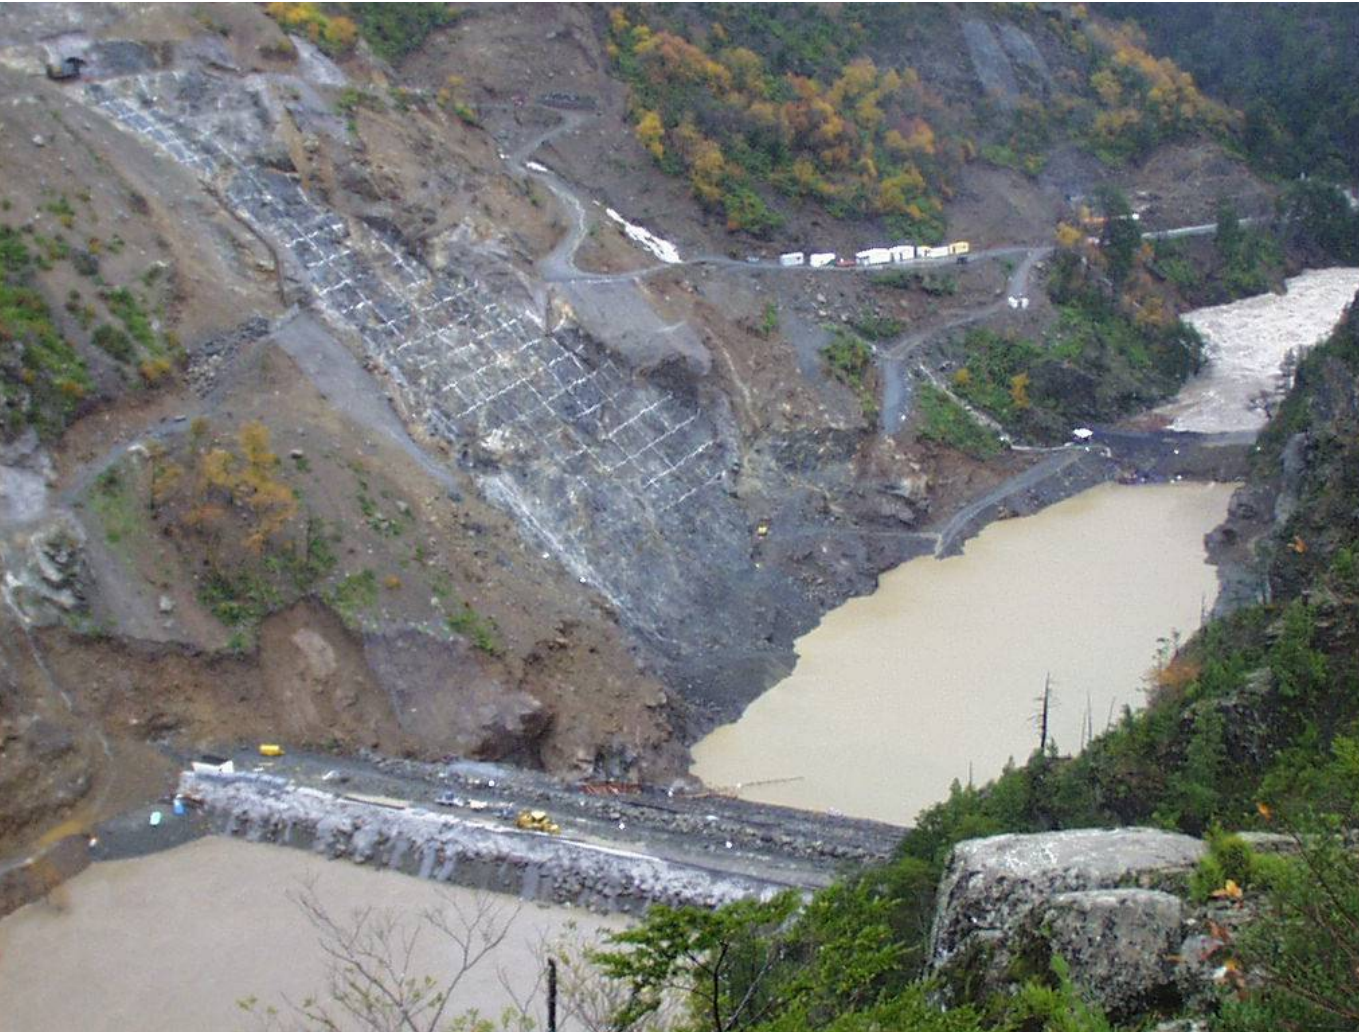
### COFFERDAM OVERTOPPED:

- 22:30 h on 27th  
May 2001
- FAILURE  
OCCURRED  
SHORTLY  
AFTERWARDS

- **EROSION OF THE COLLUVIAL MATERIAL ON THE LEFT BANK ABUTMENT**
