DETAILS OF INTERESTING CLAIM

Type of Insurance:
EAR/ALOP

Description of damaged item:
Collapse of a MC (medium consistency) pulp tower

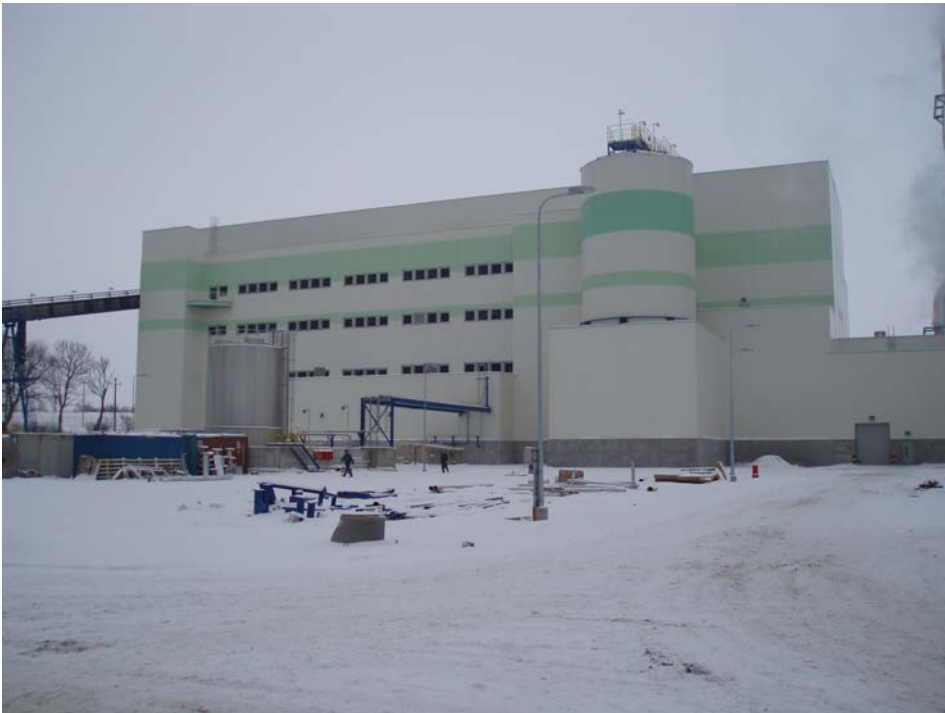
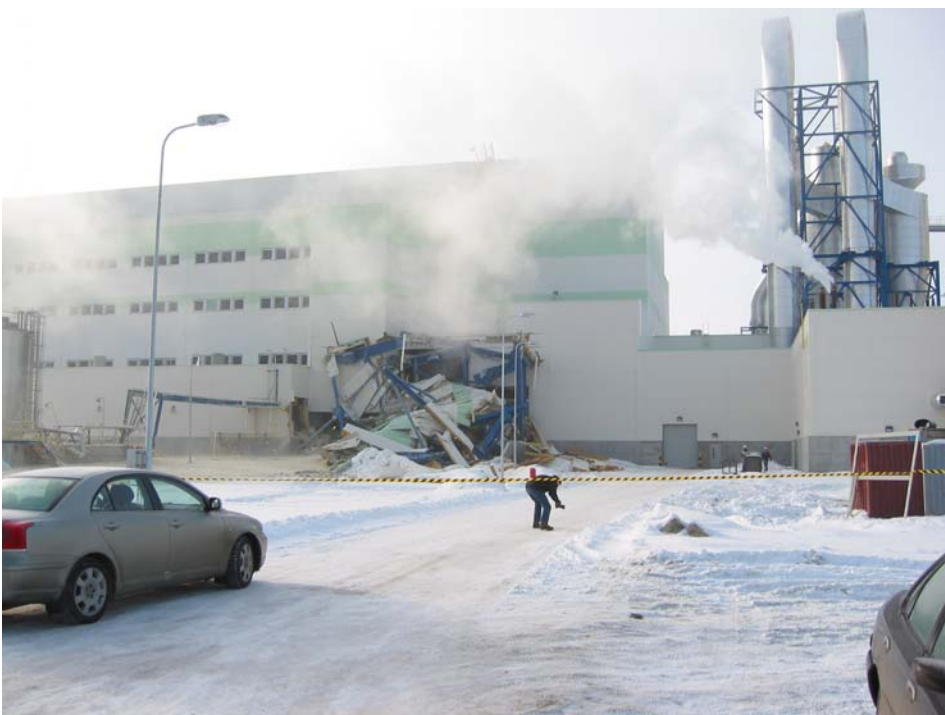
Cause of Loss:
(3) Faulty design

The MC (medium consistency; 10 % dry solids content) pulp tower (tank) collapsed during testing and commissioning when it was in the process of being filled and emptied, with a steadily rising level of filling. There were no injuries to personnel.

At the time of failure, it was at the fullest level (88%) that it had ever experienced. The failure caused total destruction of both the storage vessel itself and all its supporting structure. Most of the bolted joints in the supporting structure failed during the failure process, and the structural steelwork of the support structure was quite widely distributed. The vessel contained about 1270 m³ of pulp at the time of failure. This pulp has a density close to 1 tonne/m³, giving a total weight of the material in the vessel of about 1270 tonnes.

In the few minutes prior to the collapse, a witness observed bolt fragments to fall from the structure, and he descended beneath the structure and retrieved one fragment. This bolt is one that clearly failed in shear through its shank, though it may have been stretched before failure. The location of this bolt fragment was identified by the witness as under the tank.

The cause of the failure of the MC pulp tower was the inadequate design of the bolted joint in the diagonal tank support beams to carry both the bending and shear to which it was subjected.

In the days following the collapse of the MC Tower a decision had been reached to bypass the MC Tower in order to allow testing, commissioning and some production to be achieved while the replacement tower was being built. The bypass solution built by the Contractor enabled the owner to continue with the production activities after 1 month from the incident.

The first estimates of the necessary time for replacement of the MC Tower extended to six months after the accident. The Contractor developed a repair methodology incorporating an amended design for the silo vessel which considerably reduced the fabrication time for the stainless steel vessel itself. The result was a reduction in the repair period of at least two months and in that regard the plant was fully restored before three and a half months of the accident had passed.
