DETAILS OF INTERESTING CLAIM

No: DOIC 46

Lime Kiln Cracking

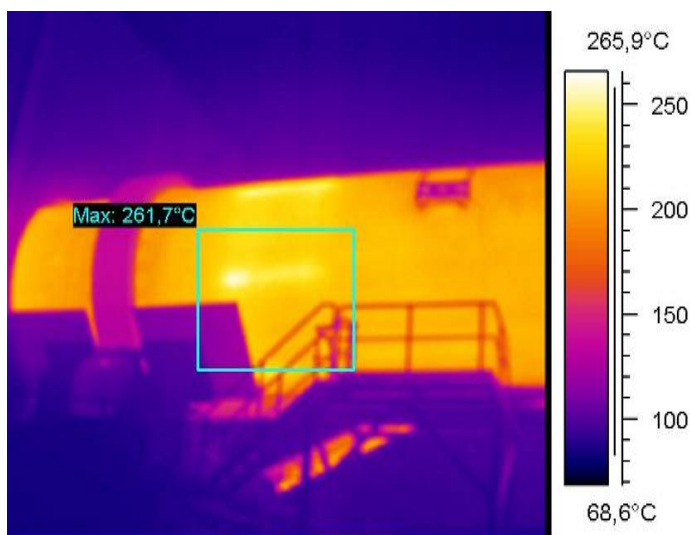
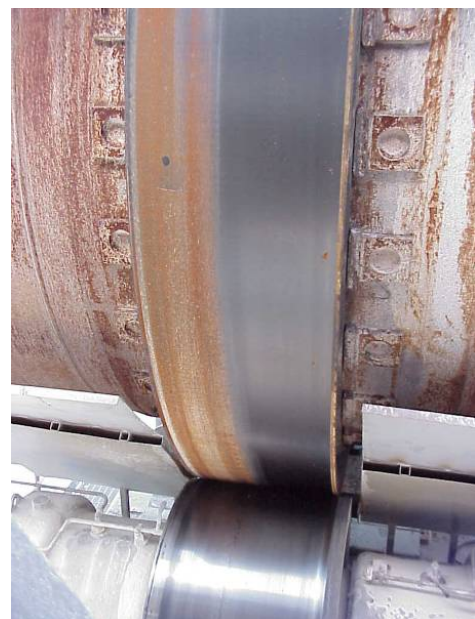
Failure had take place first on the brick lining. This had been diagnosed using on-line thermograph (like in the picture to the eft, although it is not the same failure as the picture below). After relining and starting up, the riding ring got stuck due to an unnoticed dent in the casing. The lining fell down due to overheating of the oven. The overheating caused a dent. When the riding ring is not properly riding and carrying the load on most of the connecting surface, it will start cracking.

Replacement of a 6 m long casing part with the reinforced part for the riding ring. The part with the riding ring on was welded to the casing. The replacement could be made after postponing the change to the scheduled summer production stop by intensively testing the ring at all production stops using ultrasonic and magnetic particle testing.
