DETAILS OF INTERESTING CLAIM

No: DOIC 52

Road collapse after heavy rains

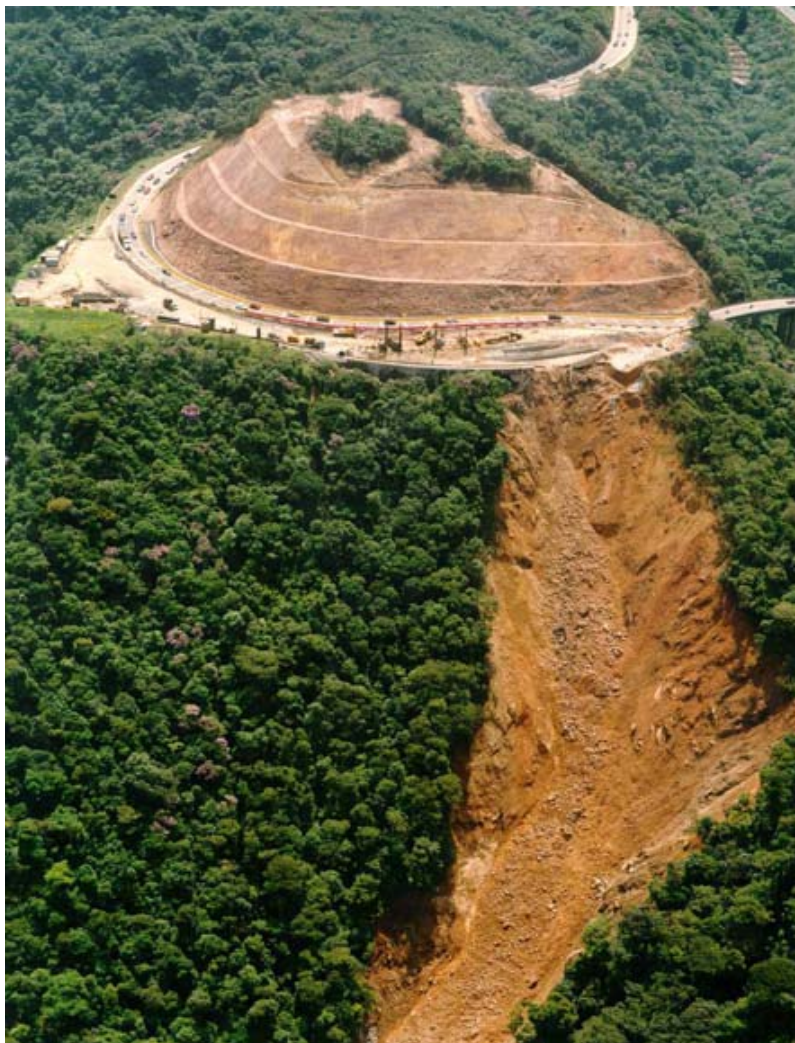
Extraordinary heavy and continuous rainfall/defective design: inadequate drainage. Risk description: The highway was built in the 1950's through the national park, at an average height between 750 m to 800 m connecting. Yearly rainfall more than 3 000 mm with maximum values reaching 5 900 mm is standard for this region. During two days a local rainstorm occurred with 274 mm precipitation over a three days period causing landslide 100 m downhill of south lane highway: 20 m depth, 100 m width and 200 m length. Cracks occurred on road surface. During one day after the first period precipitation of 111 mm within 8 hours caused additional subsidence of the slope below the highway.

The Failure was caused by transient water flow through the joint system of the rock strata, which opened the joints and caused landslide. Immediately stabilisation measures by installation of a concrete piling with pre-tensioned anchors and horizontal drainage prevented further collapse. Conclusion:

The Insured was not aware of the instability of the rock strata. Loss occurred due to insufficient monitoring of possible soil movement and installation of suitable drainage and stabilisation measures.
