Amount of Loss

CHF 1,850,000

Three days of constant rain followed by a heavy downpour caused uncontrollable flash flooding, which affected a site where a headrace tunnel for a hydropower project was to be built.

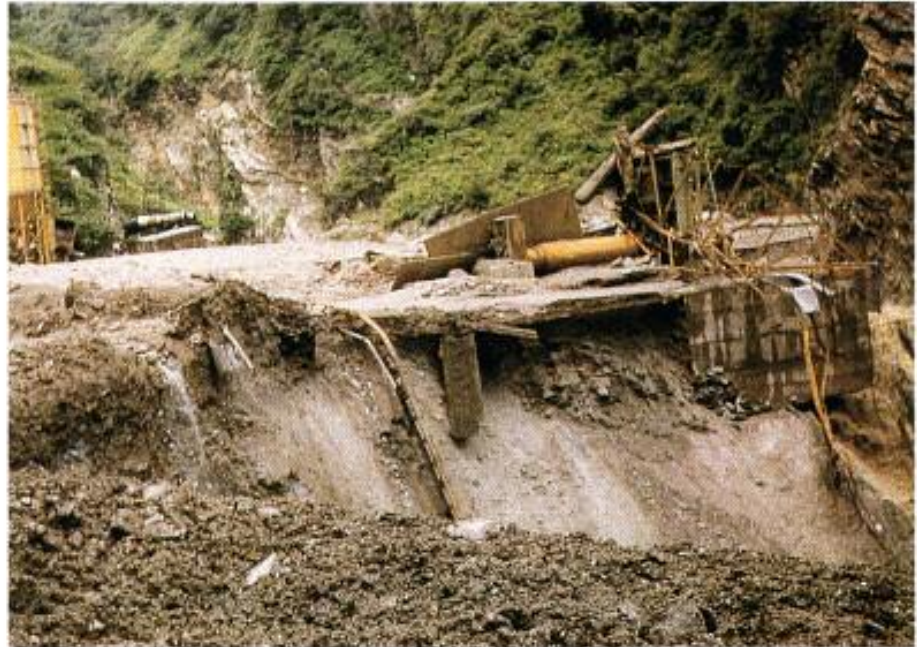
Slide No. 201

Some fixed parts of the plant were torn out of their foundations. Concrete slabs were undermined by the landslide

The items affected were steel tunnel liner plates. 133 out of 384 of them were allegedly bent in the flood. There was extensive damage to the plant and equipment. Some items were washed away, broken or twisted. Fixed parts of the plant were torn out of their foundations and damaged beyond repair. Other items were choked up with silt and had to be dismantled.

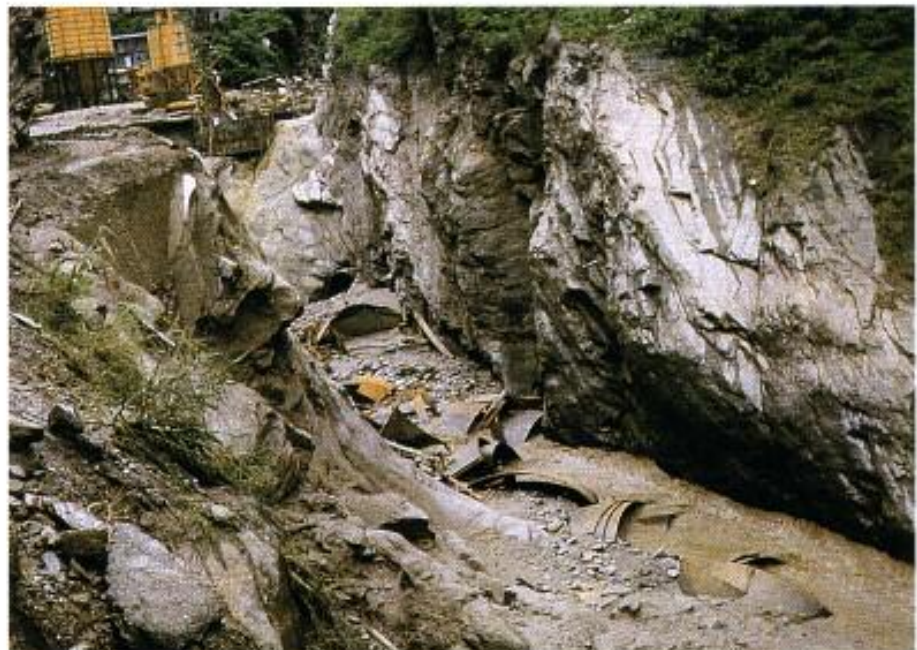
Slide No. 202

CPE and tunnel liner plates washed into the river-bed
