Project

Oil tanker unloading facility belonging to an oil refinery.

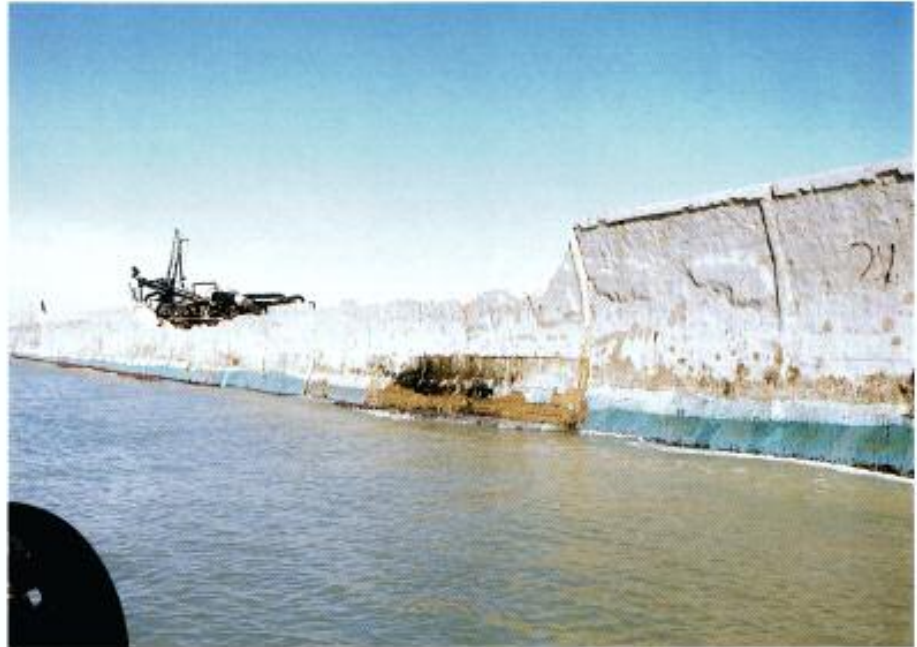
Fig. No. 222

View from the open sea of the damaged breakwater

Storm tides lasting for two days, accompanied by force 8-9 winds and heavy rain caused the breakwater to be breached, damaging the loading and unloading pipelines which it was protecting. Parts of the harbour installations were hurled up to 100m into the sea.

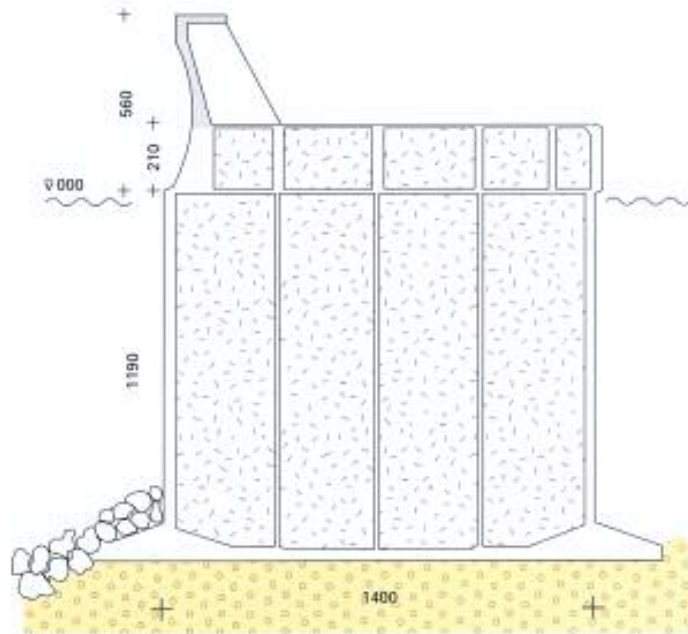
Fig. No. 223
Cross-section of breakwater
with wavebreaker

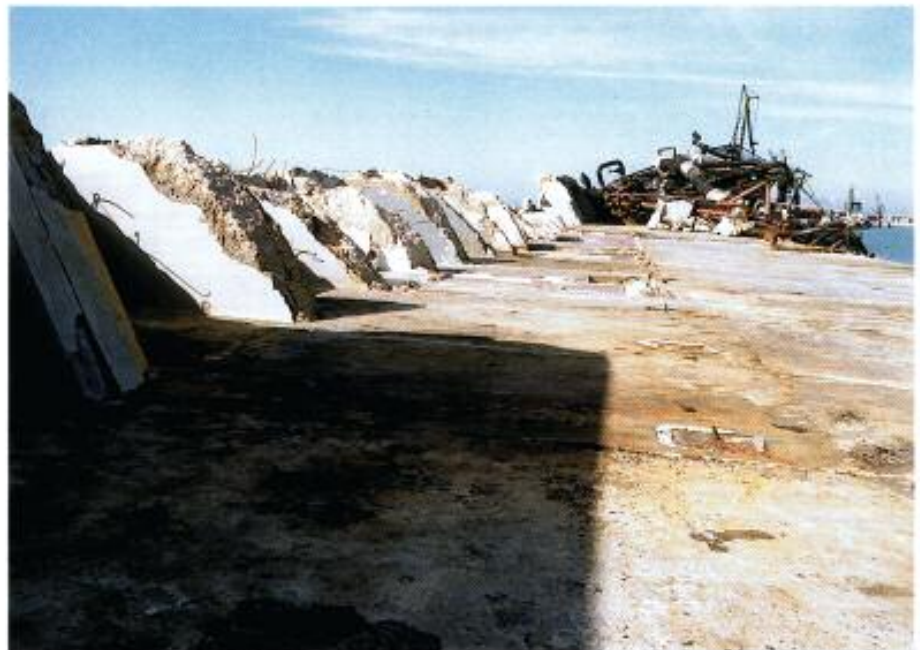
Fig. No. 224
The top of the breakwater and
the damaged wavebreaker can
be seen to the left, with
destroyed equipment in the
background

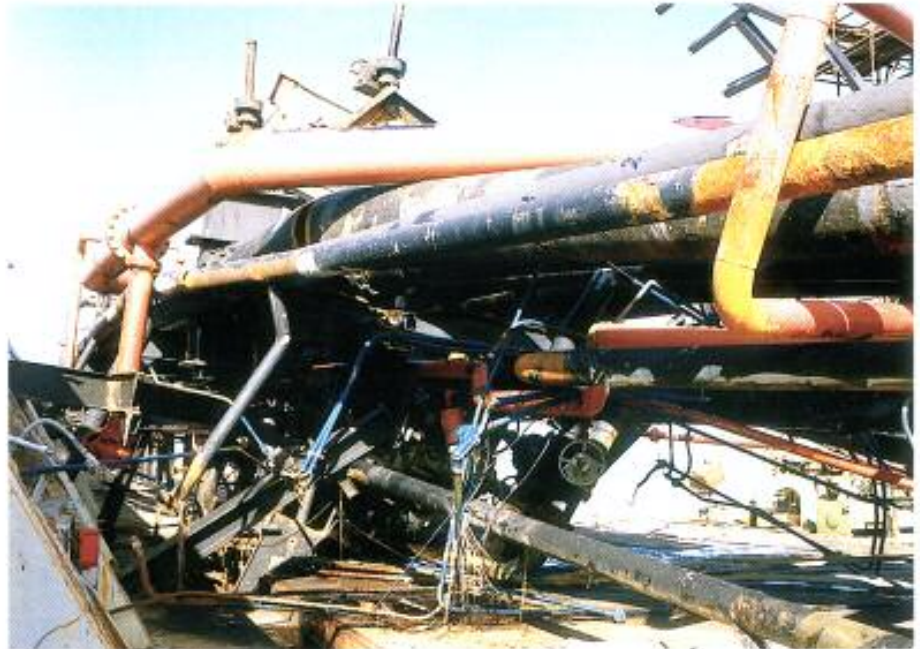
Fig. No. 225
Loading and unloading
pipelines damaged beyond
repair

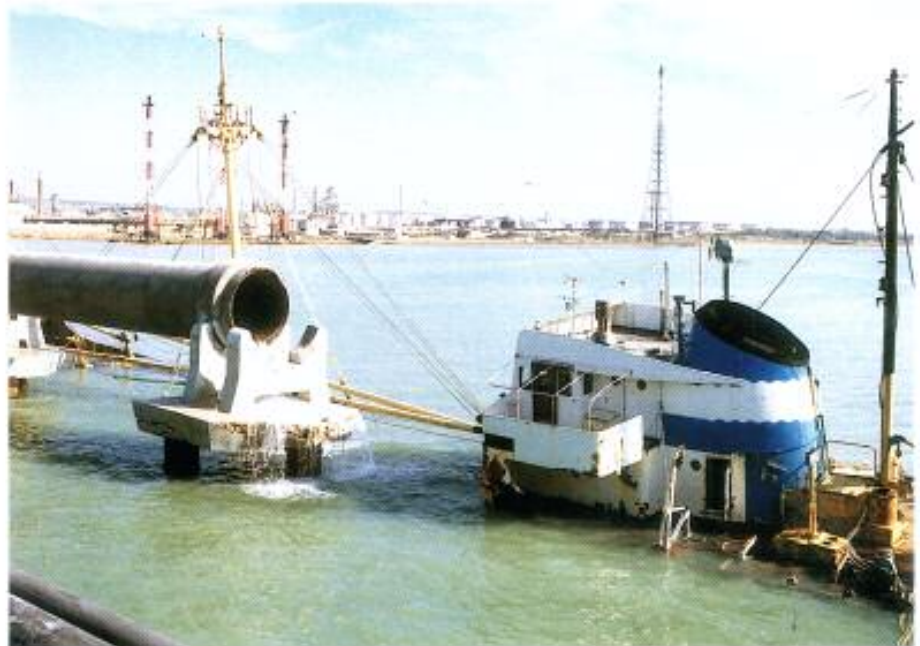
Fig. No. 226
Damage to pipelines and
supports. One vessel sank
to the seabed
