Country report Finland

IMIA Conference –Gleneagles, Scotland 2008

September 15th, 2008

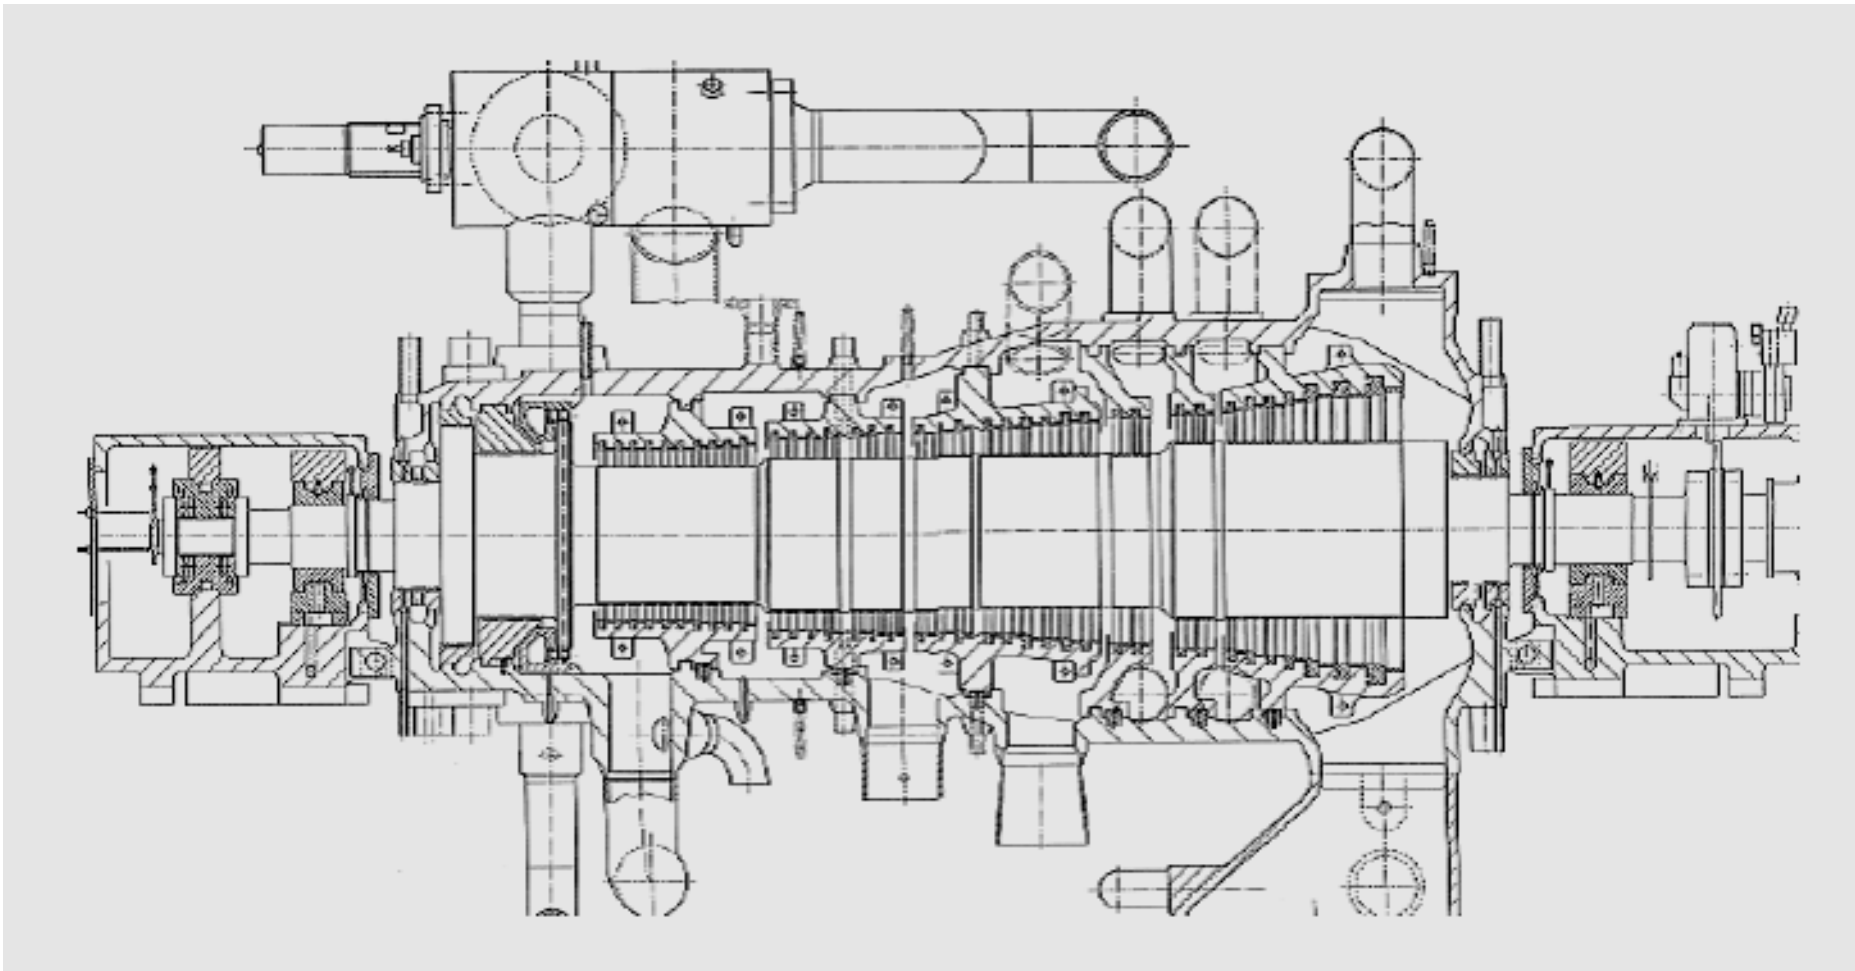
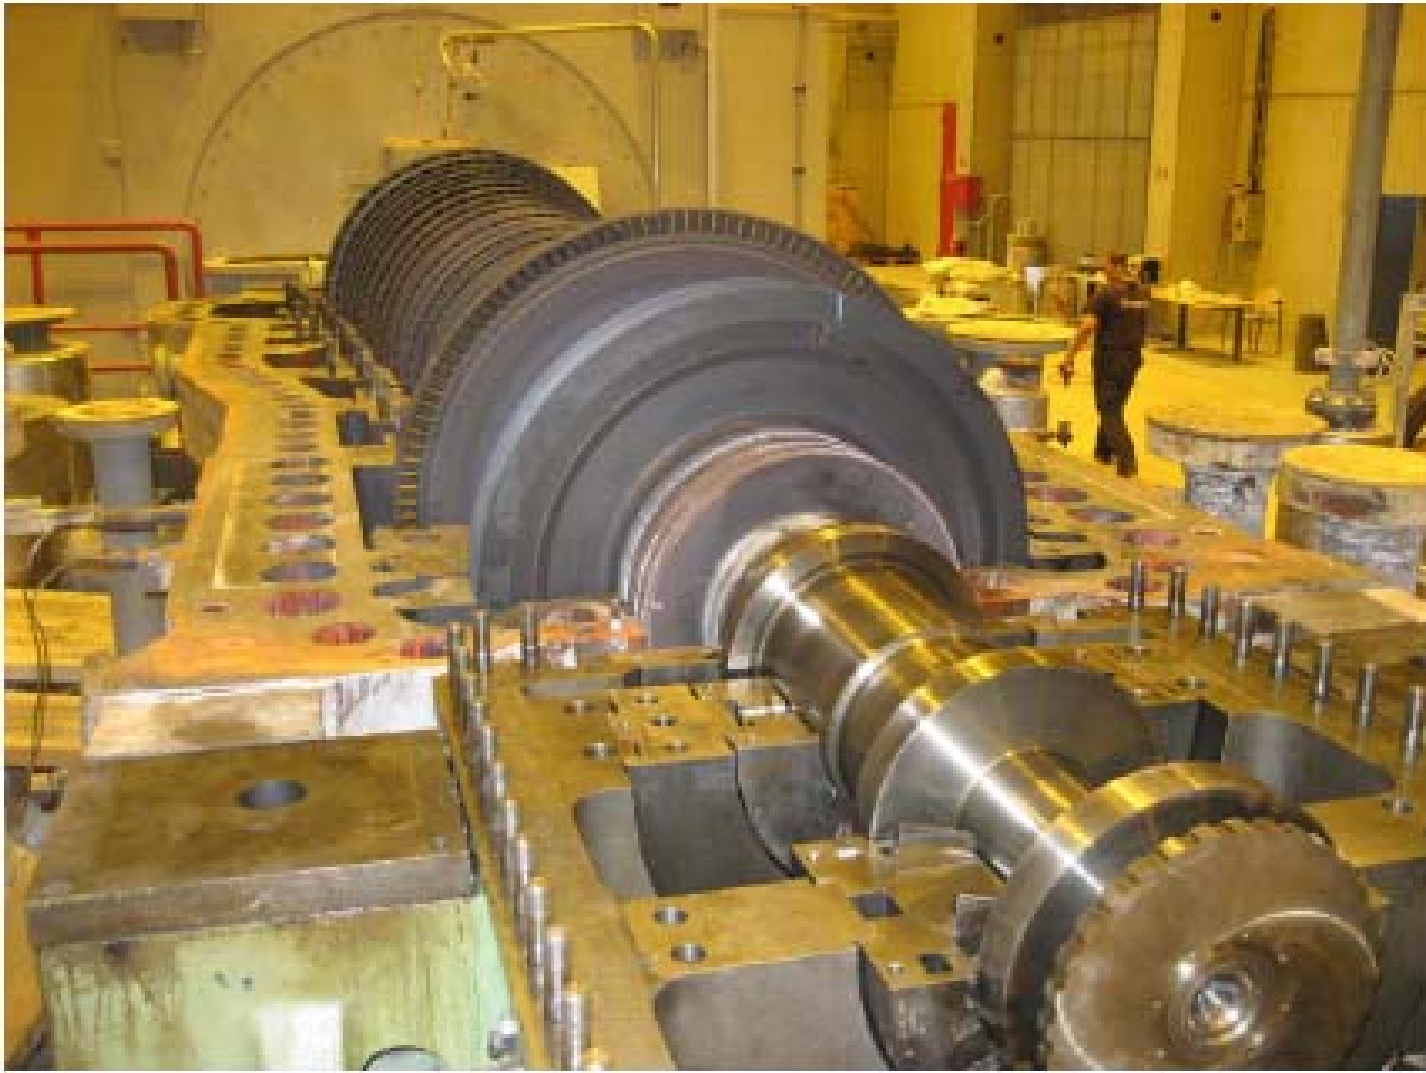
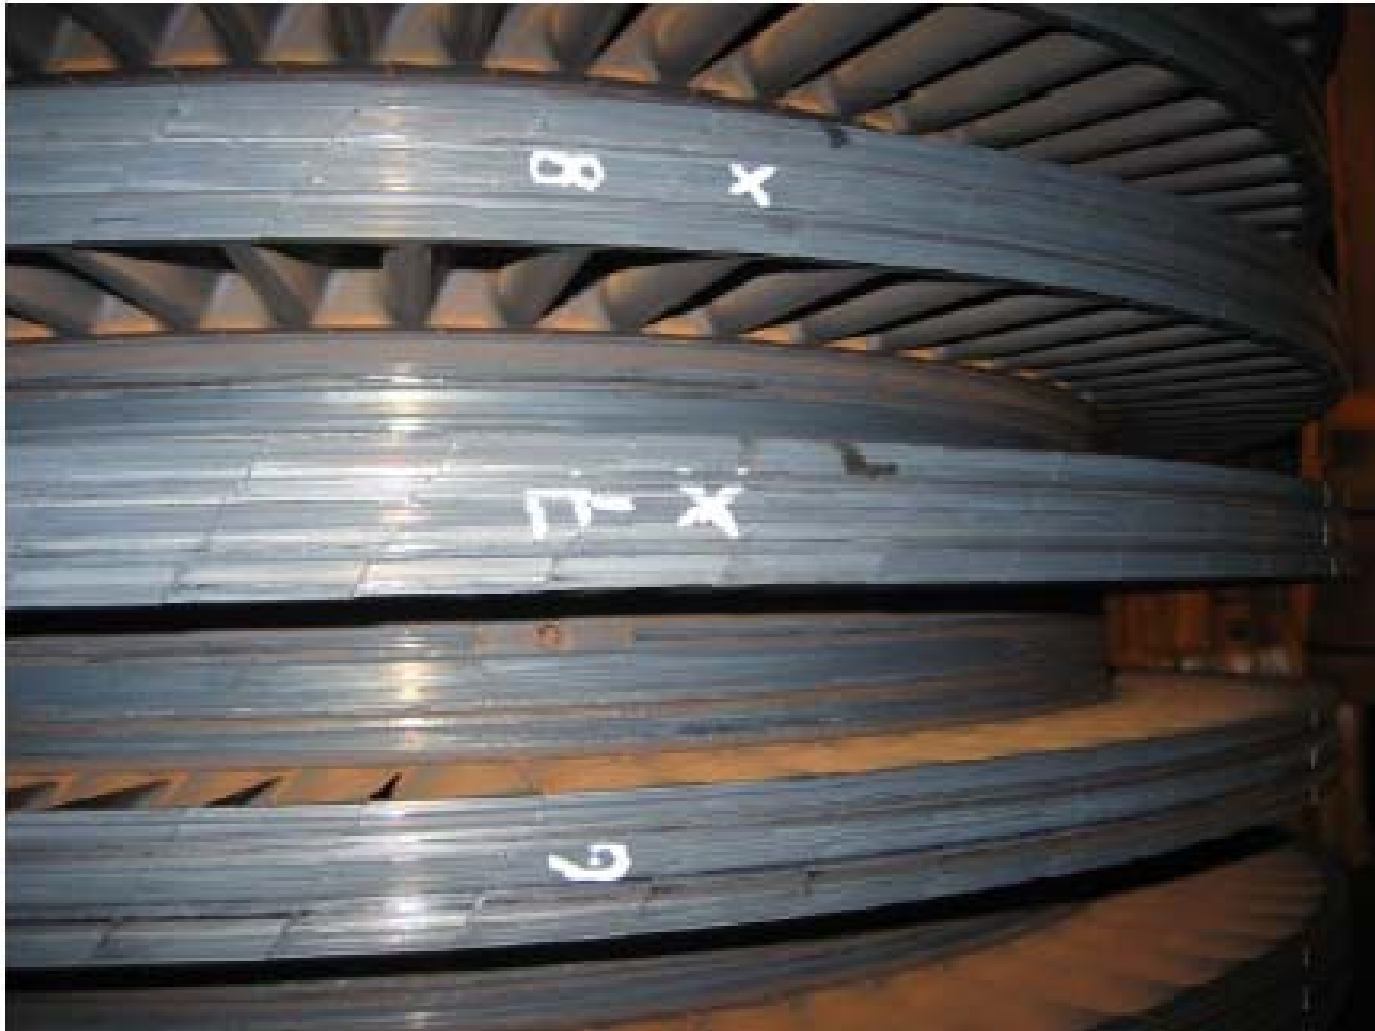
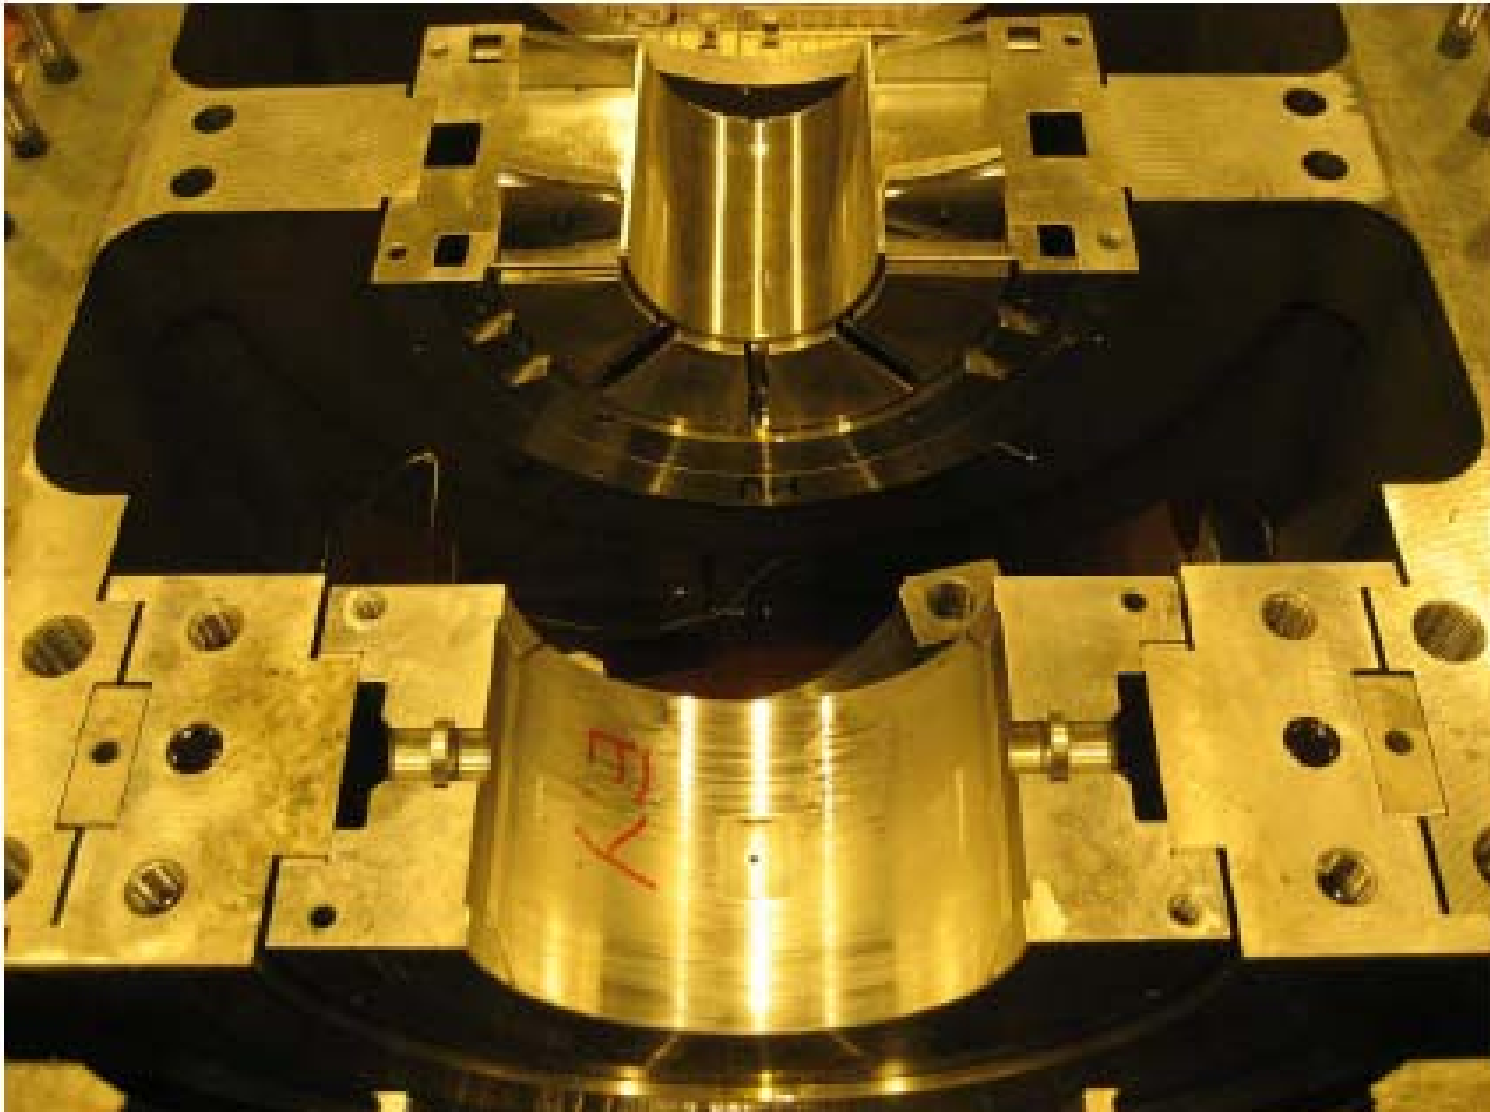
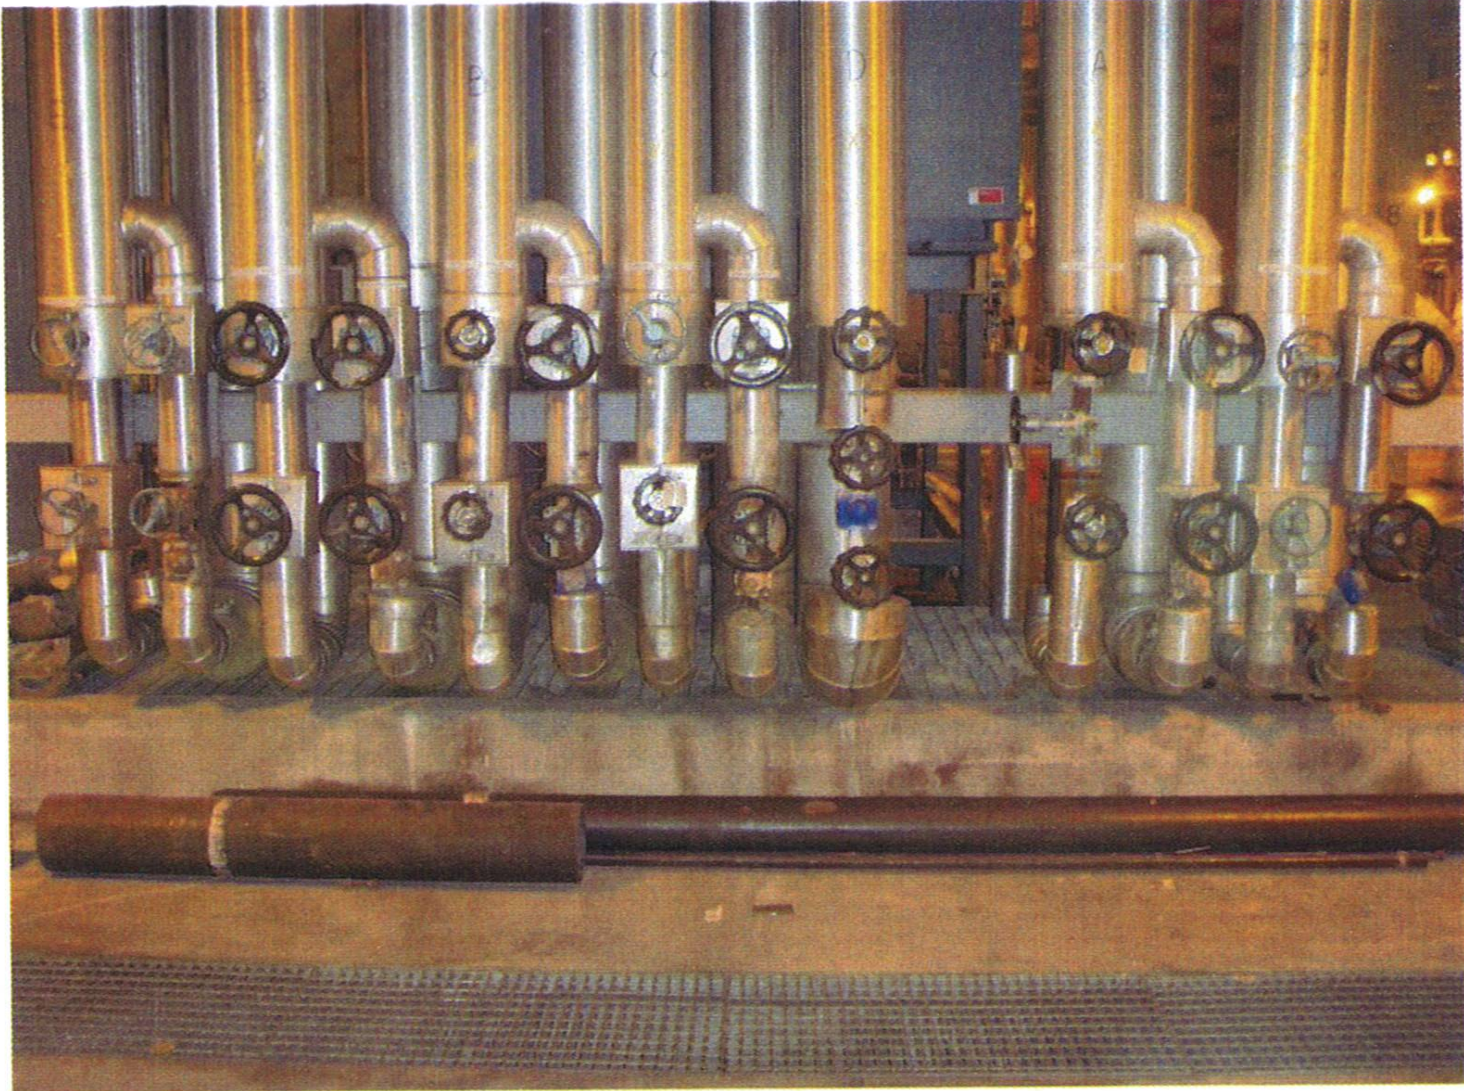
The turbine case:

- The damaged turbine is a 95 MW backpressure turbine
- Endoscopy testing revealed a considerable number of turbine shroudings, blades and sealing strips damaged due to water injection rub compounded by attempts to turn the thermally locked rotor.
- The rubbed areas had a hardness almost double the normal and had to be turned 3..4 mm down.
- The damage occurred during a normal run-up after a short stop. The first attempt to start the turbine failed due to excessive vibration and also a second attempt failed due to excessive vibration.
- The rotor shaft was bent and had to be rectified and post-annealed.

- The cause was partly faulty operation in that the manual draining had been partly neglected or performed on wrong valves.
- Additionally the cause was a faulty design due to the fact that the main steam pipe had a divided loop with only one side temperature instrumented.
- Preventive risk management measures: better schooling, clearer marking of valves, more automatic drainers and an enhanced level of temperature instrumentation of the pipes.
