## DETAILS OF INTERESTING CLAIM

No: DOIC 47

Breakage of Gear case of limekiln

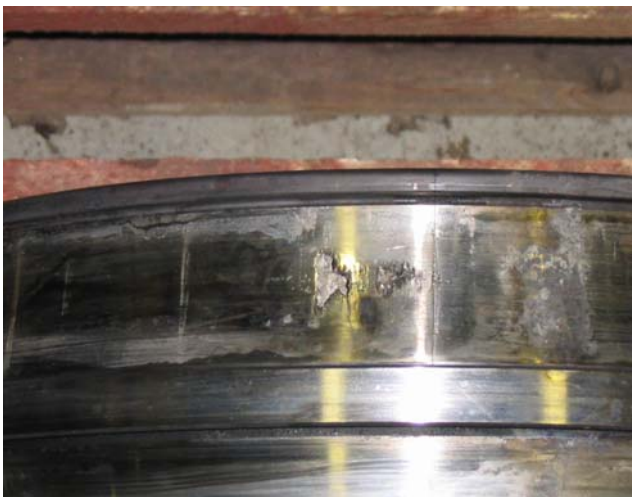
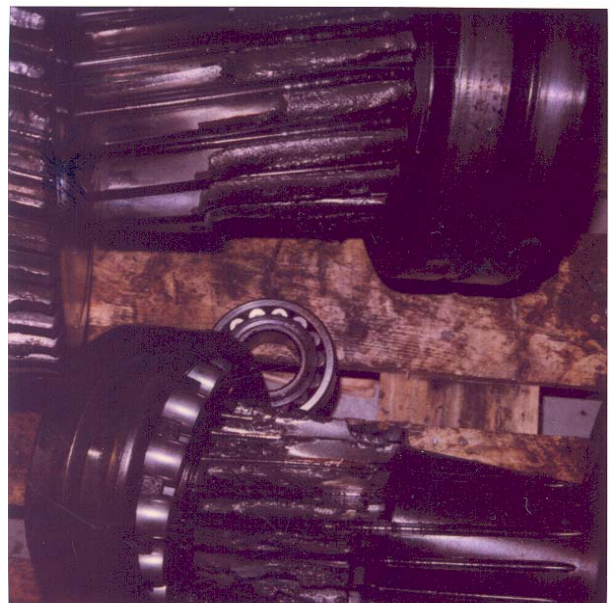
Failure had take place on gear case. The acoustic emission monitoring system showed activation on one of the two gear cases rotating the limekiln. Preparations for a fast shift from having used two to using one gear case could be made. At the same time the limekiln production rate was slowed down to cope for the reduced rotation force. The cause for the breakage of gear teeth and bearings is not clear. It might be a clear under dimensioning of the components in the gear case.

The damaged gear case was pulled back and a new assembled on a very short notice. The remedy is to more closely monitor the case using vibration measurements and acoustic emission. A spare gear case is also now at hand.
