ALOP Claim following Damage to Air Pre-heater

**IMIA Conference in Delhi
Sep. 2013**

Bhatawadekar & Co.

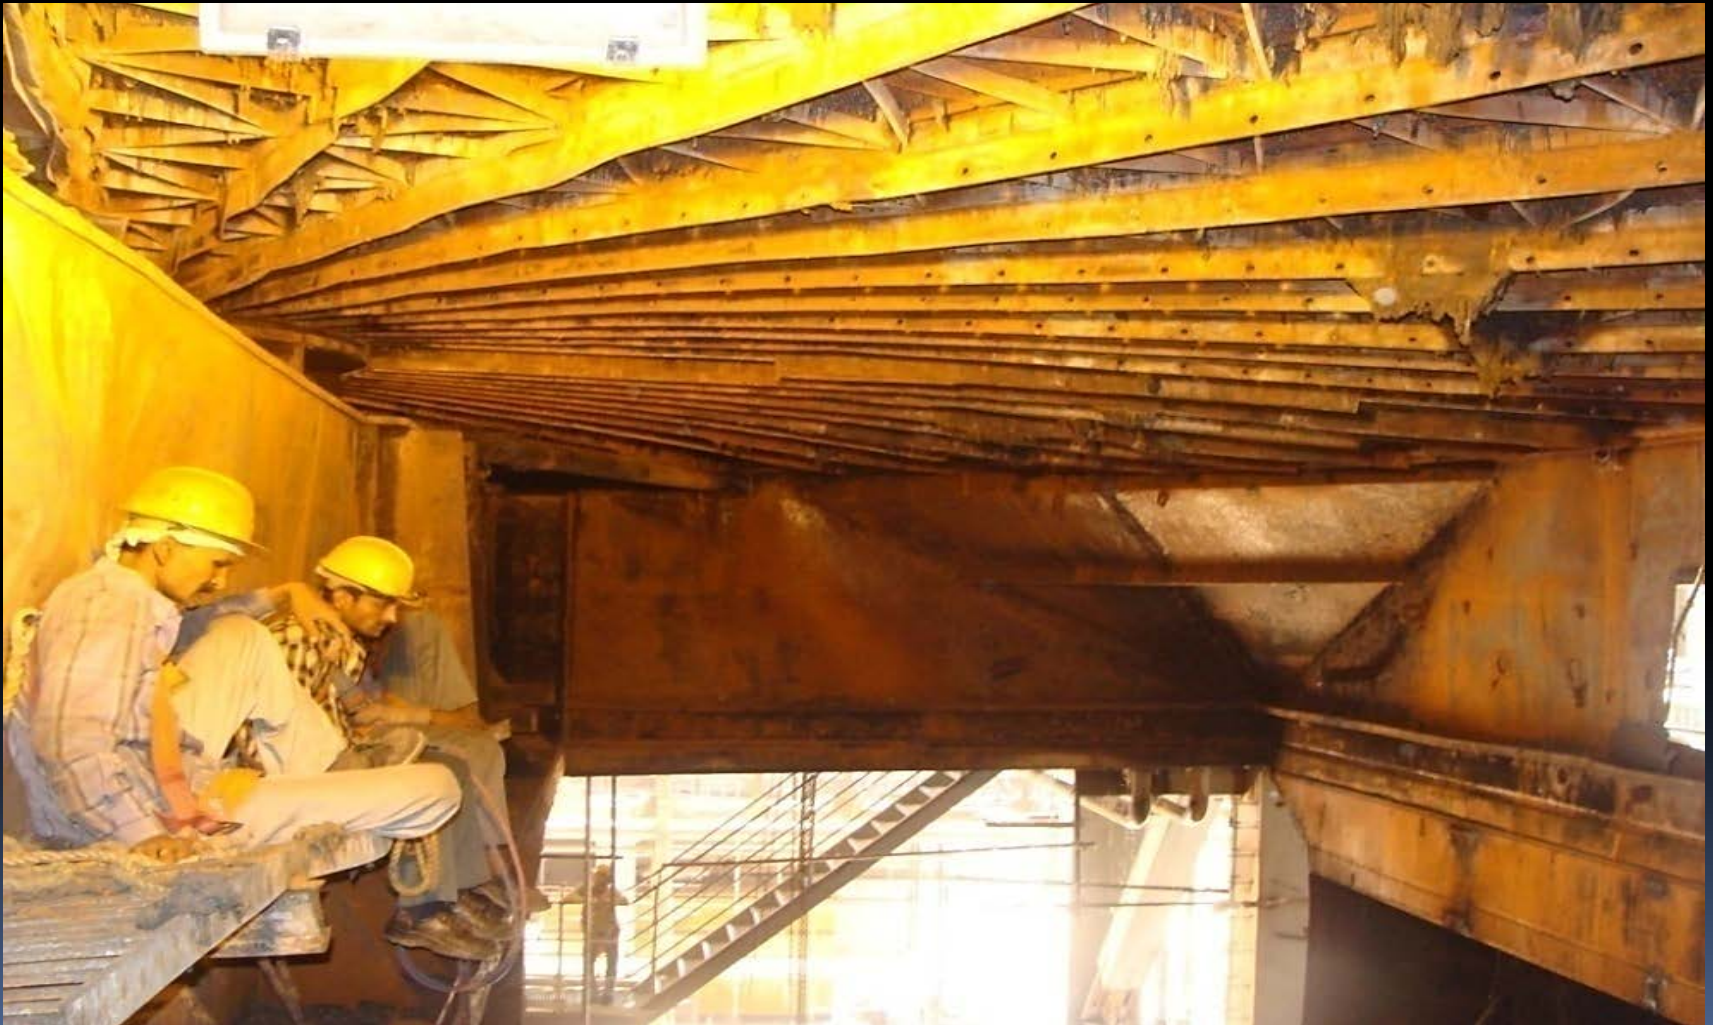
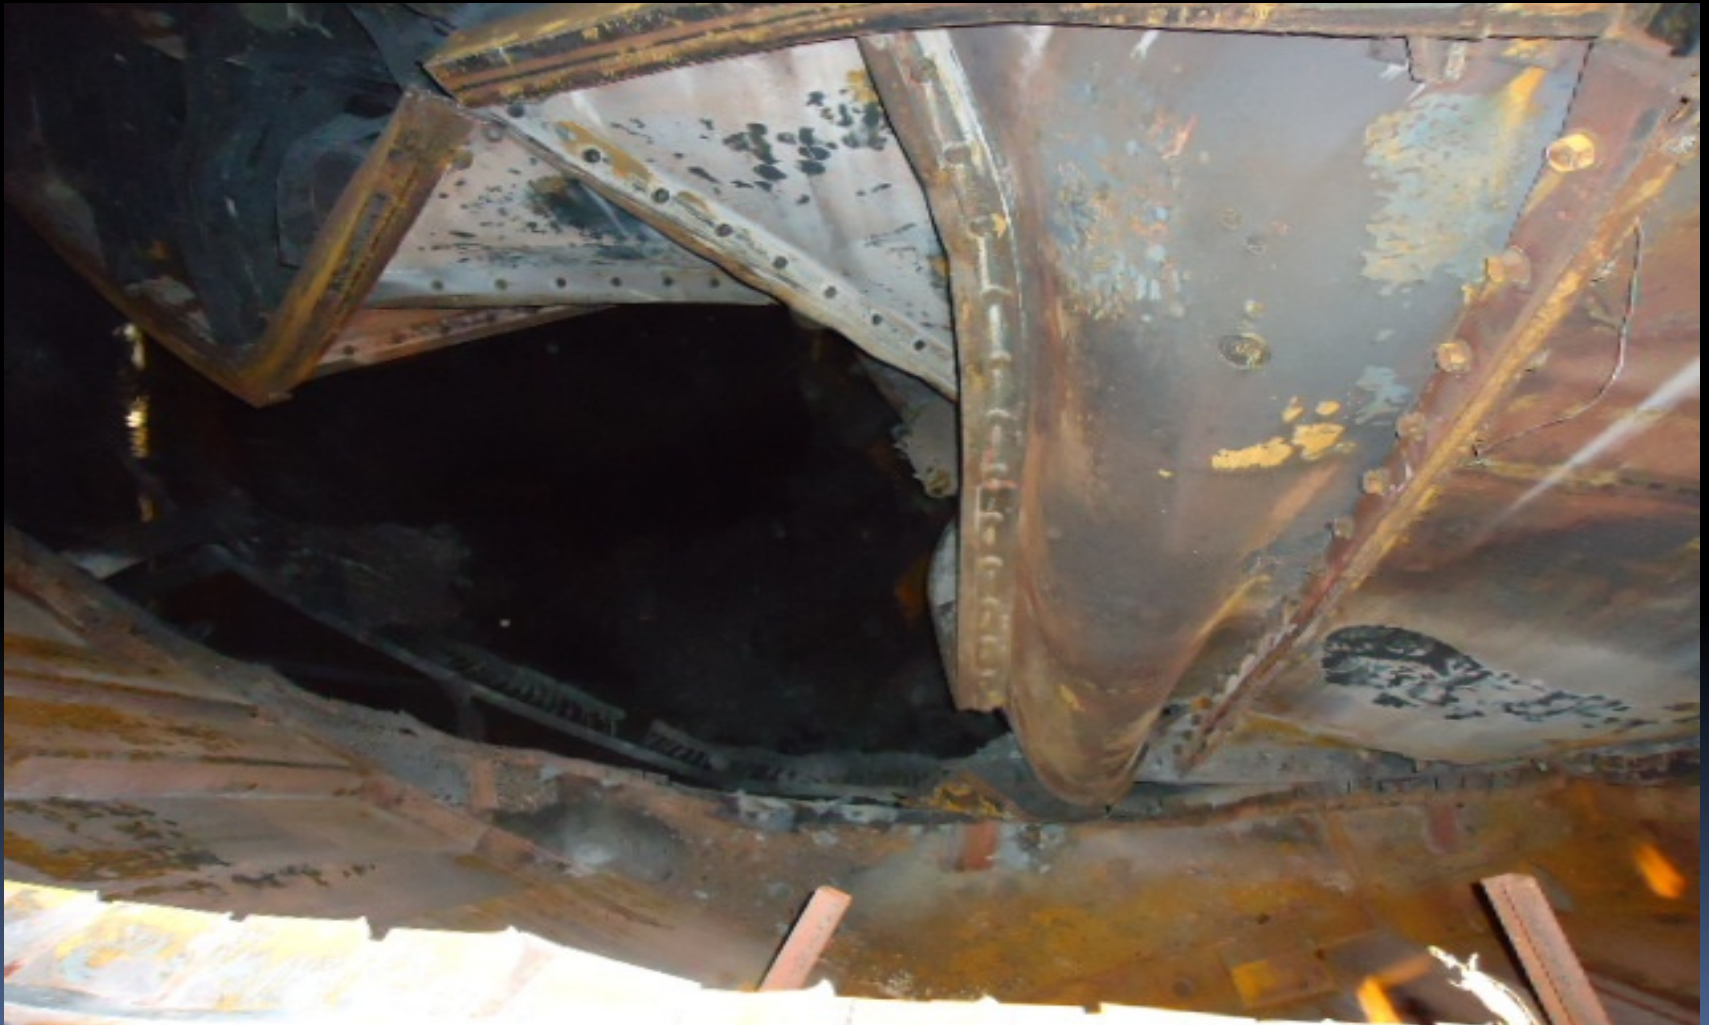
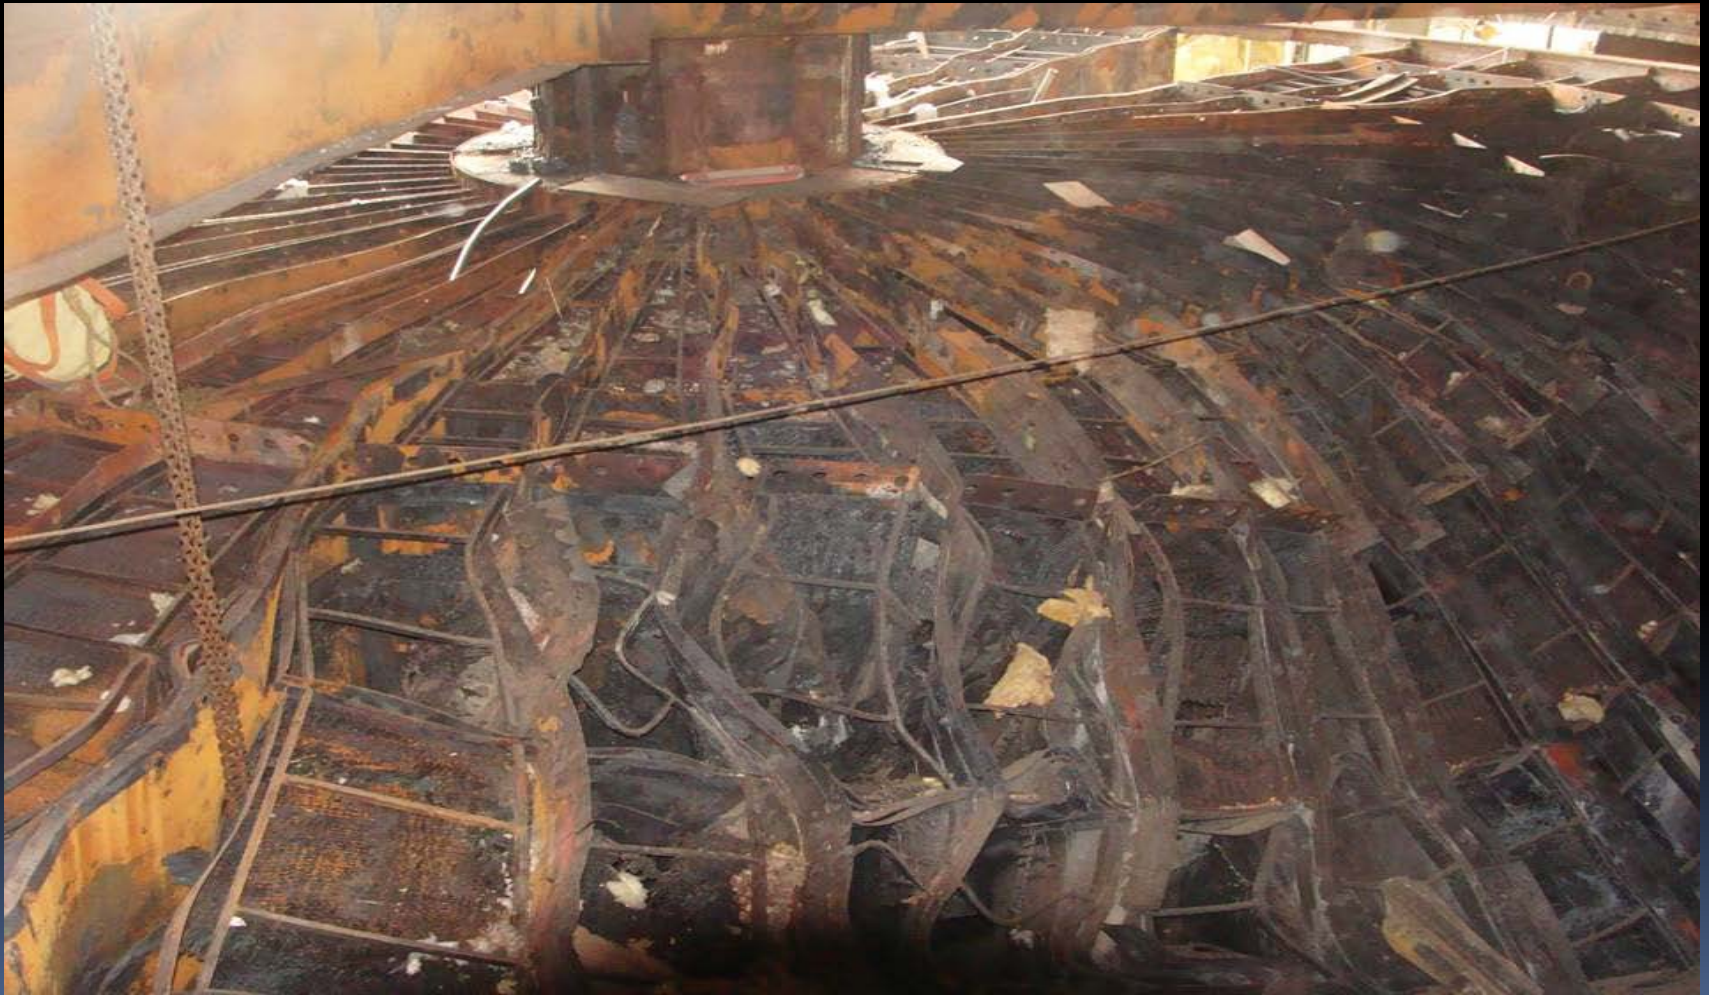
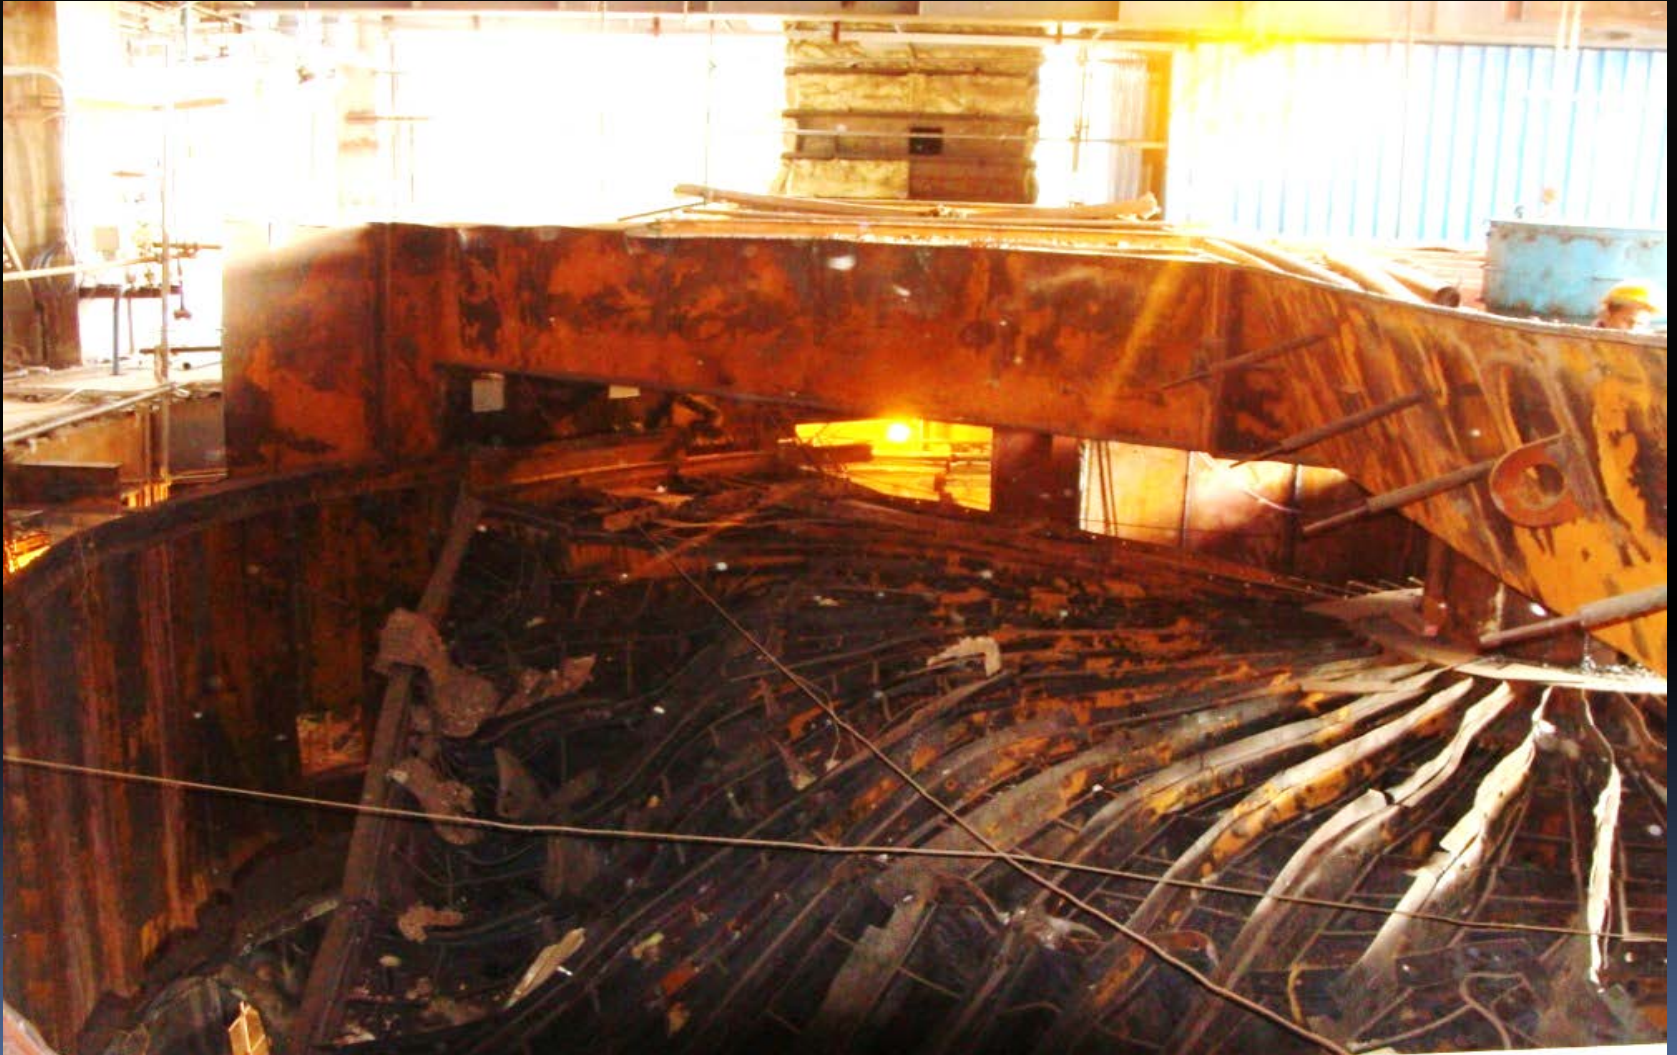
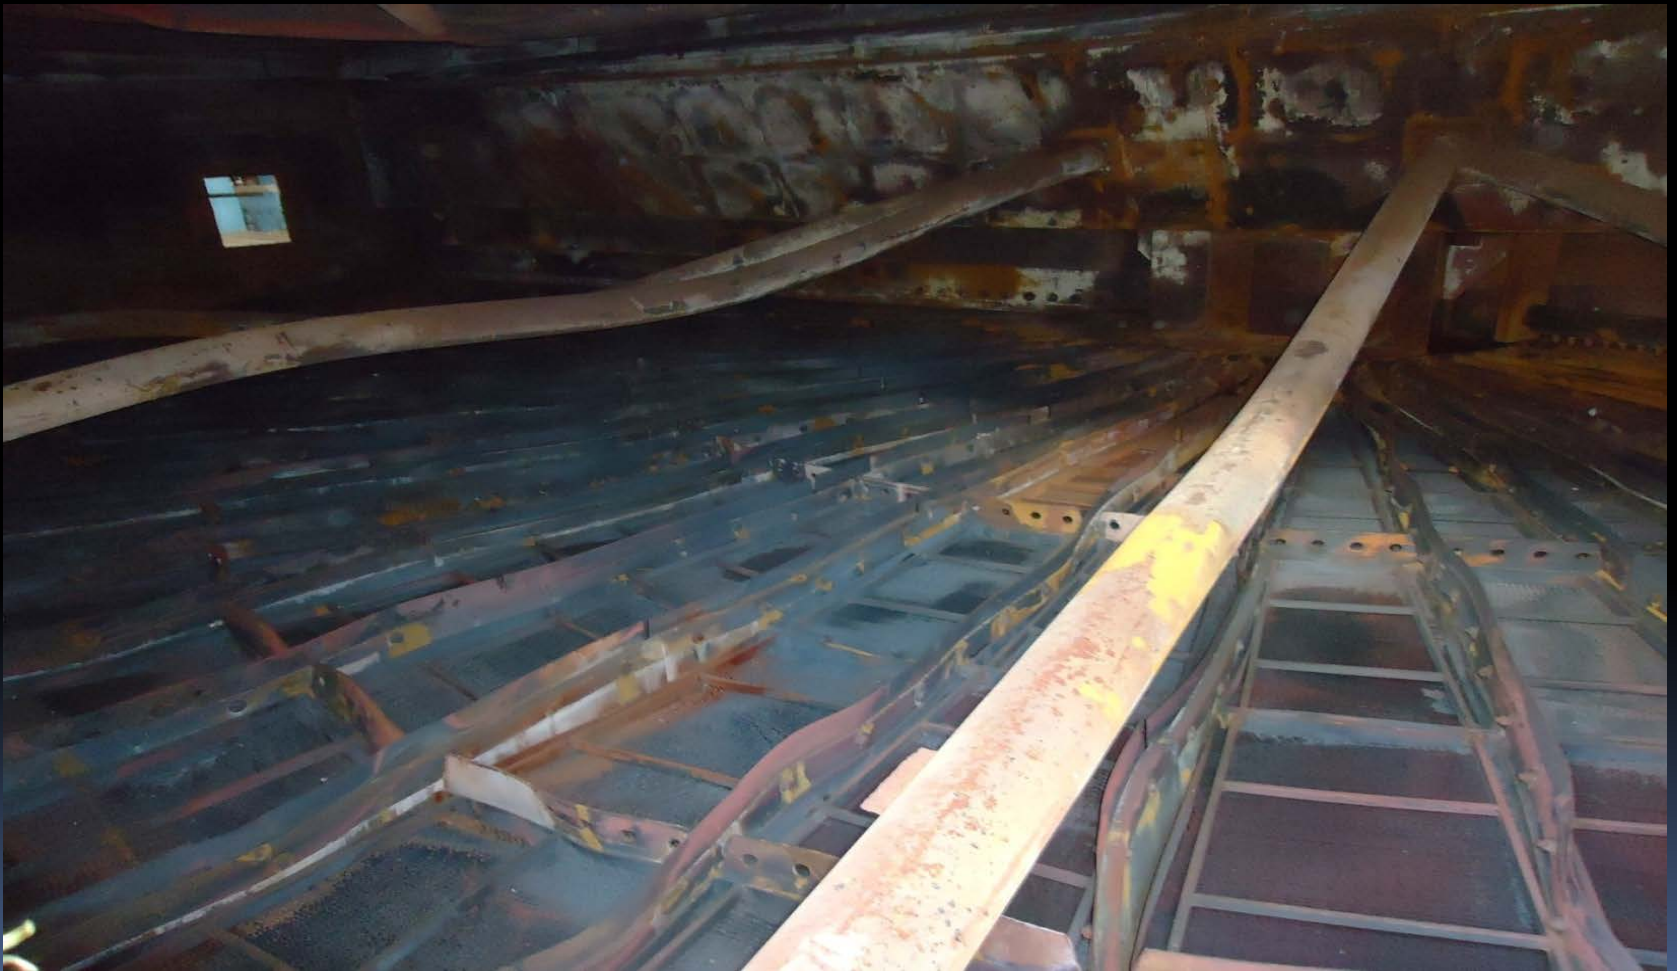
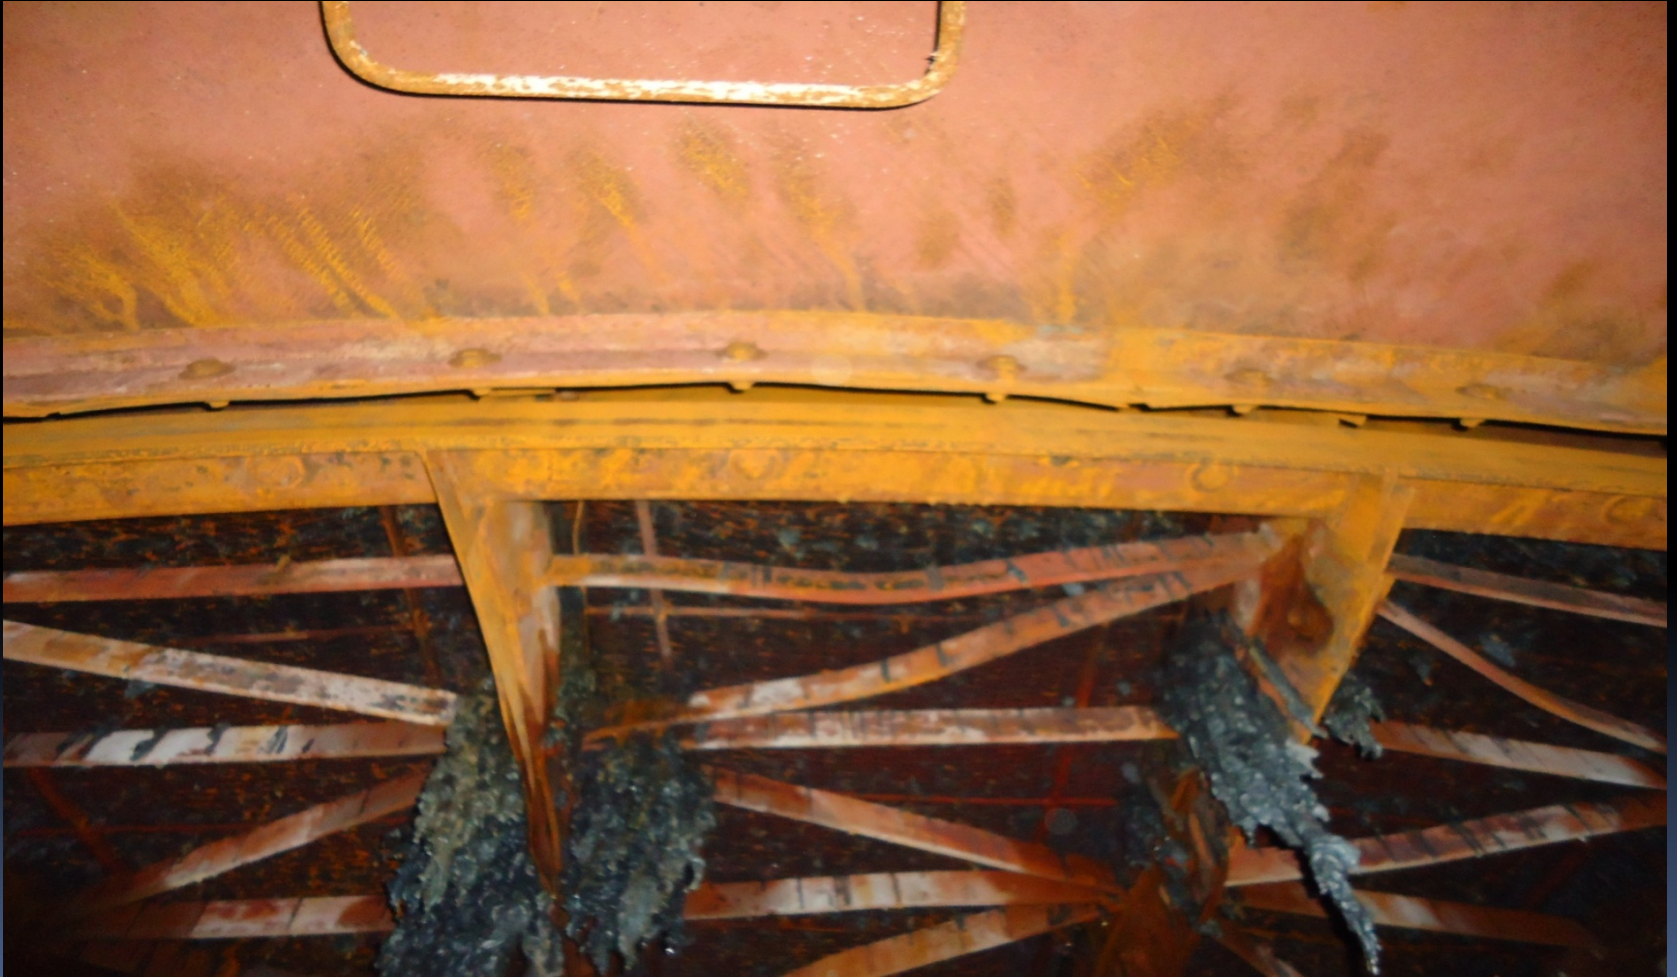
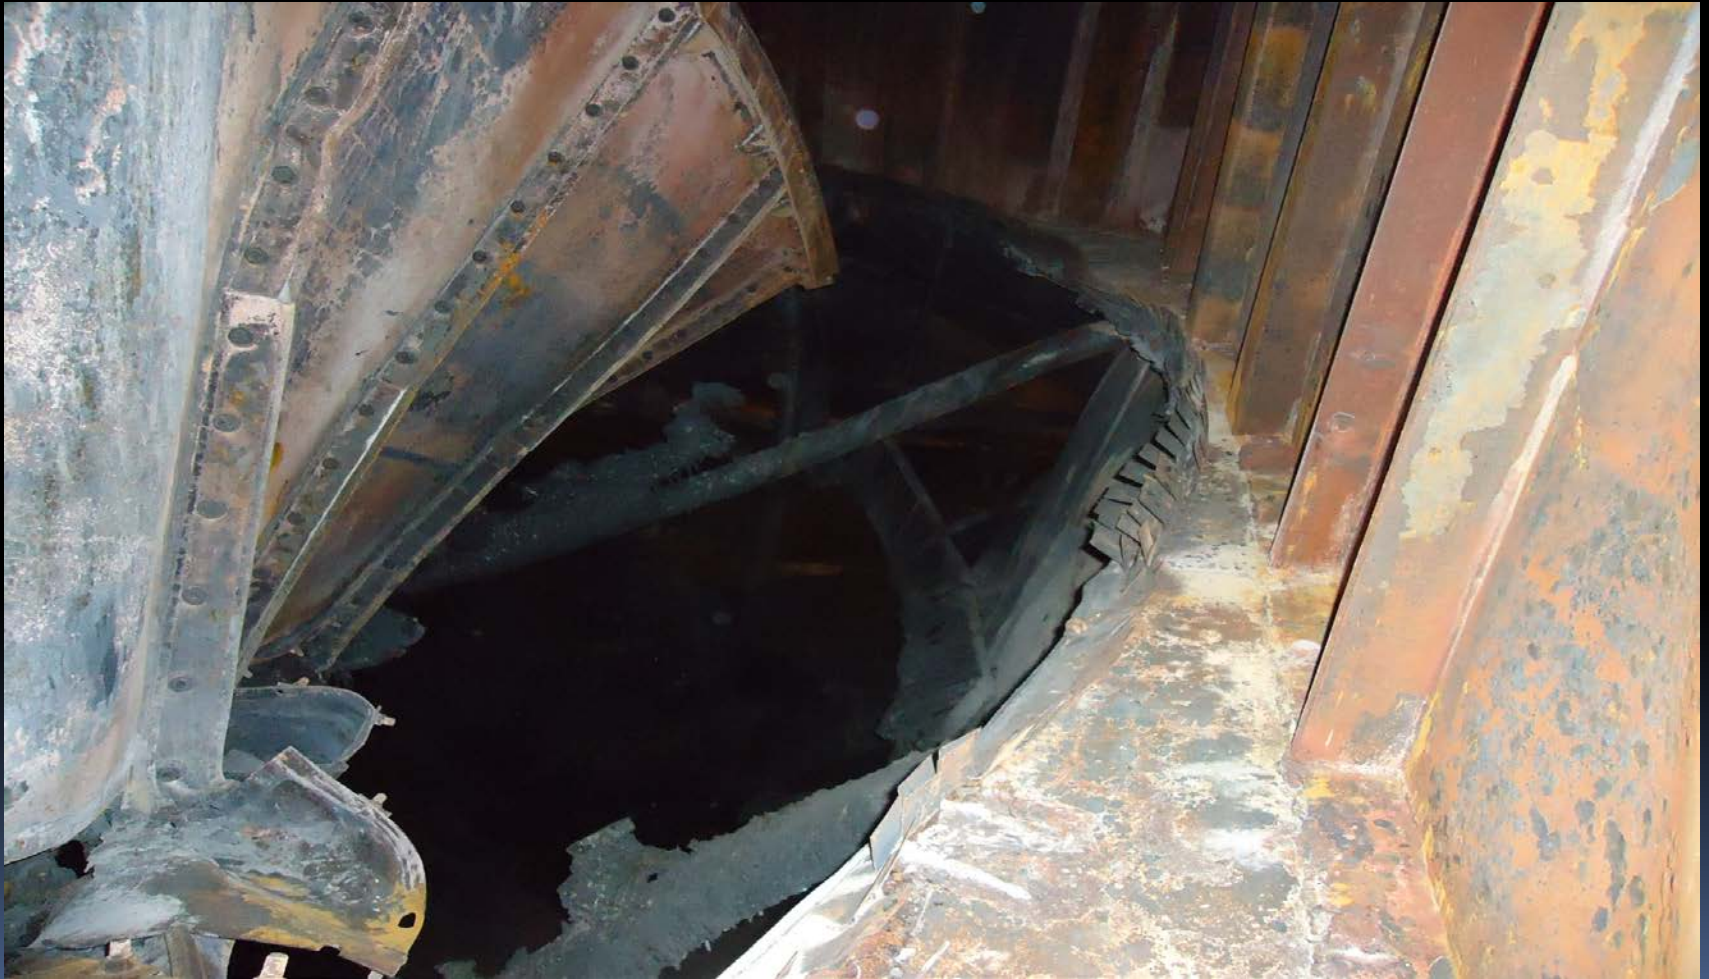
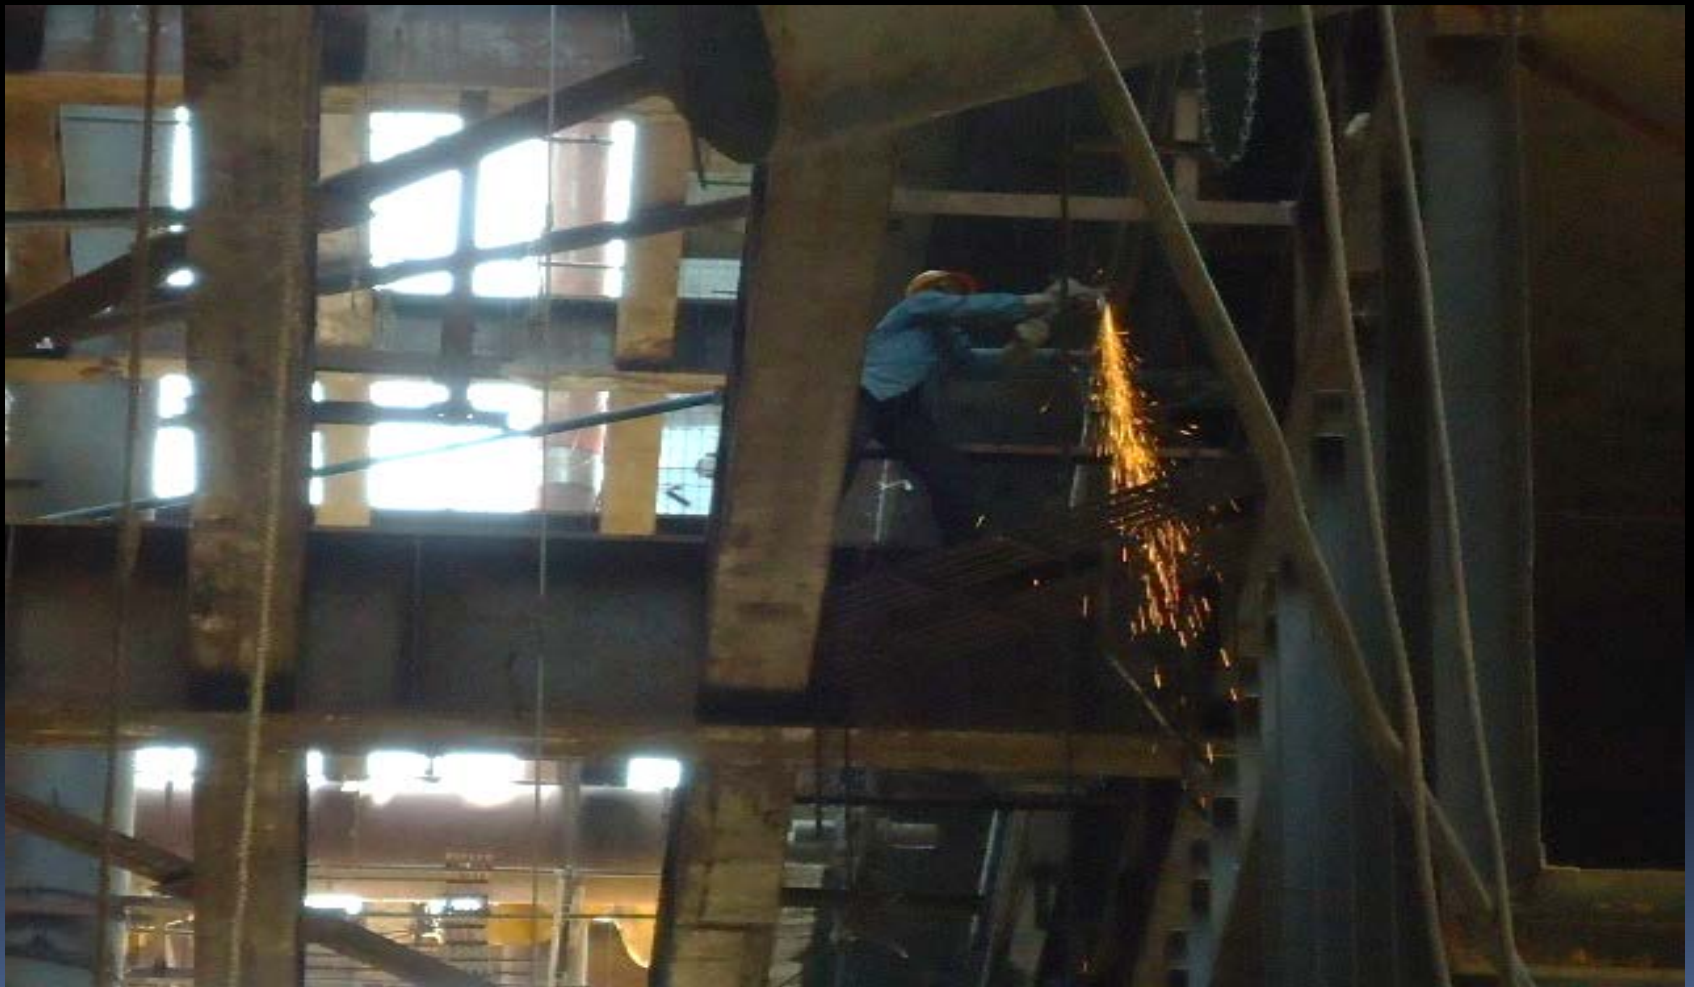
- The APH was totally destroyed/damaged. What was not damaged by fire was damaged by explosion, as few photographs in following slides will show.
- APH is a very large assembly and weighed **728 Tons**.
- Part of this is a rotor weighing **560 Tons**.
- Top of the assembly was at:
+ **20M** height from GL & **14 M** being the assembly height
Diameter of the APH was 13 M.
