## **IMIA – WGP 54 (07)**

### **Water Distribution Systems in Buildings during Construction**

International Association of Engineering Insurers

40<sup>th</sup> Annual Conference – Tokyo, October 2007

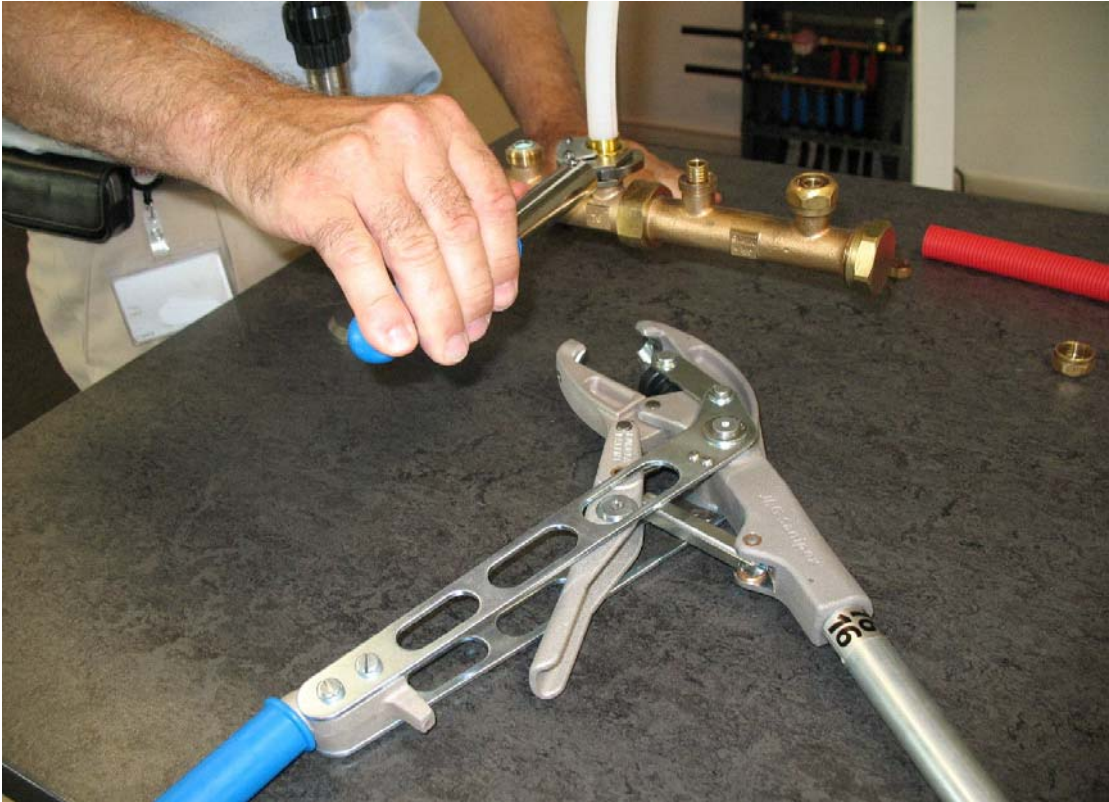
Tools needed for the JRG Sanipex System

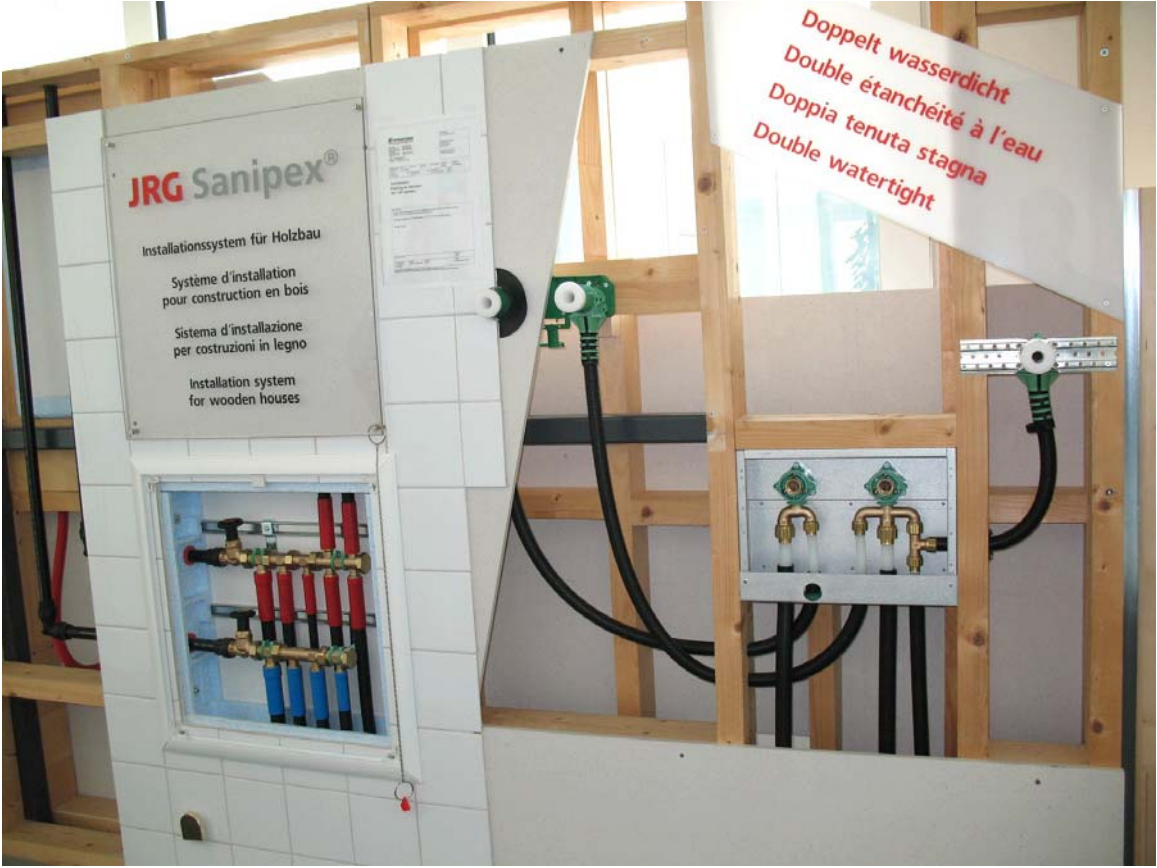
The principal lay out of an installation of a pipe in pipe system in a wooden frame house showing also a sample of the components needed.

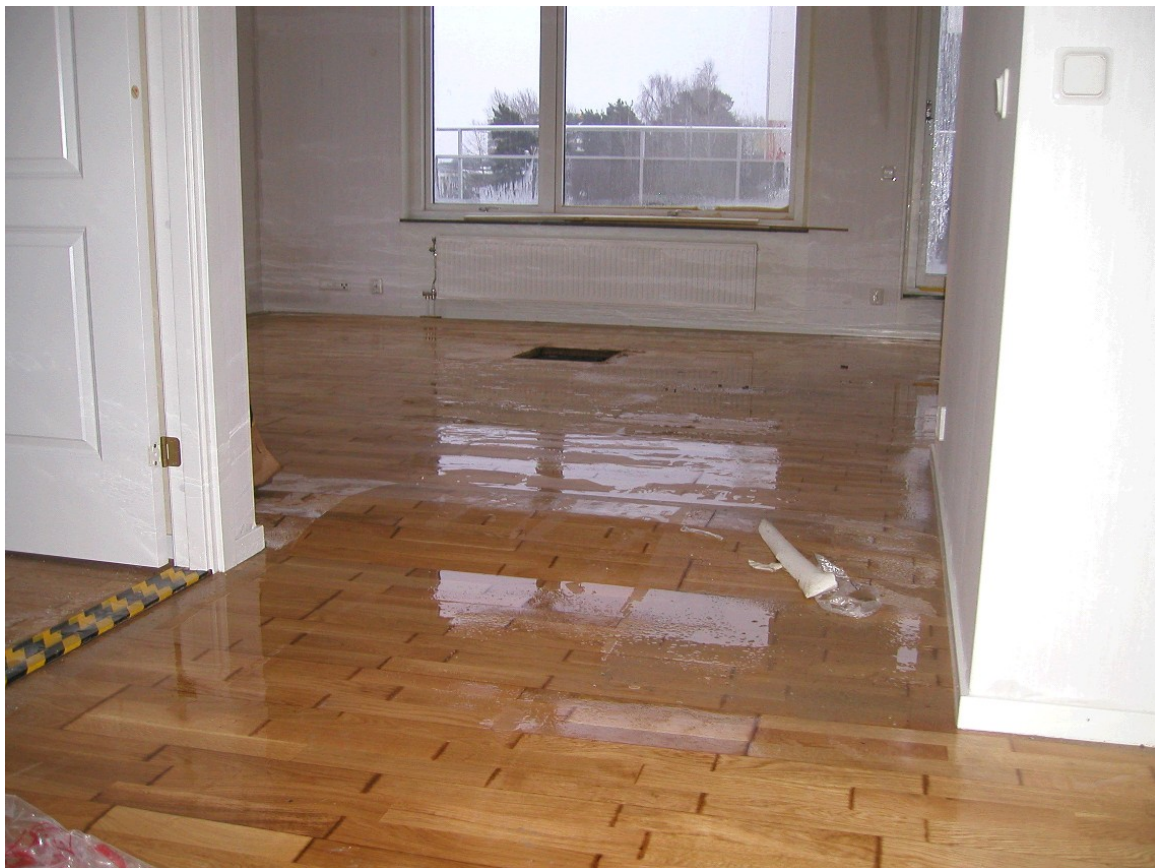
That Monday morning in one of the living rooms, this and eight other apartments were totally flooded.

A press fit coupling came loose from a manifold during a weekend on the top floor of a five storey residential building shortly before handing over. The large volume of escaping water caused substantial damage to the building structure as well as internal fixture and fittings already completed. Nine apartments had to be totally stripped and re-fitted after the concrete structure had been dried out. Handing over and taking into use delayed by eight months.

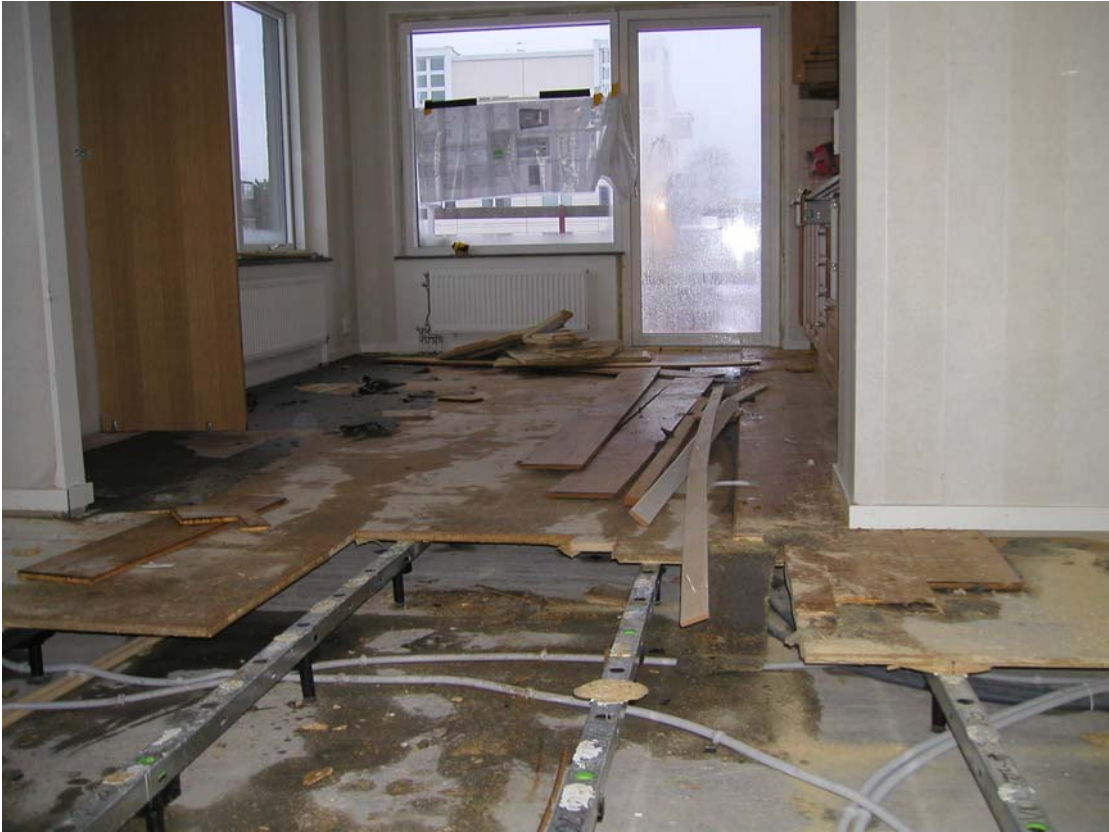
The similar view during stripping out of internal floors and other fittings

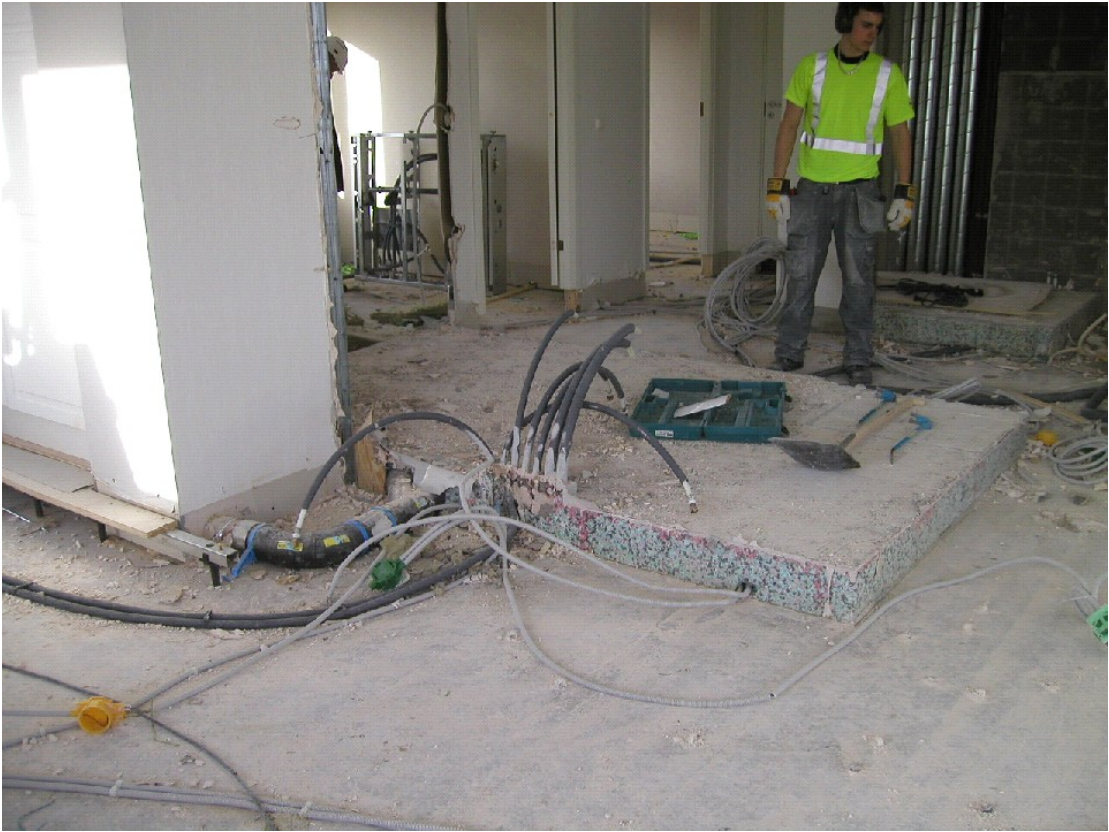
The strip out is completed and the drying out process is ongoing

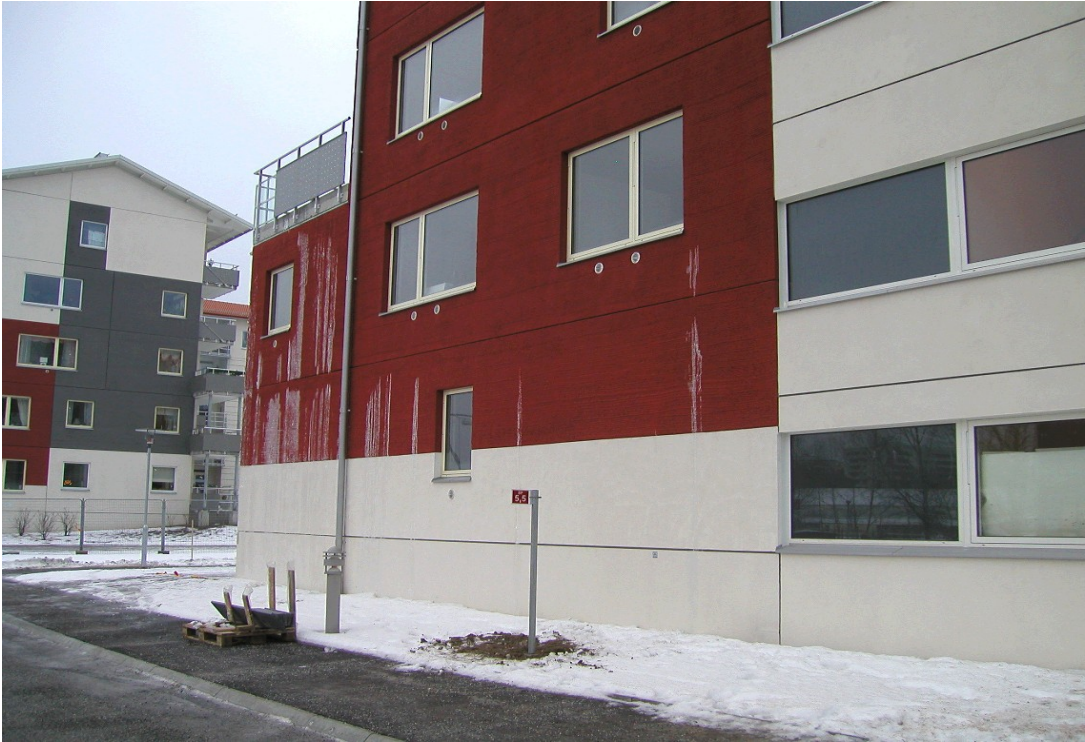
The structure was of prefabricated concrete and due to the volume of escaped water it also penetrated through and poured down the facades. The drying out of the concrete structure was complex and the hollow concrete floor structure had to be penetrated to release water and to make drying out possible.

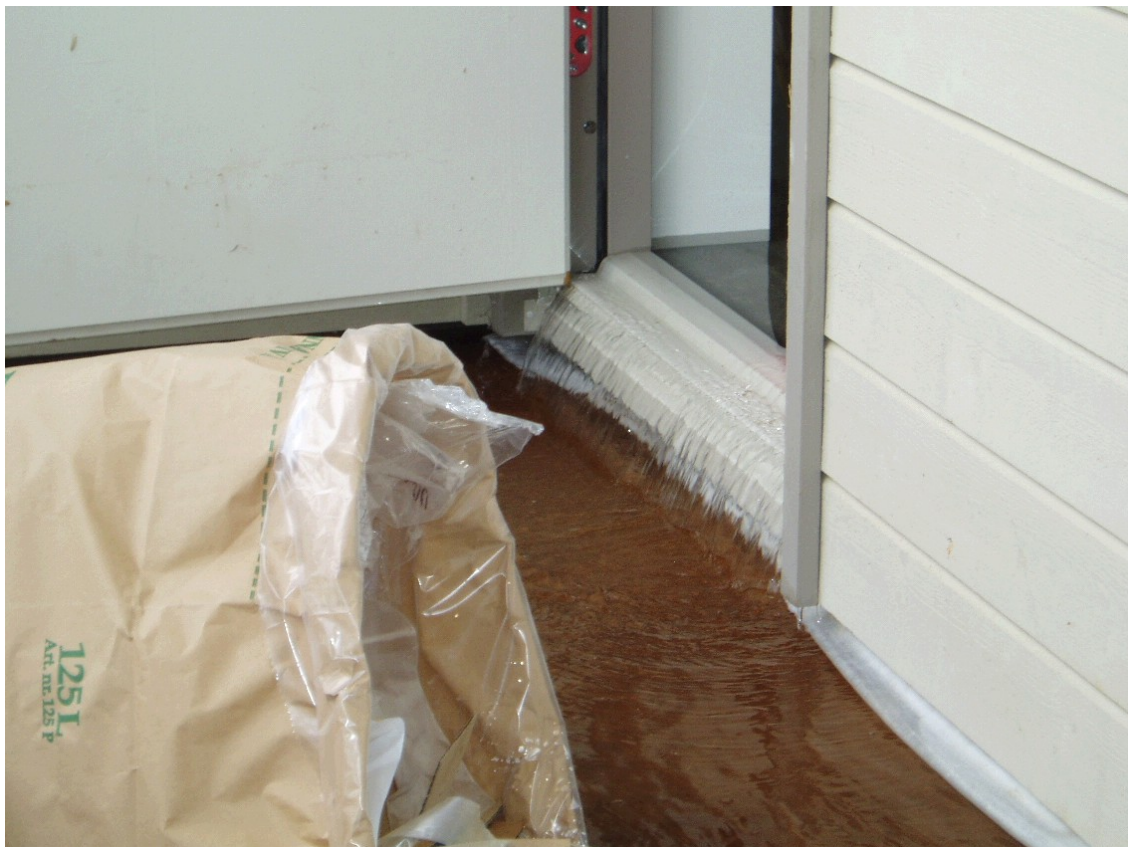
The main inlet pipe (plastic) came loose from the coupling due to faulty workmanship but had initially withstood the water pressure. The water stood 25cm high on the ground floor (no cellar) when the front door was opened. As the house was close to handing over substantial damage was caused to fixture and fittings on the ground floor and had to be stripped out. As the drying process is time consuming the handing over after re-fitting was substantially delayed.

The water standing 25cm high was released when the front door was opened.

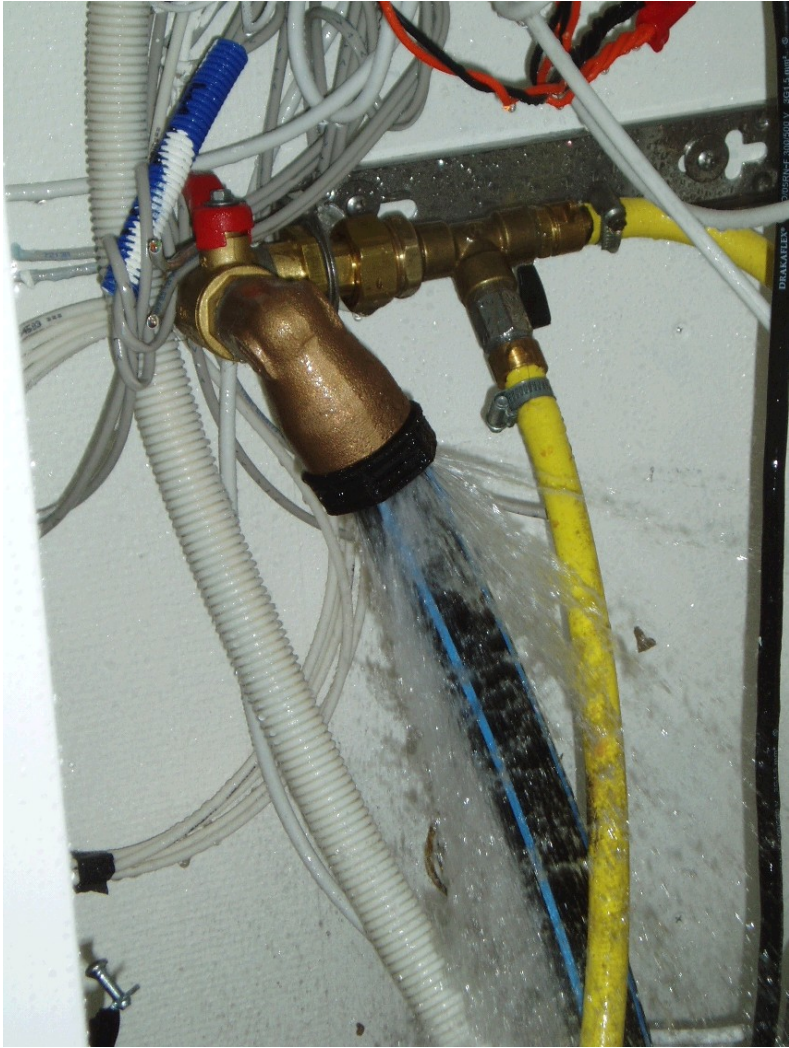
Damage caused by not correctly tightened coupling = faulty workmanship

The cause of loss, a not correctly tightened coupling came loose due to faulty workmanship.
