The road crossing project over the Moskva River with cable-stayed bridge (Zhivopisny Bridge) and damage occurring at a temporary support

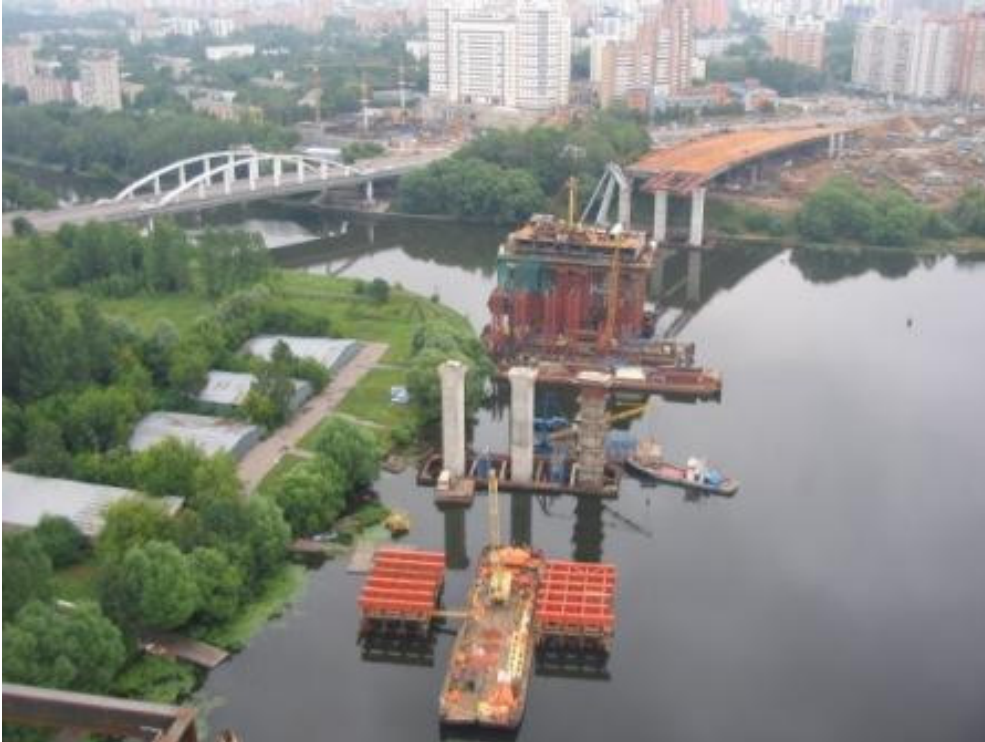
Various stages of construction are shown in the following pictures:

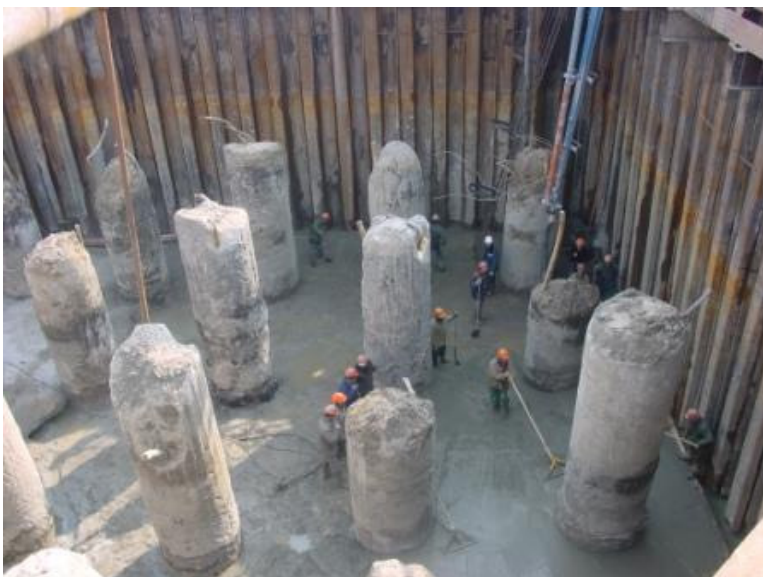
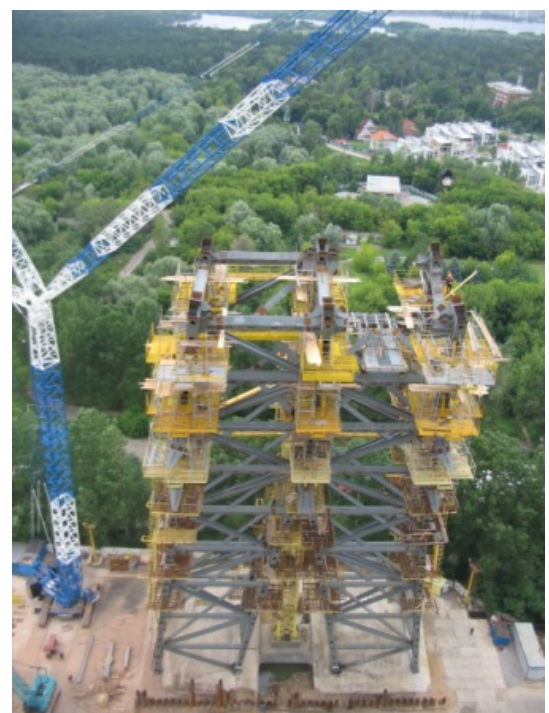
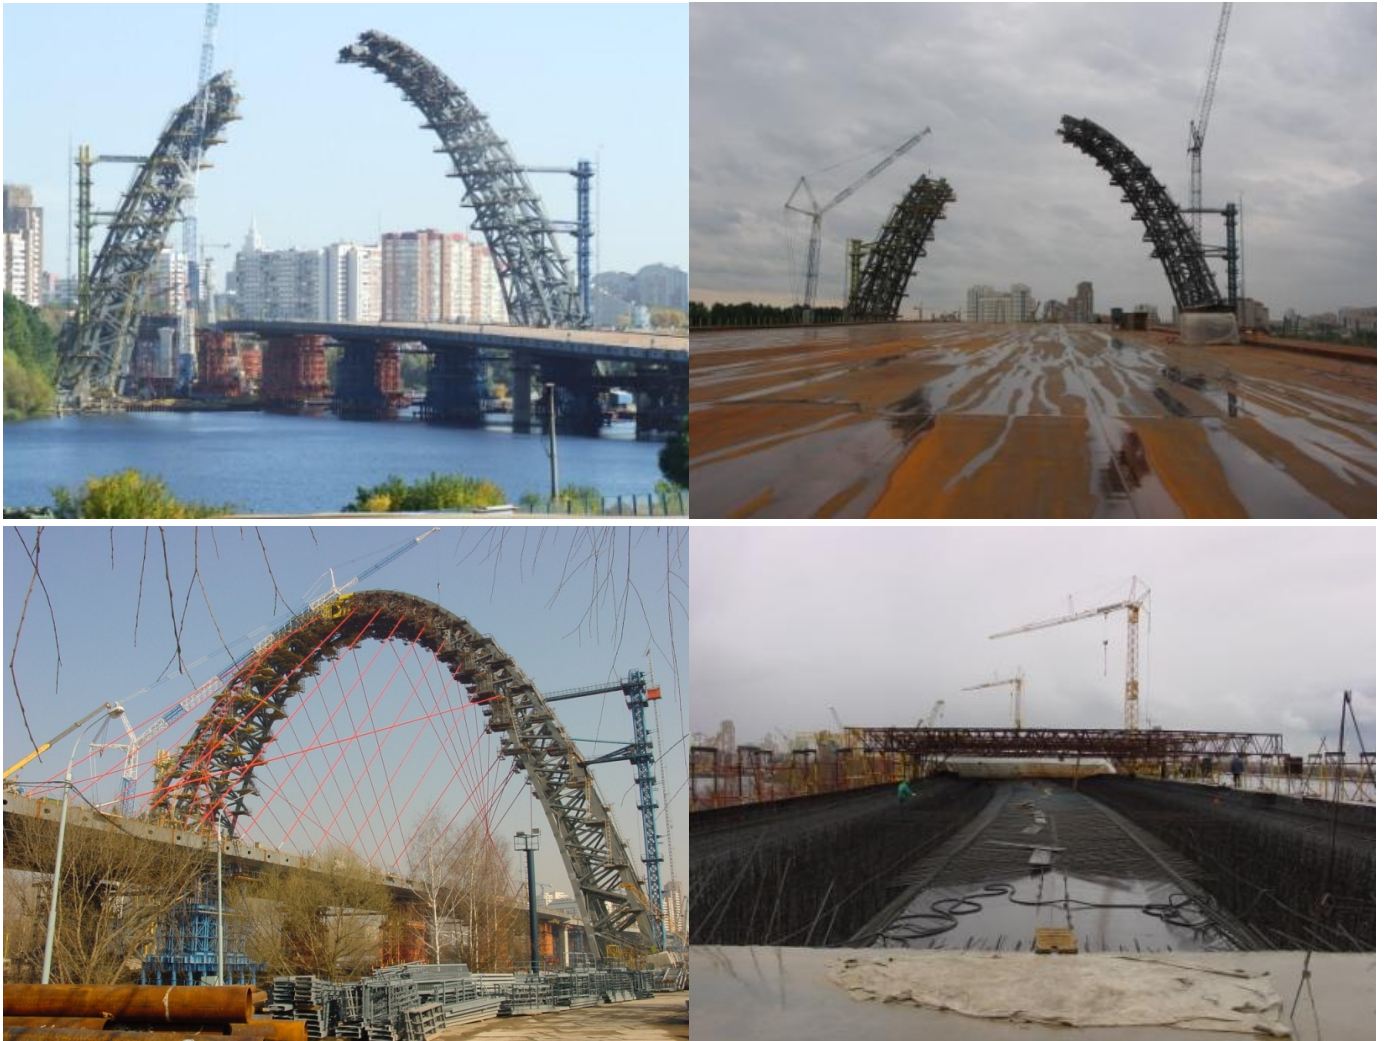
The arch pylon structure was assembled by the semi-cantilever method. As soon as the pylon is built and the superstructure is launched, the cable system consisting of 72 ropes to hold the superstructure to the pylon was installed.

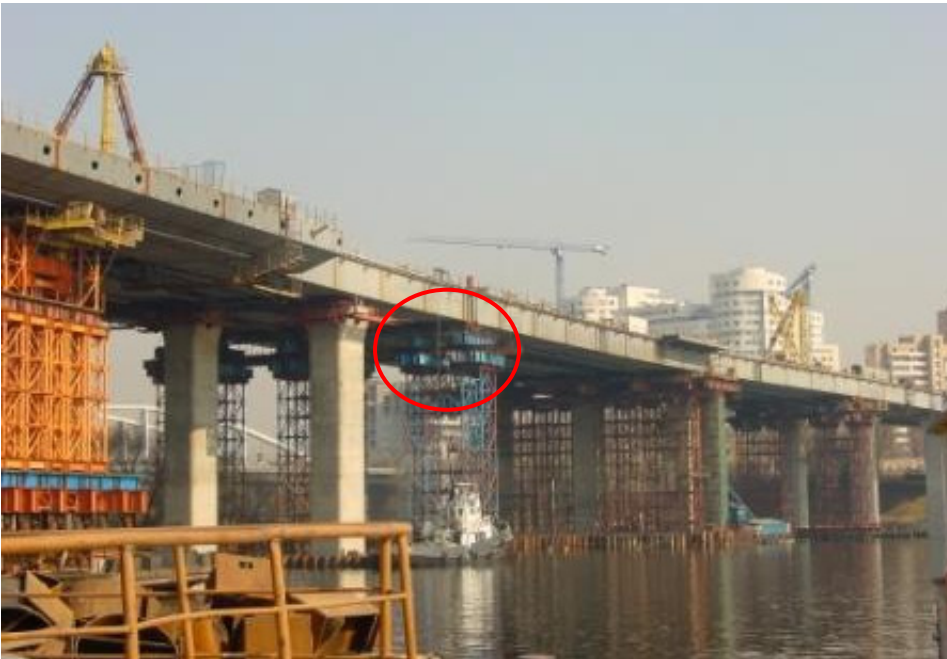
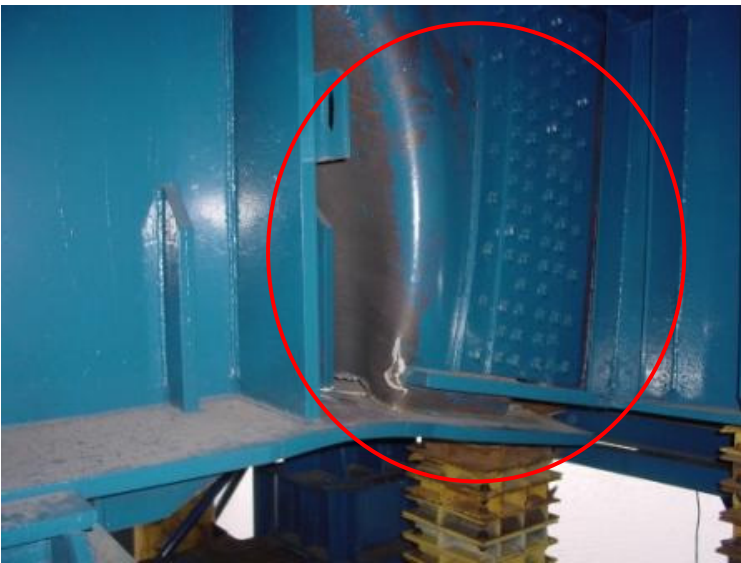
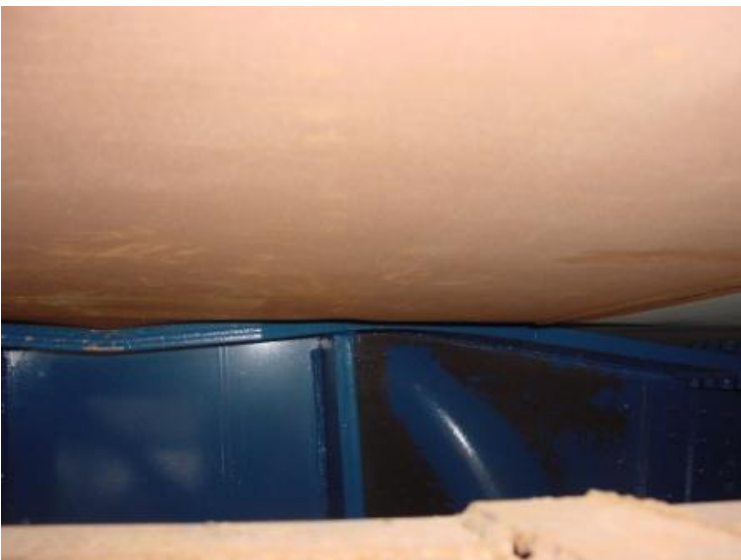
Soon after beginning the next launch cycle of the superstructure section 2-4, bending of the transverse beam occurred when P41 superstructure block passed the right temporary support B04 (marked in red).

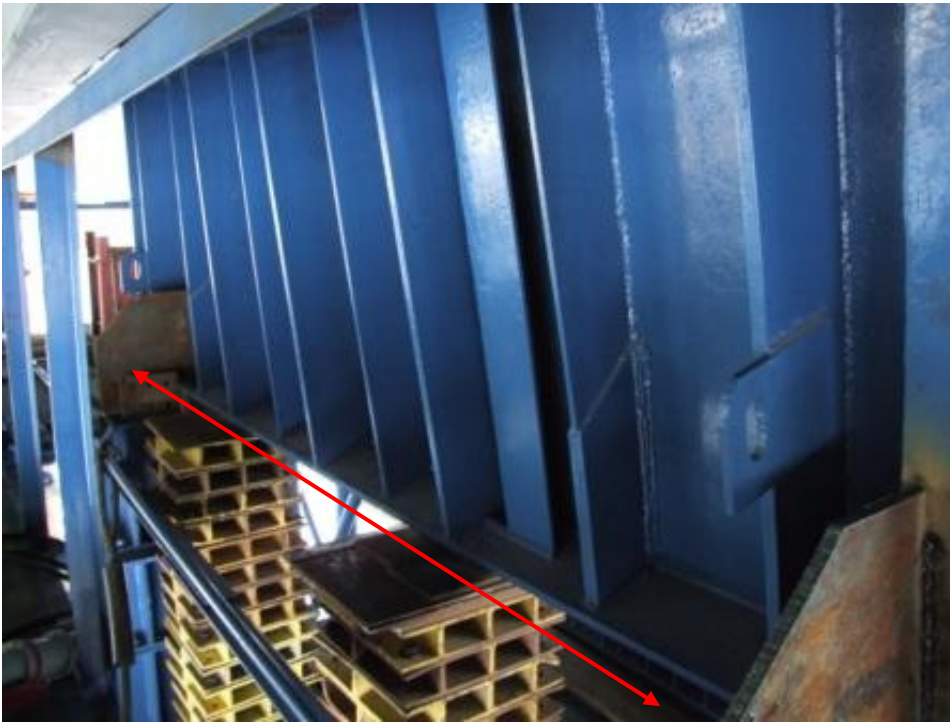
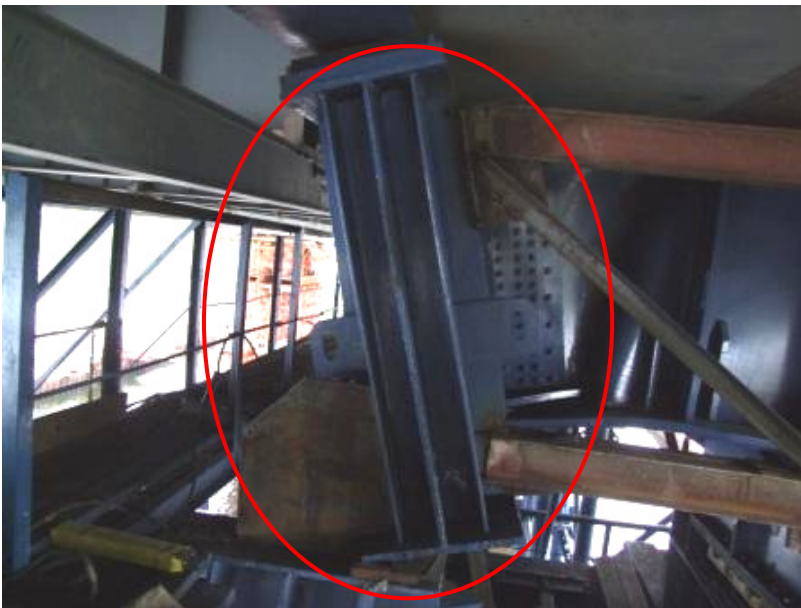
The launching process was stopped. Owing to the transverse beam's bending the following defects took place:

- subsidence of the superstructure at the right temporary support B04;
- local deformation of the superstructure right box girder lower slab by a 120 mm deflection of the slab inward the box girder;
- deformation of sway beam located under the box wall nearest to the bridge axis: the girder got screw-shaped;
- longitudinal sway beam walls of the rolling facility got deflected from its vertical position with the result that the lower slab under the superstructure box girders lost its surface support against the rolling ways;
- failure of the ball bearing under the rolling facility of the cross beam owing to the fact that the upper sway beam rotated in excess of allowable values.

The main cause of the accident is excessive friction while moving the superstructure over the rolling facility in the course of launching, the friction having grown owing to pollution of the rolling ways with abrasive materials used while cleaning the superstructure and the pylon steel surfaces. And this was due to the personnel's negligence in removing the cleaning waste material from the rolling tracks. Besides the BO4 right temporary support also other temporary supports suffered damage.

Owing to the accident, the rolling facility at BO4 of the right temporary support and the ball bearing under this facility could not be used any more. The rolling facilities at BO4 (left), BO5 and BO6 temporary supports as well as the deformed lower slab of the P41 superstructure right box girder could be repaired.
