## Top of Switzerland – Opportunities, Threats and Challenges of mountain rail- and cableways systems

Schilthorn – Piz Gloria: Best view of Eiger, Mönch and Jungfrau!

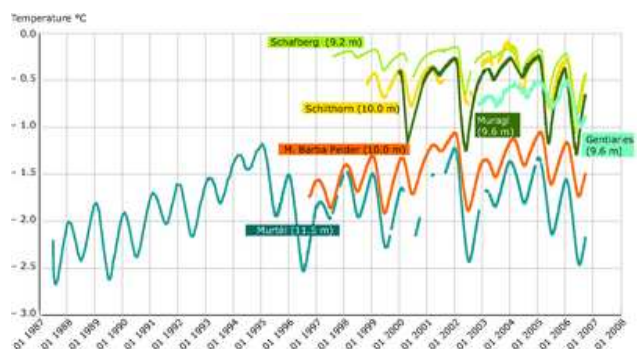
Temperature measured in different boreholes in mountain permafrost in Switzerland 1987-2007  
(source: <http://www.eea.europa.eu>)

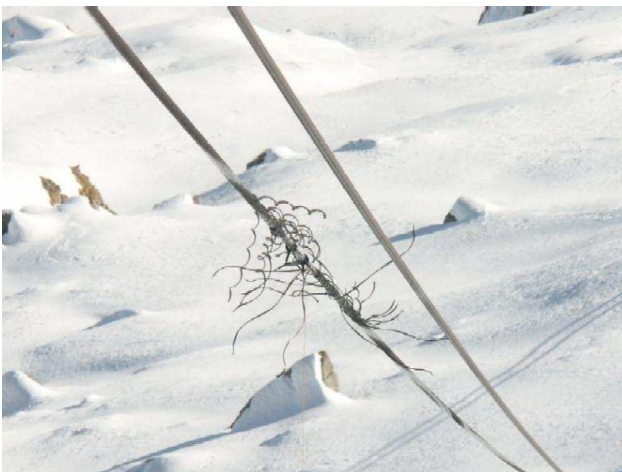
Damage on the track cable wire

What was the cause of this accident? By the first cable movement in 1979, an abrasion took place between the track cable and the deflecting piece of the top terminal. The abrasions were not discovered by the stipulated visual controls. In the course of time microscopic cracks occurred in the area of the abrasion from hydrogen-assisted stress-corrosion cracking (HSCC). The progressive damage of the wires could not be detected by the last magnet-inductive test in 2003, due to the fact that at that time, most likely, no wire had broken yet. With time some cracks had reached a critical size which led to the spontaneous break of the affected profile wires. There appeared a concentration of cracks, consisting of approx. three to four adjoining spontaneous breaks. The broken profile wires came out of the main cable. Other profile wires were overstrained and have also broken. The released energy of the cable lead to a chain reaction with which all profile wires broke. The amount of loss added up to approx. CHF 3 million (including Business Interruption).

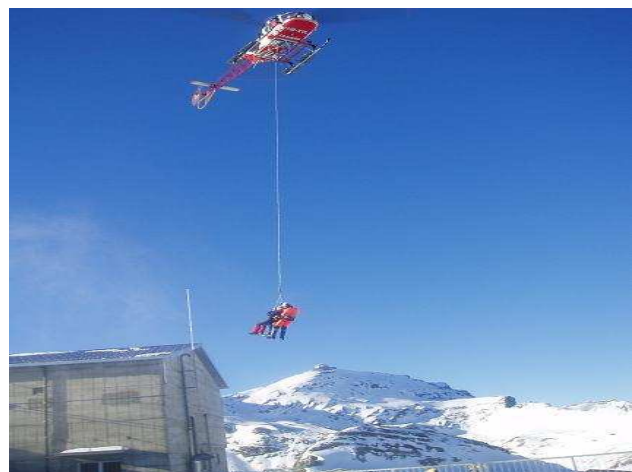
The Schilthorn accident on 29<sup>th</sup> of December 2004 confirmed that cableway operating companies are advised to be concerned with insurance. What happened? One cabin of the cableway was traveling uphill with 53 persons on board. Around 150 m below the summit, the cableway was urgently stopped after staff heard an ear-splitting bang and saw that one of the track cable wires had come out. All passengers were safely rescued by helicopter. Due to rapid and correct response of the staff, no one was hurt.

Recovery by helicopter
