Slide No. 117
 Collapsed highway bridge deck. Indicated faulty zone was found only 16 meters from the pillar

Amount of Loss	Nil
Cause	Faulty workmanship, mainly poor welding work.
Short description	When a 90 ton trailer crossed the 4-year-old bridge, the bridge suddenly collapsed.
Comments	The investigations revealed poor quality of weldings through lack of supervision. Further observations show a thin and badly executed concrete deck and strange design incorporating thin steel members. Faulty workmanship as the cause is supported by the fact that the faulty zone was found only 16 m from the pillar of the 50 m middle span. If the collapse were produced by a live load on a healthy structure, the collapse would have more likely occurred in the middle of the span. The policy covered "named perils": fire, earthquake, storm, floods, rockfalls, aeroplane crashes and vandalism. Therefore the refusal of the claim was accepted by the insured.
Conclusion	If a competent engineer had checked the structure, which should always be the case before issuing a CC-policy, his report would have warned the insured about the critical condition of the structure and the collapse could have been avoided.

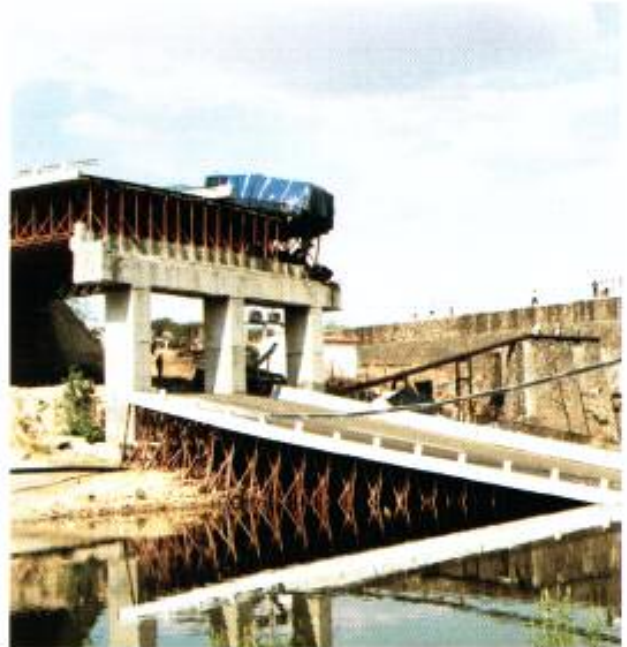
Slide No. 118
Collapsed bridge as part of highway

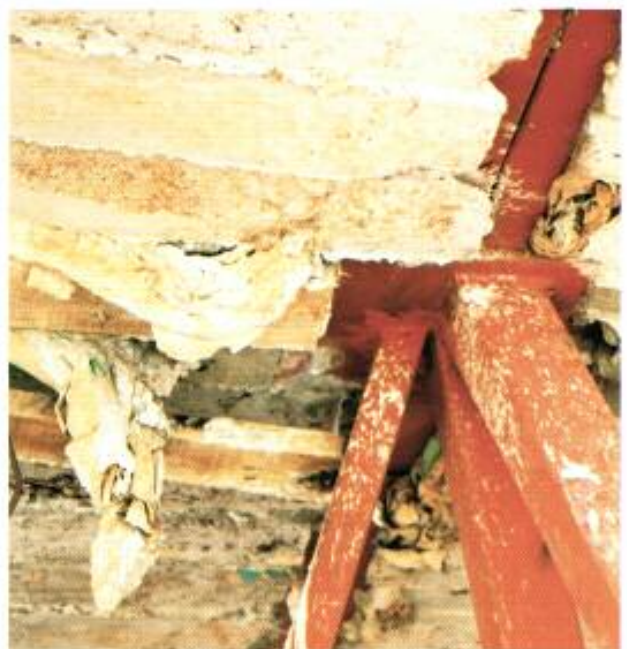
Slide No. 120
One of the welds which failed by simply coming loose
