Slide No. 205
Flooded and caved in trench

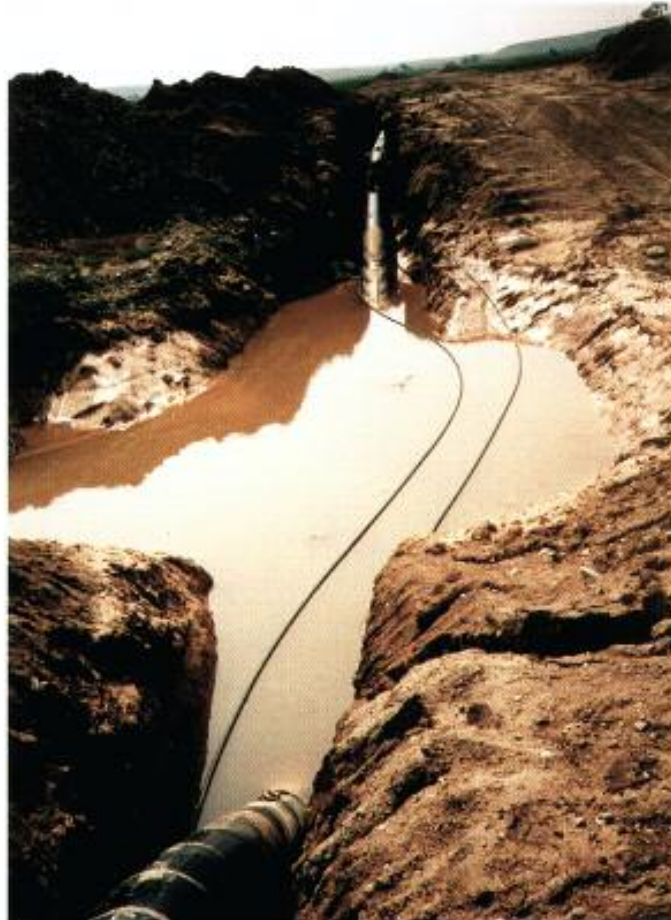
Heavy rainfall led to the trenches being flooded during construction of the pipelines:

- Sand bedding and padding were washed away.
- Trench walls partially collapsed and the trenches filled with water, mud and other materials.
- Pipes were lifted out of the trenches.

No limits on the maximum length of non-backfilled trenches were laid down in the policy. As a consequence, contractors left open trench sections of over 20 km in length for more than one month during the winter.

The maximum length and time periods allowed for open trench sections sections must be stipulated in the policy. It is also important that a precise definition of the term "single occurrence" be given in the policy.

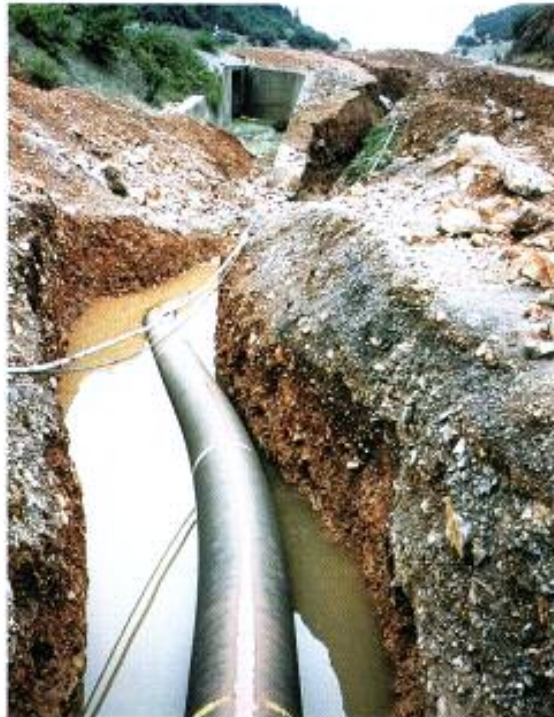
Slide No. 206
Flooded trench

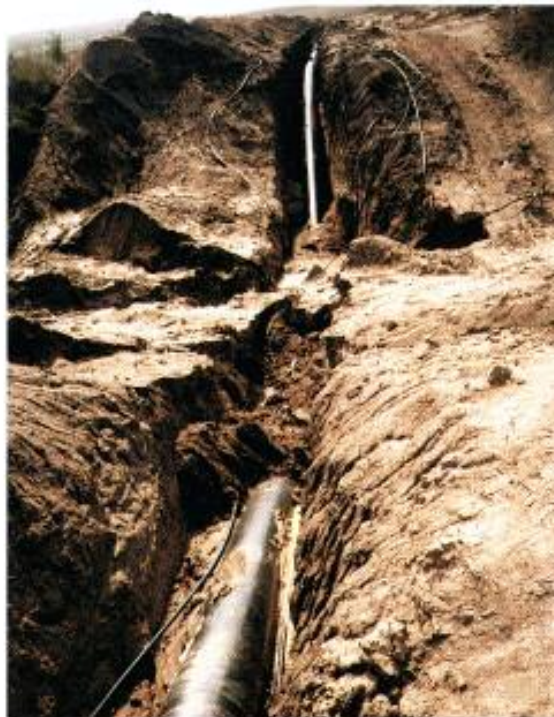
Slide No. 207
Eroded and collapsed trench
slopes
