## DETAILS OF INTERESTING CLAIM

No: DOIC 39

Lime Kiln Failure

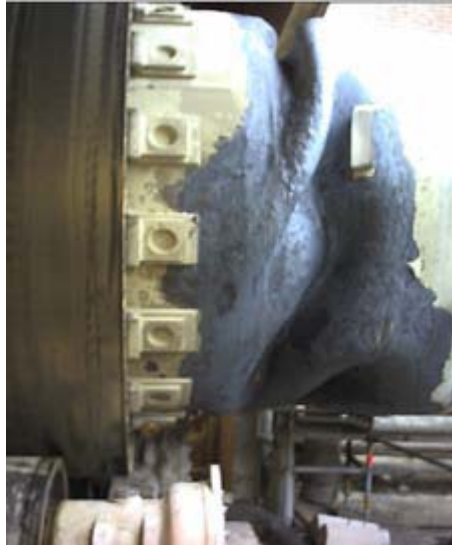
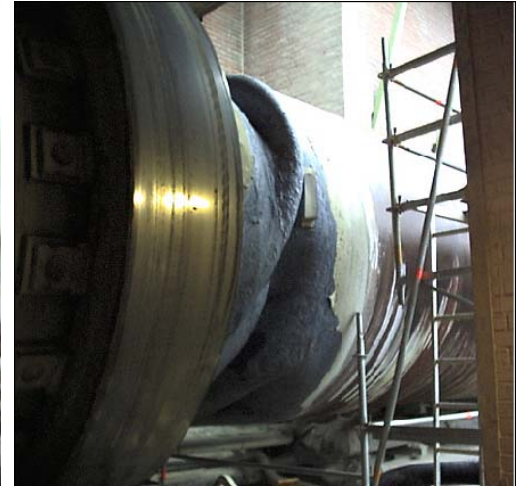
Failure of casing to lime kiln, which has suffered plastic deformations in “screw” form.

The brick lining had become detached in the combustion zone of the kiln, in a ring form around the casing. Rapid heating of the casing material (steel 30-500mm) had taken place locally, until it had been plasticized, after which warping had occurred.

Replacement of a 4,2m long casing part, which was welded to the existing part. The thermographic heat scanner should cover the whole lime kiln.
