EAR+DSU/ALOP – Damage to pipe rack due to collapse of adjacent concrete water tank (not insured under the policy)

SARAS is one of the largest refineries in Europe. It was built in the early fifties and is located in Sardinia, Italy.

The construction of the Sarlux Integrated Gasification Combined Cycle (IGCC) project within the refinery began in December 1996 and was completed about 5 years later. The plant converts heavy oil residues provided by the refinery into synthesis low calorific gas ("SYNGAS"), which in turn powers gas turbines to produce electrical energy. The energy is sold to "Ente Nazionale per Energia Elettrica s.p.a" (ENEL), the Italian state-owned electricity utility. The plant also supplies steam and hydrogen for the process units in the refinery.

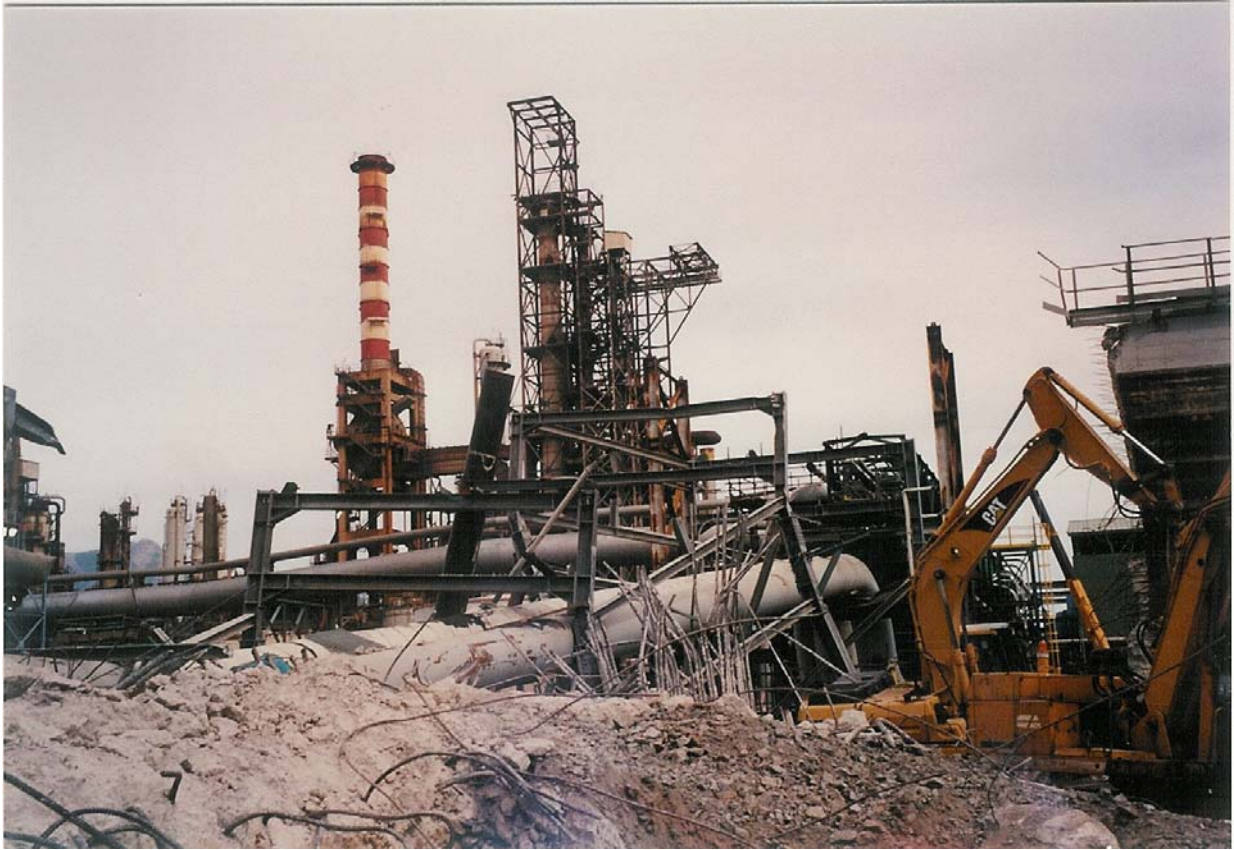
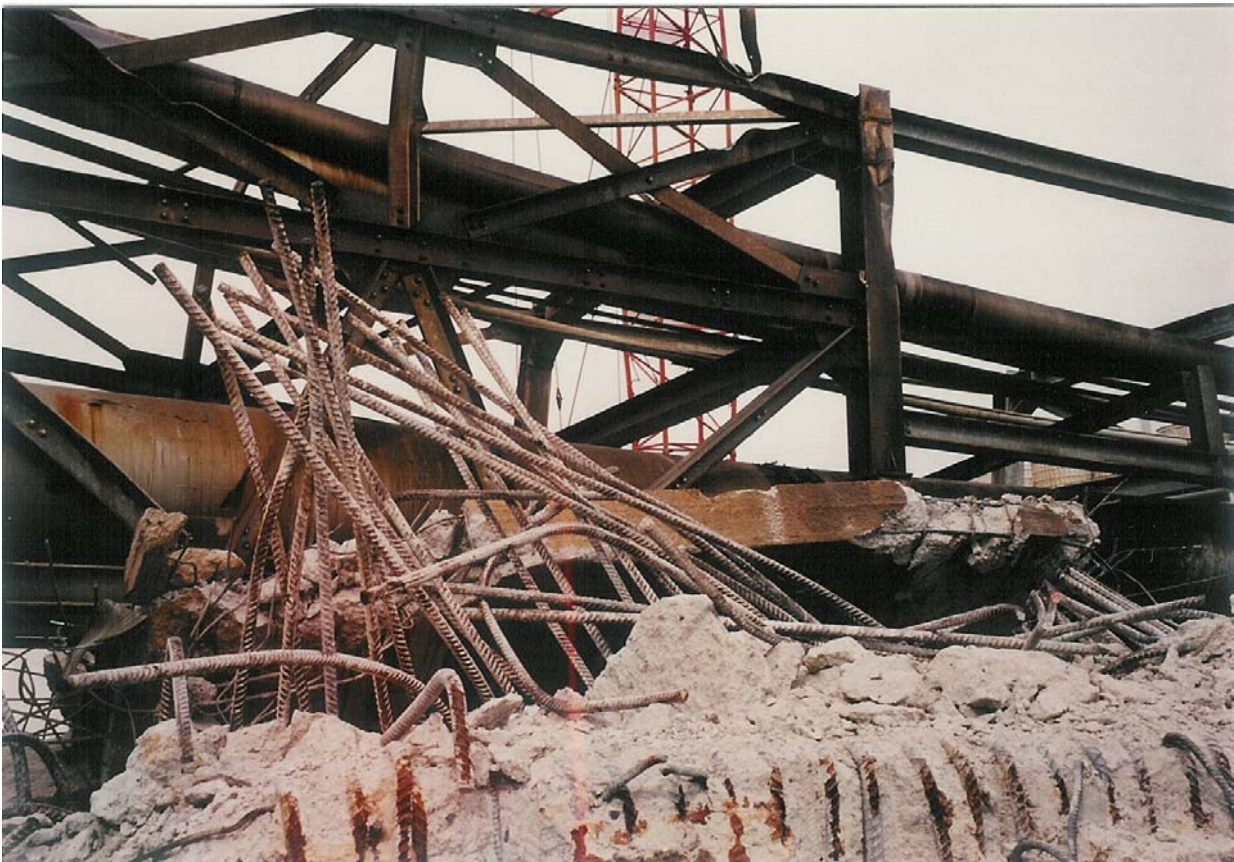
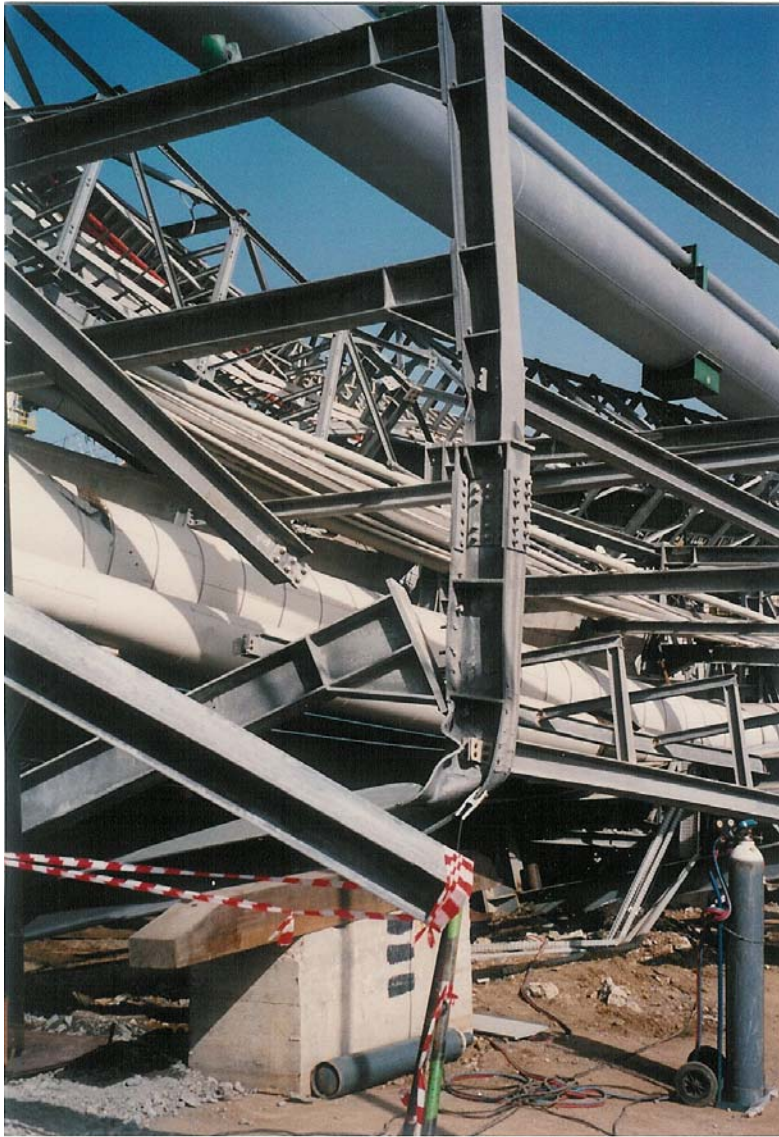
The operator detected the collapsed pipe rack section and a surrounding area flooded by water. Further investigation revealed that the concrete waste water basin installed close to the rack structure – which was being filled up for the first time and due to faulty design - had burst impacting the rack and releasing about 15.000m³ of water. The rack collapsed along a length of approximately 80m.

It was only good fortune that the 60 inch blown down pipe containing high inflammable syngas was only distorted and not leaking, as the procedure to vent the complete plant from syngas took two hours and was only possible by using this pipe.
