Part I:

Observations on tunnelling in general

Application of Wordings – Case studies

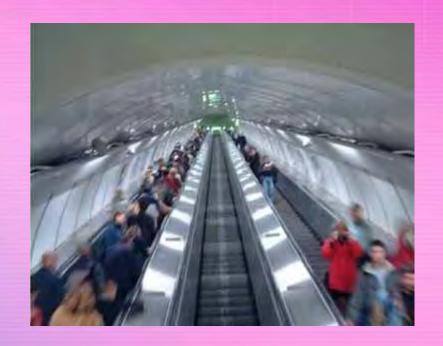
Depth of tunnel determined by financial/political considerations e.g. Escalator length

- 90m long / 65m deep escalator in Prague Metro
- Significantly deeper in Moscow
- Longer escalators can save 100's of millions of dollars / years of construction time...by reaching "economic" rock formations

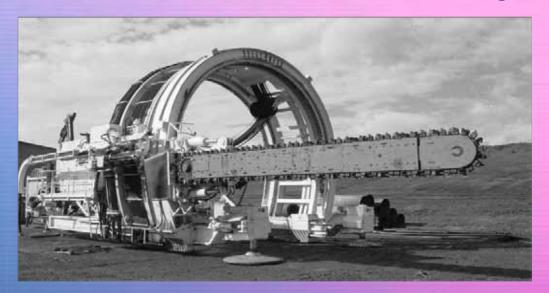
- Rail line diversion Prague Chomutov with 1.7 km tunnel
- Tunnelling predominantly in plastic clays and claystone
- Area affected by undocumented coal mining activities
- Use of Perforex or "Pre-vault" Tunnelling Method

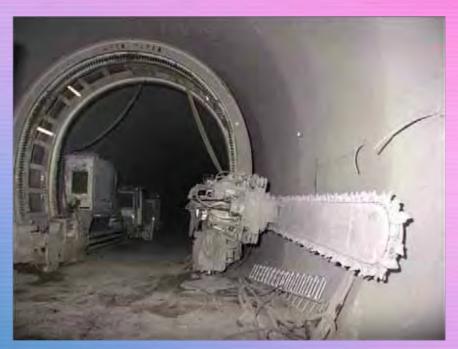
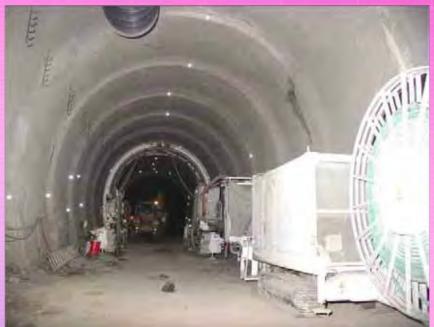
Perforex chain saw and back-up

Perforex "Prevault" Tunnelling Method

- 20cm thick 5m long slits cut along tunnel circumference
- Slits then filled with sprayed concrete
- Overlapping slits form protective pre-vault
- Full face excavation follows by invert closure

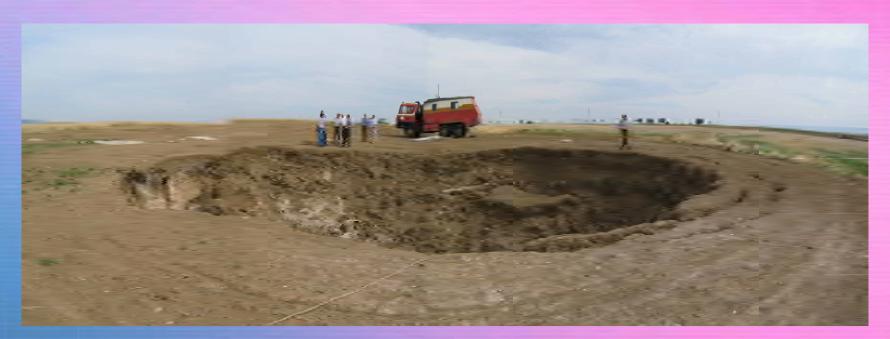
May 2003 prevault 196 collapsed triggering 80m collapse at 27m depth

Loss considered to be "faulty design" since model used to verify tunnel geometry did not:

- Reflect soil conditions encountered
- Correspond to structure specified on design drawings
- Adequately model the construction sequence

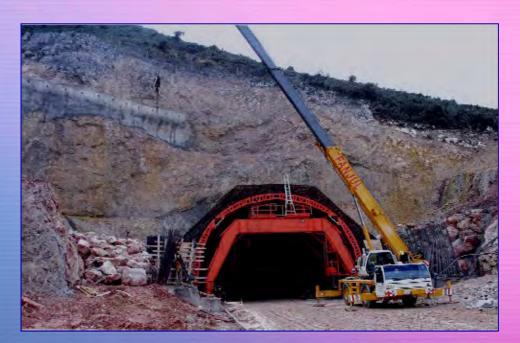
- 550m tunnel for High speed Rail Link Barcelona- Lleida Spain
- Tunnelling predominantly in plastic clays and claystone
- Area affected contained known geological slickenside fault

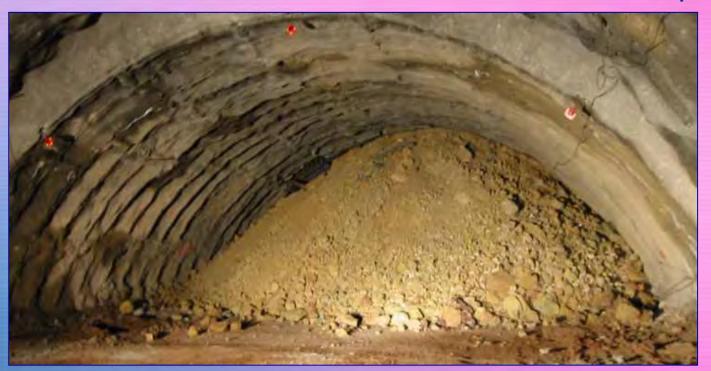
Following a period of heavy rain and tunnelling advance of 40m, northern tunnel entrance collapsed

Loss occurred as consequence of:

- 30m false tunnel length inadequate
- Failure to provide adequate surface water drainage at geological fault location
- Slope design at northern entrance too steep

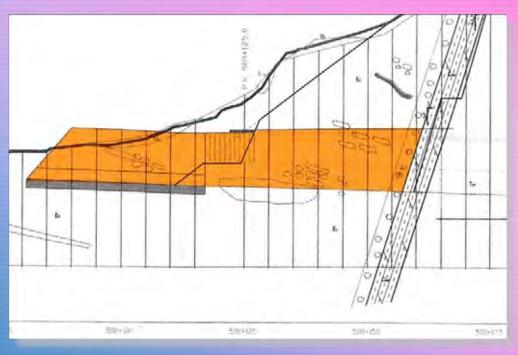
Original Design:

- "Cut and cover system" 30m from northern tunnel entrance
- Construction of "False Tunnel" (Reinforcement tunnel arch by reinforced concrete) up to geological fault crossing tunnel route at 60m
- Tunnel excavation through solid material up to geological fault from southern direction

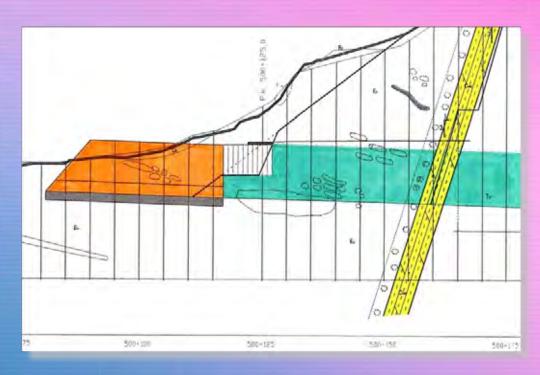
Alternative design adopted:

- Slope excavation in clay with inclination 3:2 30m from northern tunnel
- Construction of a "False Tunnel" 30m length
- Placement of fill to support lower slope section and lateral tunnel slopes
- Tunnel excavation from
 southern direction carried out
 after false tunnel completion/
 slope protection

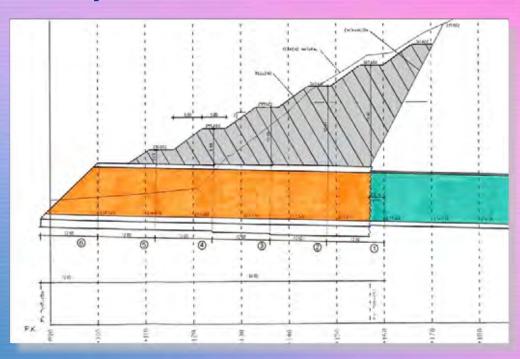
Tunnel repair followed original design, but more expensive due to:

- Removal of collapsed slope material
- Slope stabilisation at fault zone
- Construction of longer "False Tunnel" up to geological fault zone crossing tunnel route heavy reinforcement steel structure
- Replacement collapsed slope material to original profile

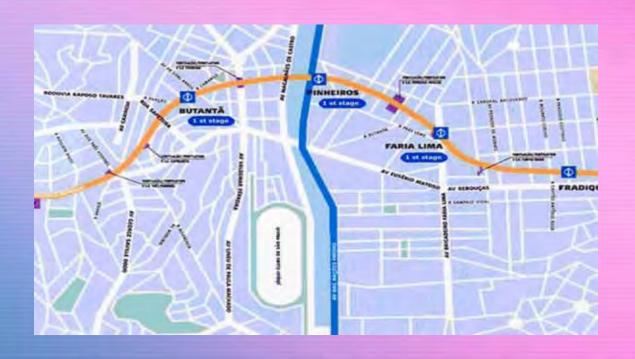
12.8 km of tunnels and 11 stations

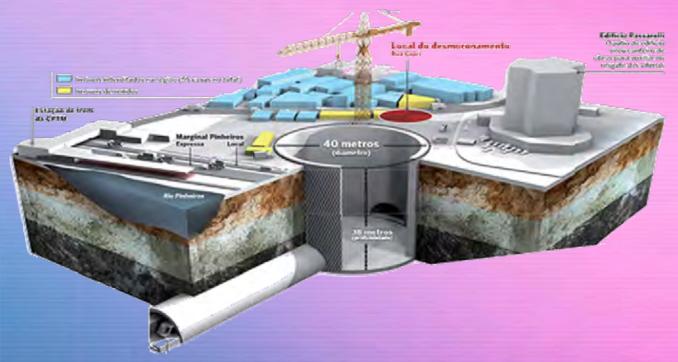
Cutaway section through Pinheros station shaft

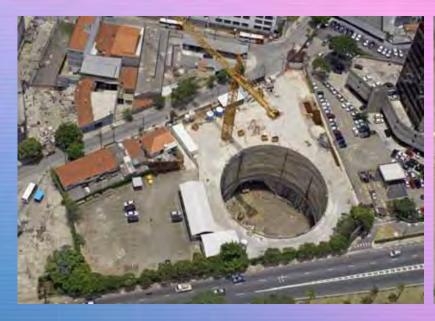
One week before collapse

- Convergence readings increased over Christmas break
- Collapse of tunnel, 8 people dead, extensive TP damage

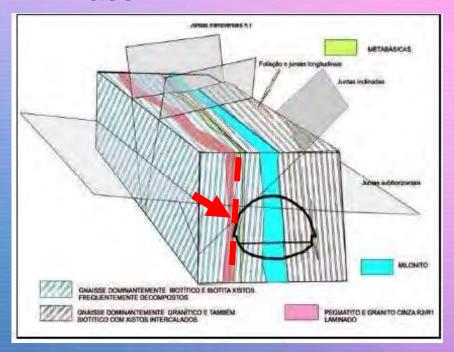
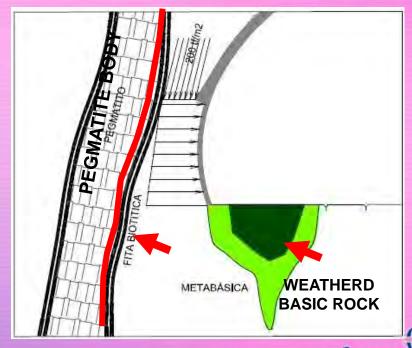
- Unforeseen adverse geological conditions
- Weak micaceous weathered layer within lateral rock mass

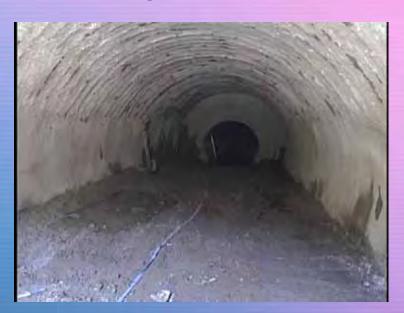
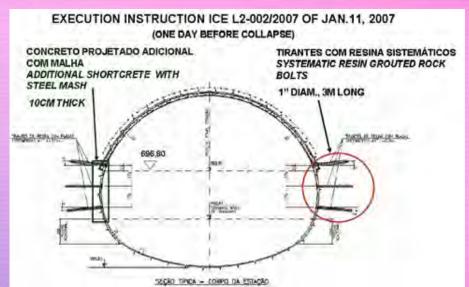
Meeting with designer day before failure on 11th January 2007:

Designers recommended installation of 3 lines of rock bolting each side with 10cm mesh reinforced shotcrete

- Unforeseen geology
 - "combined effect of a number of geological features, some of which were known at the time of the design some not foreseen, probably not foreseeable"
- Insured failed to install rock anchors to walls of the first bench required for (foreseen and unforeseen) ground conditions encountered at this section
