Debris of collapsed concrete grain silo

Concrete grain silo

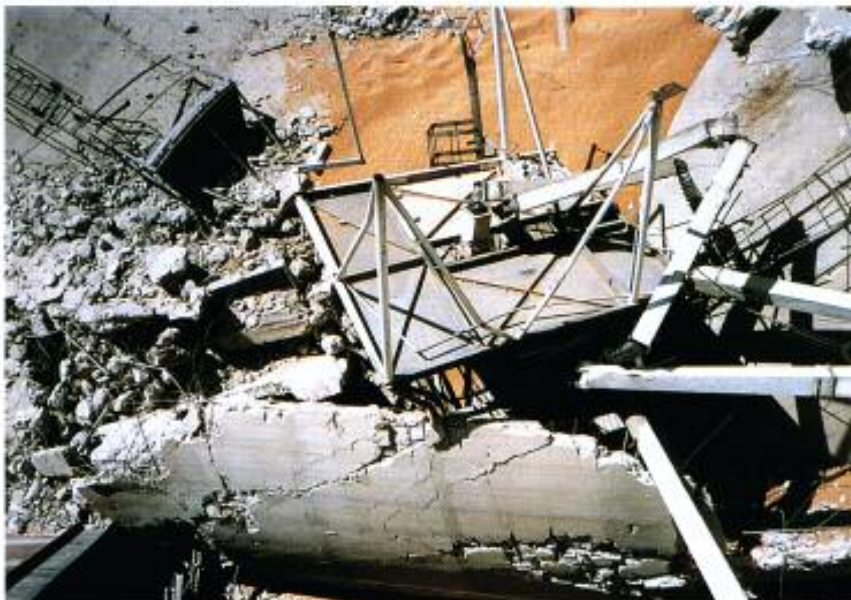
Slide No. 49

The collapse of one of two 14-year-old silos was caused by the severe corrosion of steel bar reinforcements due to cracks in the concrete structure where dampness seeped into the structure and attacked the iron bars.

The durability of reinforced concrete is basically determined by the quality of the concrete itself, the sufficient cover of the steelbars with concrete, the aggressivity of the air (i.e. near the sea) and the safety margins in the design calculations. Too often only static force to silo walls is taken into consideration whilst the increased force created by moving stored material when emptying the silo is neglected. This can cause too much stress on the structure leading to cracks in the concrete.

Modern design theory has to be applied and sufficient concrete cover of steelbars should be provided.
Adequate concrete quality tests and checking of position of steelbars and their fixation before concrete pouring have to be observed.

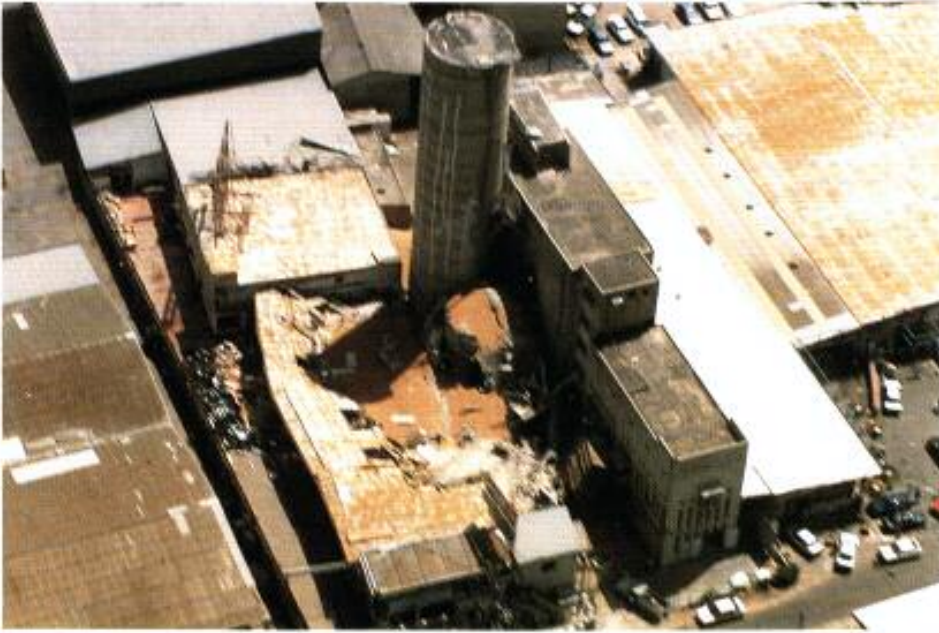
Slide No. 50

Aerial view showing collapsed silo next to undamaged one and damage to third party property

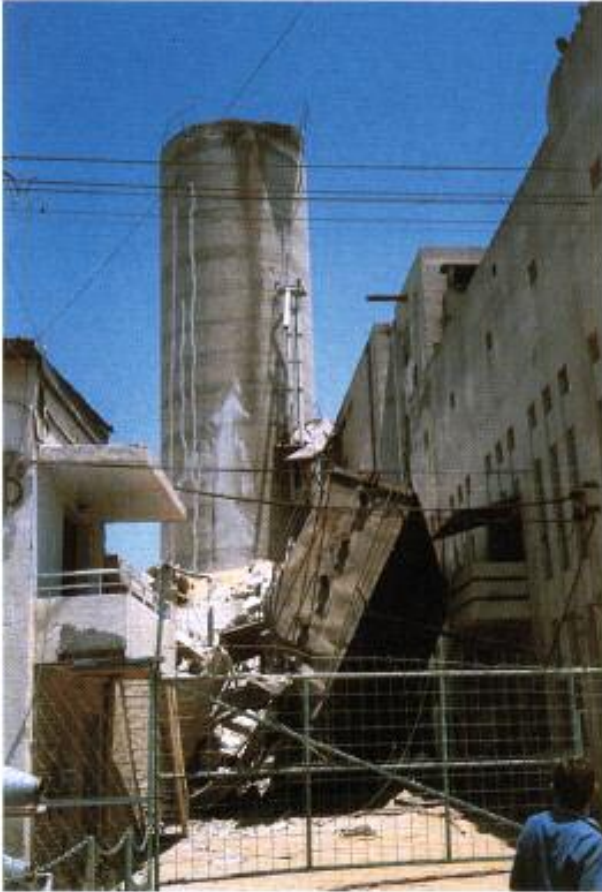
Slide No. 51

Undamaged silo and debris of collapsed silo
