DETAILS OF INTERESTING CLAIM

No: DOIC 41

Recovery boiler

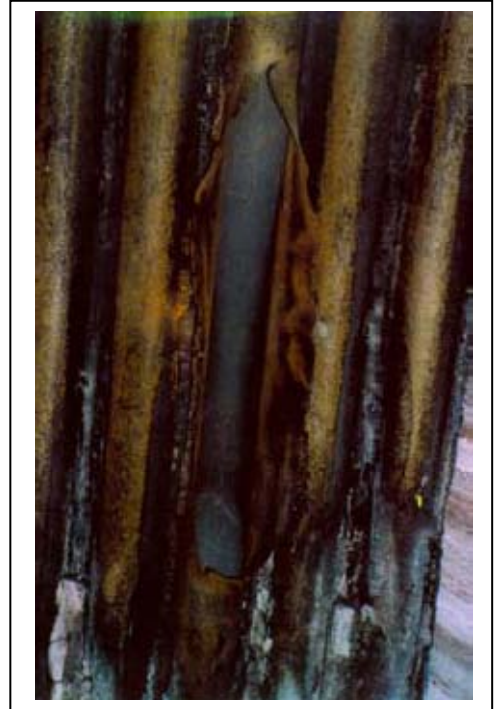
A catastrophic explosion followed after water came in contact with the smelt. The shock wave caused the boiler to deform and burst open in one corner. A fire developed after the explosion due to red-hot smelt spreading into the area. A water tube fractured under pressure allowing water to leak into the combustion chamber. The cause of the fracture of the tube is not determined.

It was possible to salvage the steam drum of the boiler, which meant that the plant was back in operation after a downtime of only four months.
